Errata Sheet

Rel. 1.7, 2010-02-19

Device	**TC1766**
Marking/Step	**EES-BB, ES-BB, BB**
Package	**PG-LQFP-176-2**

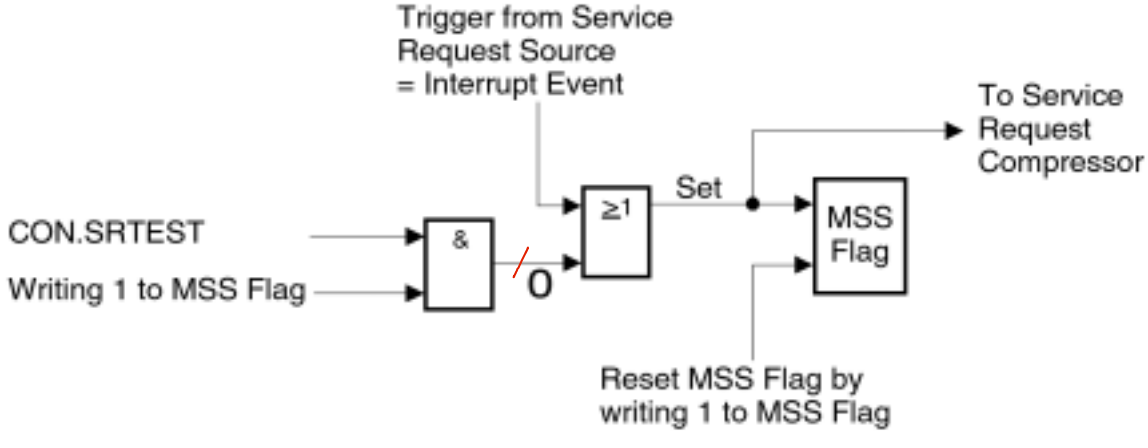
Figure 1

ADC_TC.023 Setting the MSS-flag doesn't generate an interrupt in TEST-MODE

It is possible to generate a software triggered interrupt event in TESTMODE (ADCx_CON.SRTEST=1) by setting one of the bitflags in register ADCx_MSS0/1. Due to the fact, that this mechanism is not working, it is not possible to generate a corresponding interrupt by software.

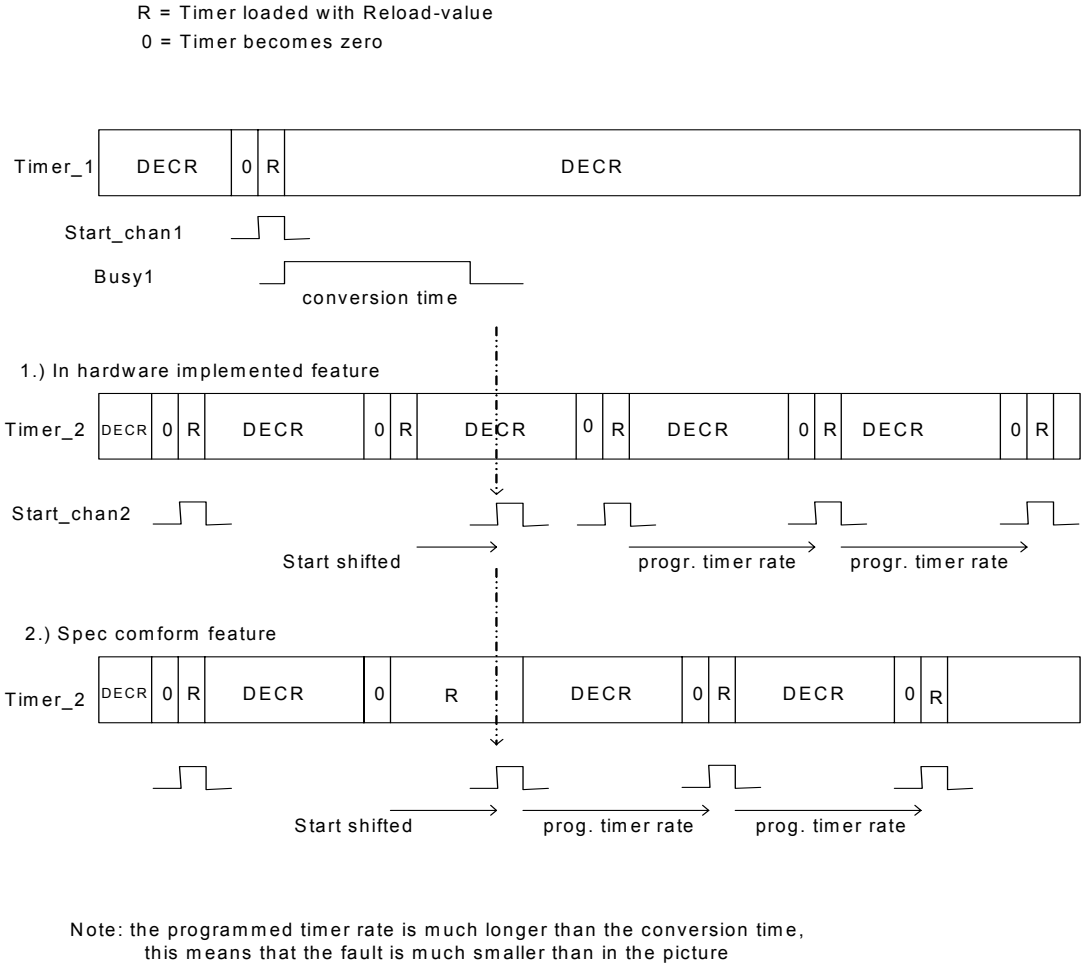
The correct behavior would be a reload when the requested conversion (of channel_2) is started.

Therefore the start of conversion for channel_2 is delayed by maximum one conversion-time. After this delay it will be continued with equidistant conversion-starts. Please refer to the following figure.

Figure 2 Timing concerning equidistant multiple timers

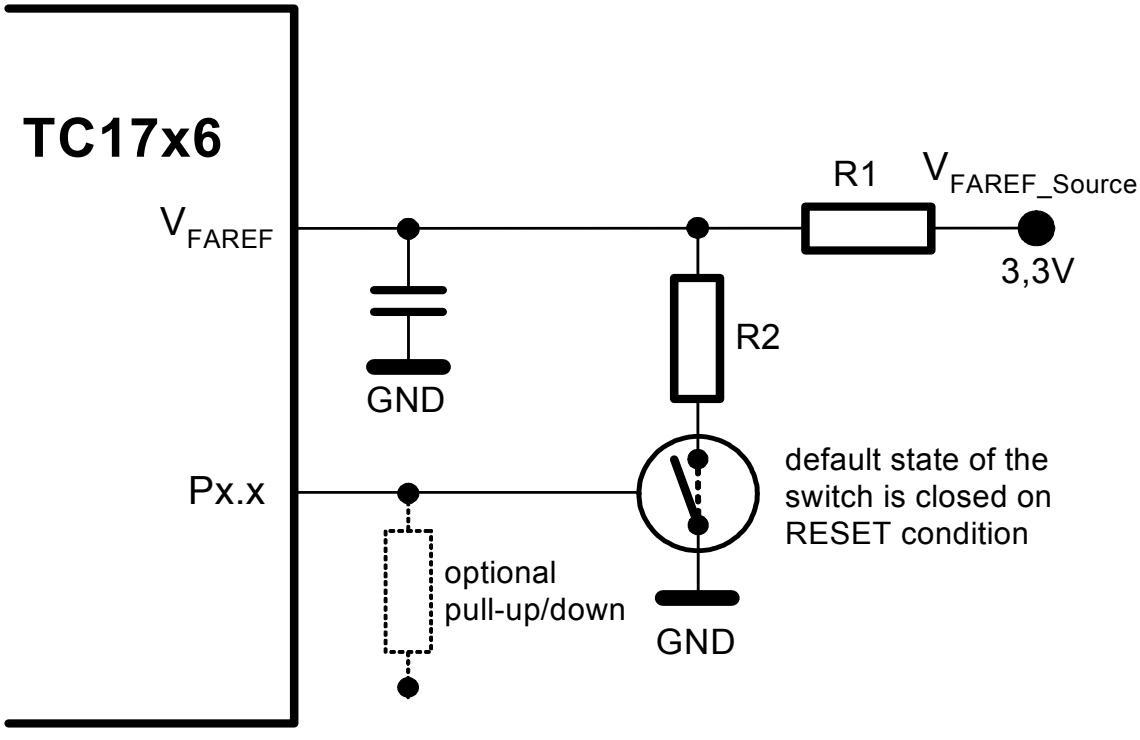
Figure 3

Stress minimization over lifetime can be achieved by the introduction of a small external circuitry applied to the V_{FAREF} pin. The circuitry might consist e.g. out of a switchable voltage divider applied to V_{FAREF} pin, which as default in any reset condition of the device assures voltage levels between 0 V to 1.65V.

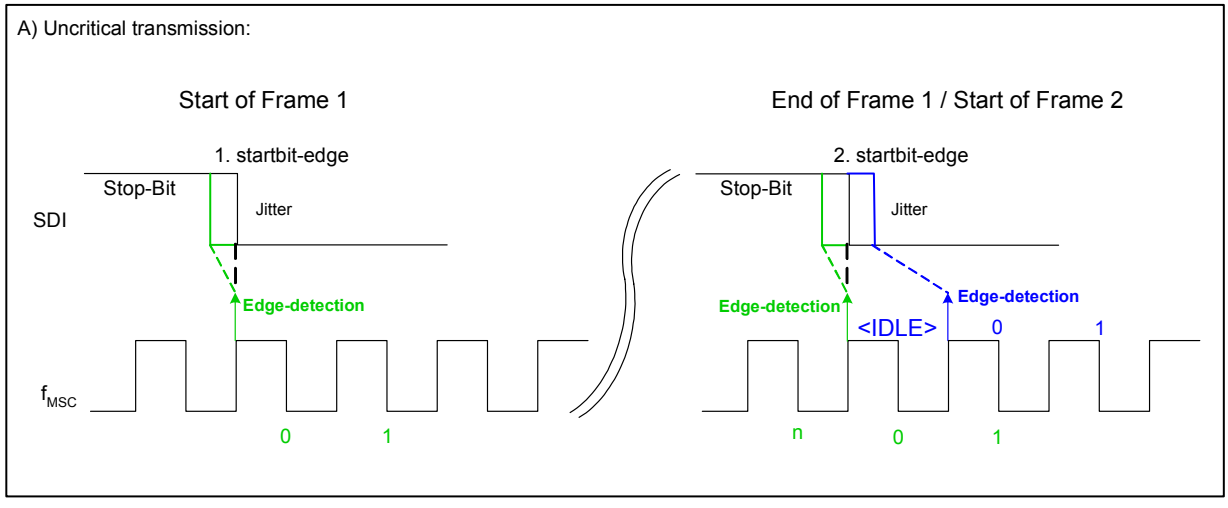
Figure 4 Uncritical transmission

As the falling startbit edge is shifted to the left of the rising clock edge (**Figure 4** left), there occurs a secure detection of the next start-bit edge in the last cycle of the previous frame (here cycle n, **Figure 4** right) independant from the applied jitter to this edge.

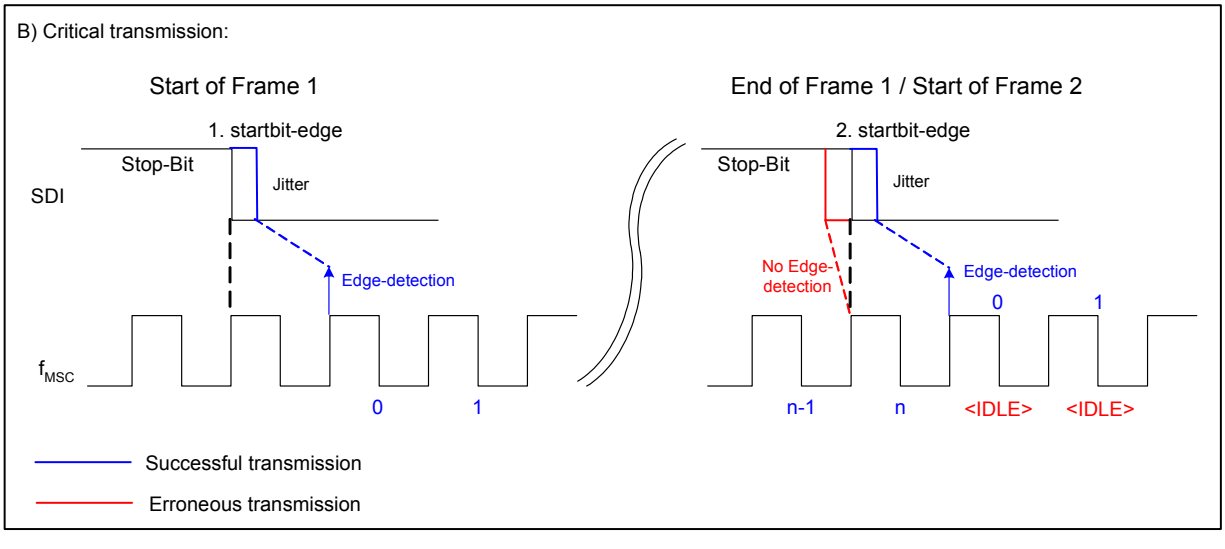
Figure 5 Critical transmission

If the high-low edge of the start-bit in the first frame is just not detected by the near clock-edge (**Figure 5** - left) and the start-bit edge of the second frame is jittering to cycle n-1 (**Figure 5** - right, red coloured), then an erroneous transmission will take place. In this case the state-machine switches to IDLE after the last state n and wakes up on the next falling edge that may be a data-bit recognized as a start-bit. If the start-bit of the second frame is jittering to cycle n (**Figure 5** - right, blue colored), then the state-machine will not switch to IDLE but will start receiving the next frame correctly.

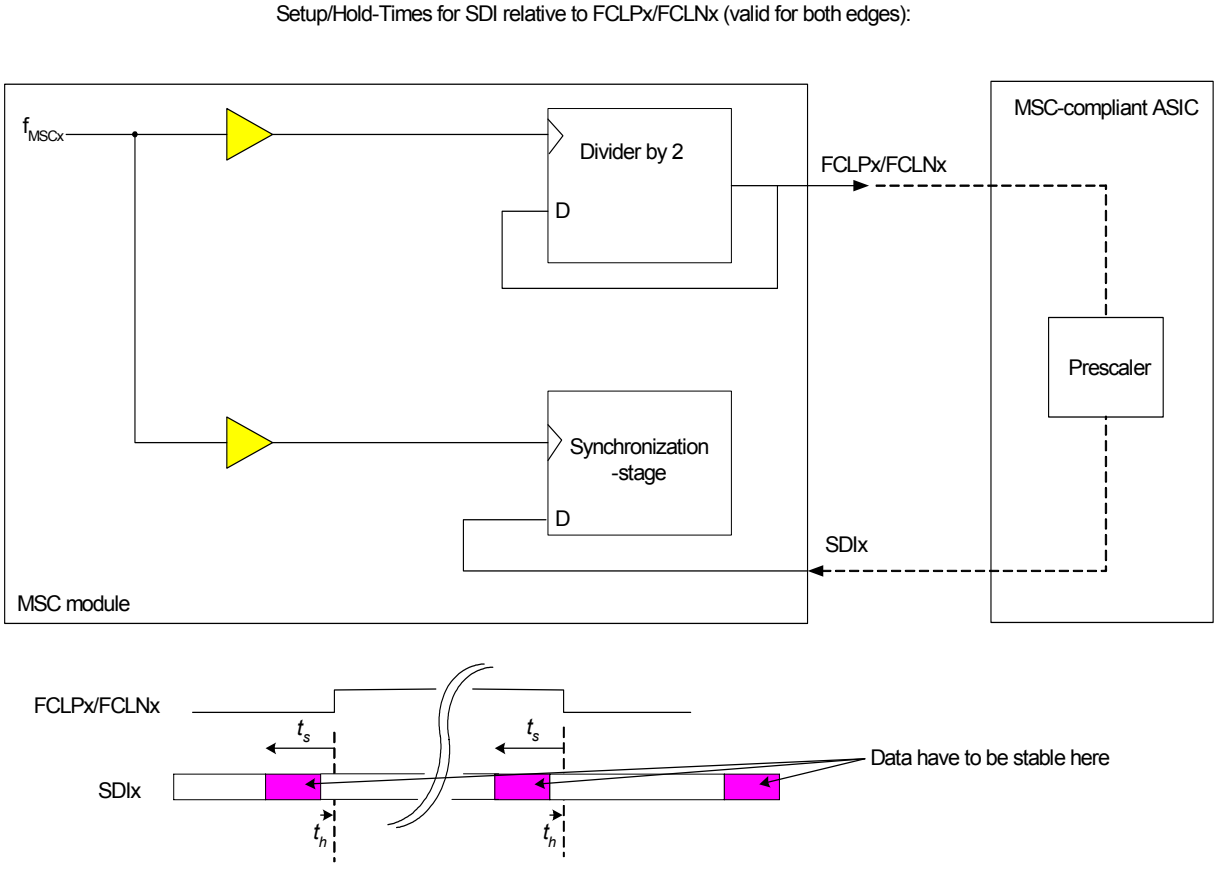
The delay depends on the maximal skew in the data-stream. For this workaround the downstream clock FCLPx/FCLNx can be measured as reference and the data stream at the input of the upstream channel SDIx has to be adjusted according to the setup- and hold-times of the input-pins SDIx.

Figure 6 shows the principle blockdiagram of the input synchronization stage of the MSC module.

Figure 6 Delay adjustment relative to the module clock

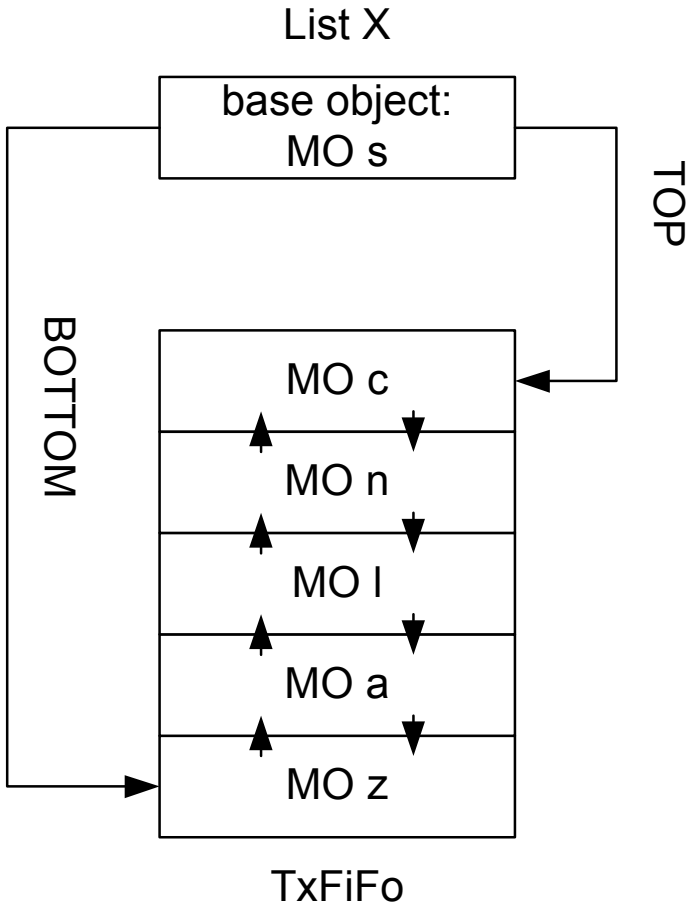
Figure 7 FIFO structure

If Tx FIFO overflow interrupt needed, take the FIFO base object out of the circular list of the Tx message objects. That is to say, just use the FIFO base object for FIFO control, but not to store a Tx message.

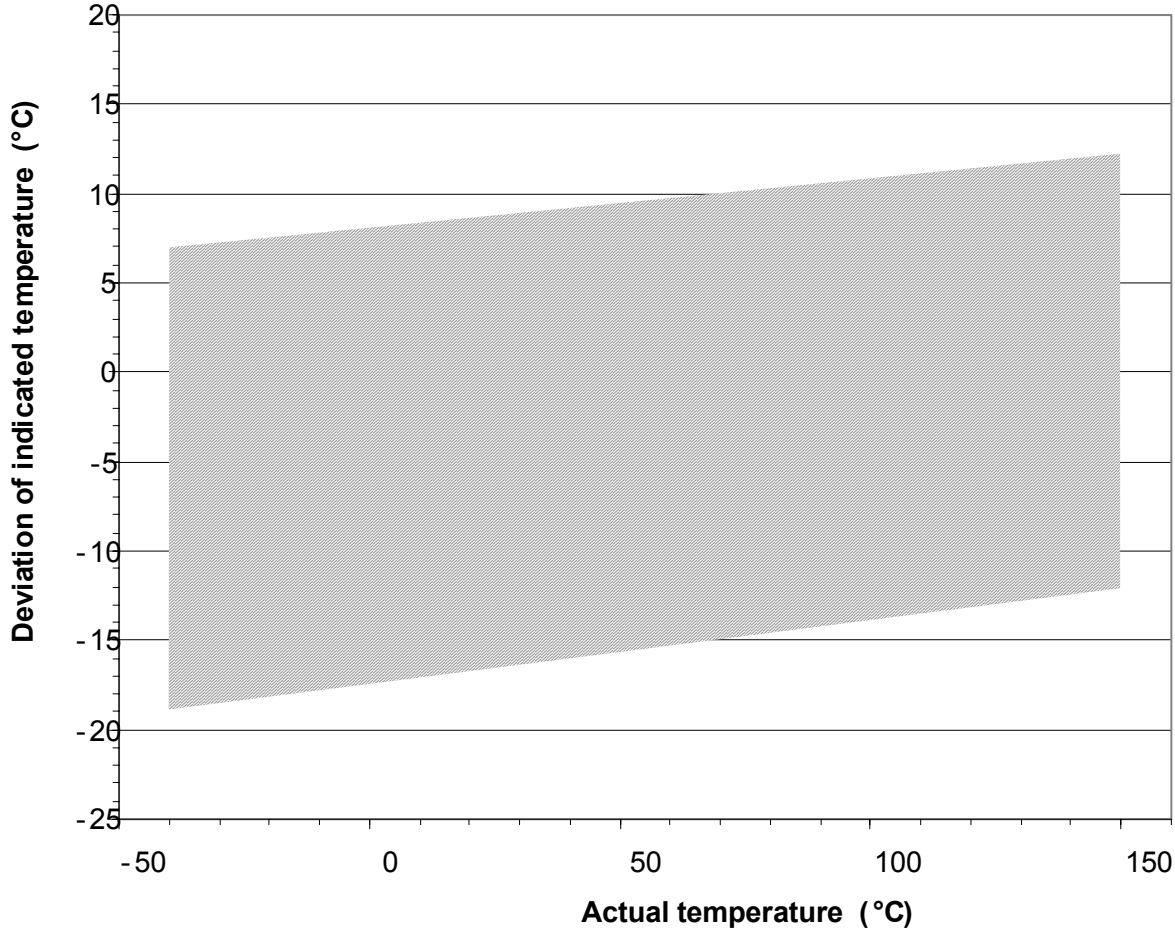
The deviation using these formulas is:

- +/-12°C at T_J = 150°C
- +9/-17°C at T_J = 25°C
- +7/-19°C at T_J = -40°C

Figure 10 Current accuracy range

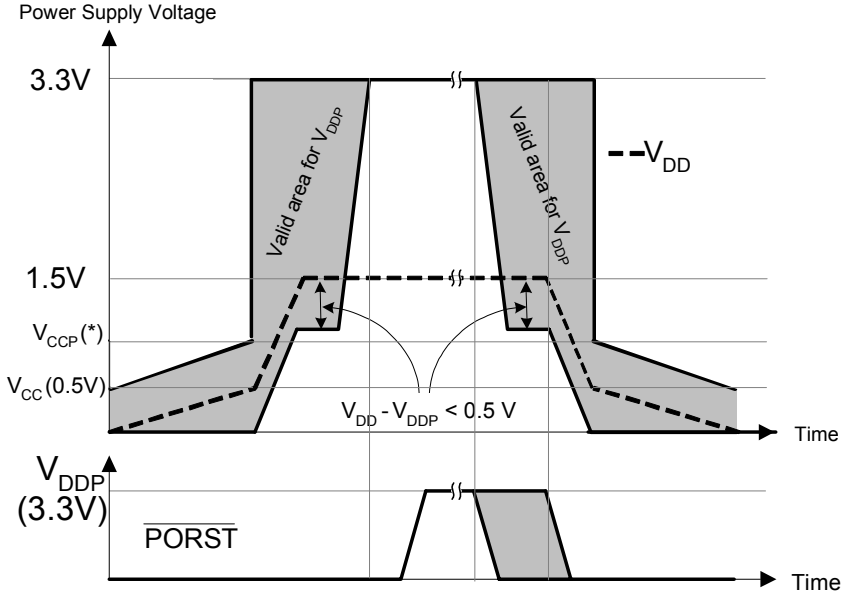
As per Data Sheet, V_{DD} - V_{DDP} < 0.5 V has to be valid at any time in order to avoid increased latch-up risk. The figure below shows the possible V_{DDP} values as shaded region for an exemplary V_{DD} ramp. Moreover, the following rules apply:

- All analog voltages (V_{DDOSC3}, V_{DDM}, V_{DDMF}, V_{DDFL3}) must also follow V_{DDP} power-up/down sequence.
- V_{DDAF}, V_{DDOSC} must follow V_{DD} power-up/down sequence.
- The absolute value of the maximum allowed deviation between any two supplies is 0.5 V while the 1.5V supplies are below their specified operating conditions.

Figure 11 Exemplary power-up/down sequence

*Note: V_{CC} and V_{CCP} in **Figure 11** refer to devices with PWR_TC.P009 erratum.*

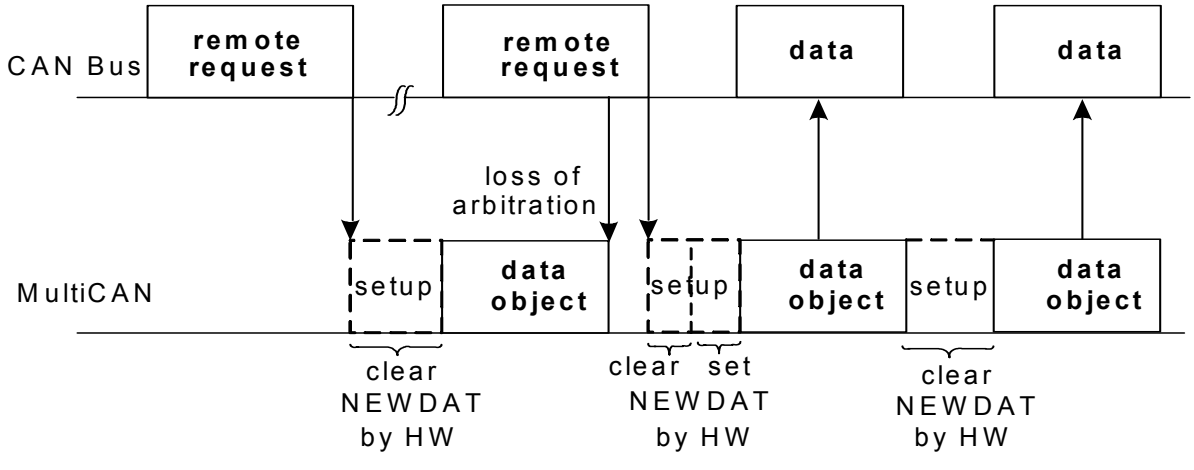
When the appropriate message object (data frame) triggered by the first remote frame wins the arbitration, it will be sent out and NEWDAT is not reset. This leads to an additional data frame, that will be sent by this message object (clearing NEWDAT).

There will, however, not be more data frames than there are corresponding remote requests.

Figure 12 Loss of Arbitration
