Errata Sheet

Rel. 2.2, 2011-10-10

Device	**TC1796**
Marking/Step	**EES-BC, ES-BC, BC**
Package	**P-BGA-416, PG-BGA-416**

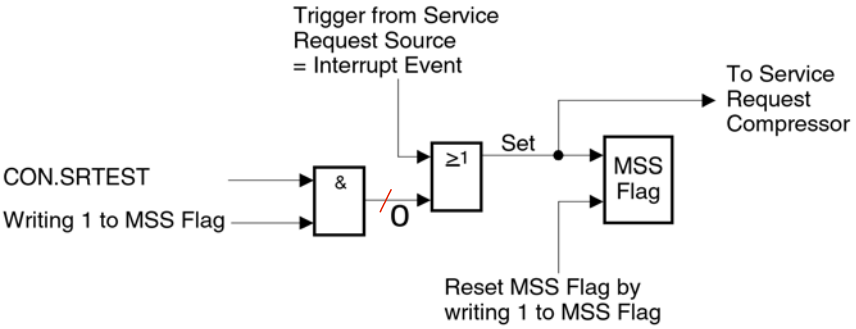
Figure 1

ADC_TC.023 Setting the MSS-flag doesn't generate an interrupt in TEST-MODE

It is possible to generate a software triggered interrupt event in TESTMODE (ADCx_CON.SRTEST=1) by setting one of the bitflags in register ADCx_MSS0/1. Due to the fact, that this mechanism is not working, it is not possible to generate a corresponding interrupt by software.

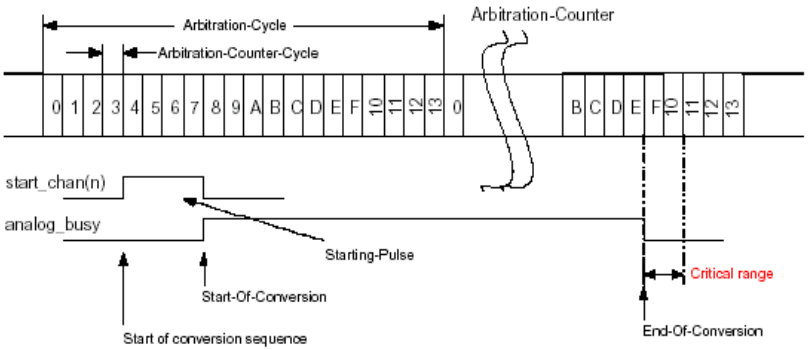
Figure 2

For details about the conversion sequence, please refer to the figure below:

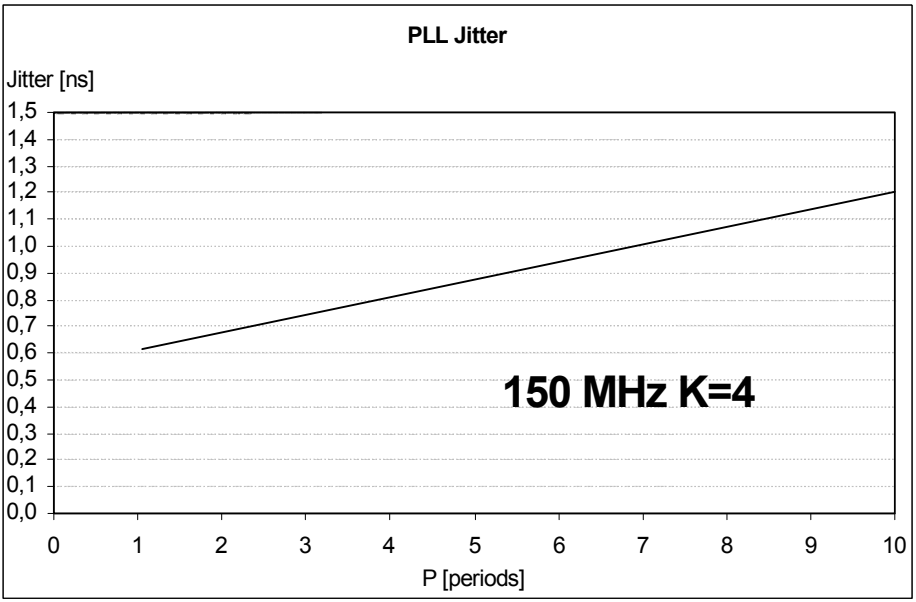
Figure 13 Short term PLL Jitter in f_{CPU} clock periods at f_{CPU} = 150 MHz and K = 4

- The capacitive load at the External Bus Unit (EBU) is limited to CL = 20pF.
- The maximum peak-peak noise on the Core Supply Voltage (as near as possible measured between V_{DD} at pin E23 and V_{SS} at pin D23 or adjacent supply pairs) is limited to:
  V_{pp_noise} = 45mV for a maximum long term jitter of t_{jLT_45}= 15ns
  This condition can be achieved by appropriate blocking of the Core Supply Voltage as near as possible to the supply pins and using PCB supply and ground planes.
  – Ceramic blocking caps in the 100nF range suppress the high frequency noise causing an increased period and short term jitter.
  – Ceramic blocking caps in the range >10?F suppress low frequency voltage spikes/drops causing an increased long time jitter.
- No device socket should be used to prevent parasitic elements between blocking capacitors and device Core Supply Pins.
- PLL jitter values:

When all listed system preconditions are fulfilled the PLL jitter at 150MHz and K = 4 with K = KDIV +1 is below the marked range as shown in the figures.

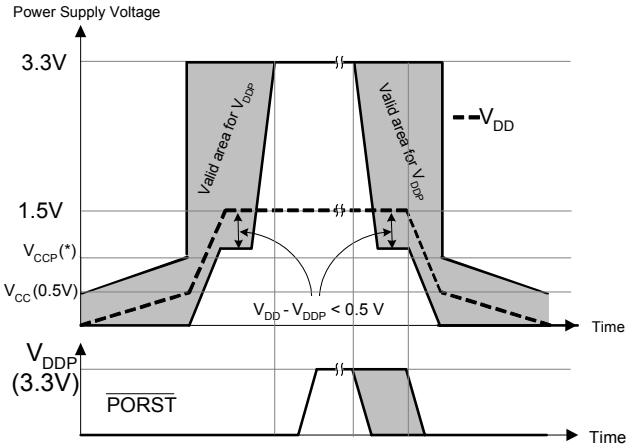
Figure 15 Exemplary power-up/down sequence

As per Data Sheet, V_{DD} - V_{DDP} < 0.5 V has to be valid at any time in order to avoid increased latch-up risk. The figure below shows the possible V_{DDP} values as shaded region for an exemplary V_{DD} ramp. Moreover, the following rules apply:

- V_{DDEBU} and all analog voltages (V_{DDOSC3}, V_{DDM}, V_{DDMF}, V_{DDFL3}) must also follow V_{DDP} power-up/down sequence.
- V_{DDAF}, V_{DDOSC} must follow V_{DD} power-up/down sequence.
- The absolute value of the maximum allowed deviation between any two supplies is 0.5 V while the 1.5V supplies are below their specified operating conditions.

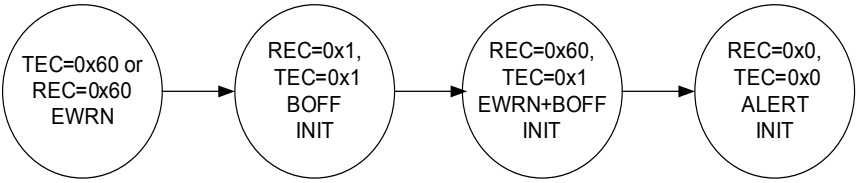
Figure 16 Alert Interrupt Behavior in case of Bus-Off

MultiCAN_AI.H007 Alert Interrupt Behavior in case of Bus-Off

When the threshold for error warning (EWRN) is reached (default value of Error Warning Level EWRN = 0x60), then the EWRN interrupt is issued. The bus-off (BOFF) status is reached if TEC > 255 according to CAN specification, changing the MultiCAN module with REC and TEC to the same value 0x1, setting the INIT bit to 1_B, and issuing the BOFF interrupt. The bus-off recovery phase starts automatically. Every time an idle time is seen, REC is incremented. If REC = 0x60, a combined status EWRN+BOFF is reached. The corresponding interrupt can also be seen as a pre-warning interrupt, that the bus-off recovery phase will be finished soon. When the bus-off recovery phase has finished (128 times idle time have been seen on the bus), EWRN and BOFF are cleared, the ALERT interrupt bit is set and the INIT bit is still set.

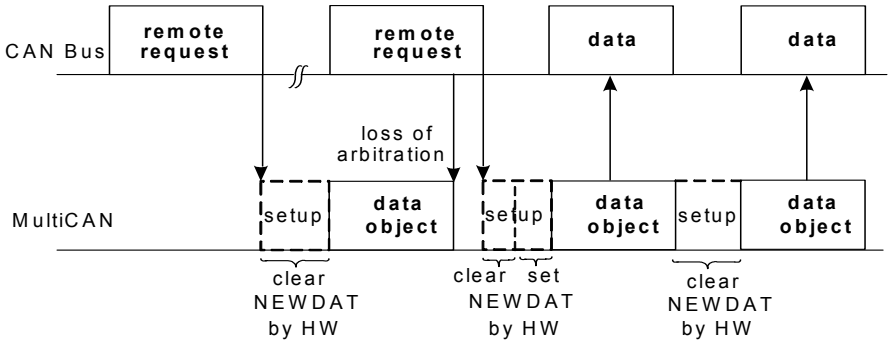
Figure 17 Loss of Arbitration

When the appropriate message object (data frame) triggered by the first remote frame wins the arbitration, it will be sent out and NEWDAT is not reset. This leads to an additional data frame, that will be sent by this message object (clearing NEWDAT).

There will, however, not be more data frames than there are corresponding remote requests.

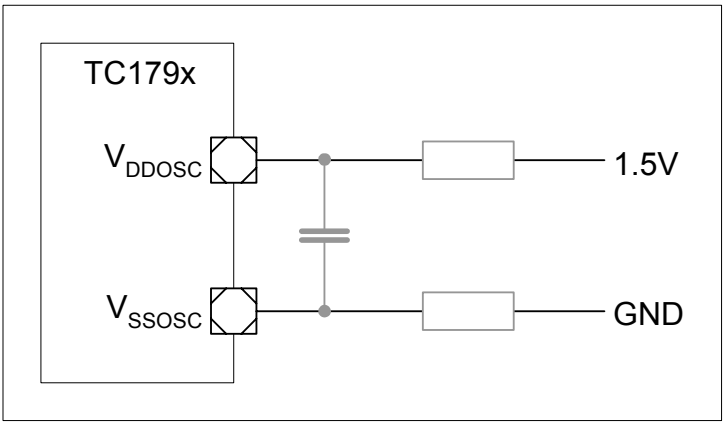
Figure 18

PLL_TC.H004 V_{DDOSC} and V_{SSOSC} bonding change

V_{DDOSC} and V_{SSOSC} silicon pads are not connected to their package balls, but V_{DDOSC} is connected to V_{DD} (core supply) and V_{SSOSC} is connected to V_{SS}, in order to reduce short-term jitter. Thus V_{DDOSC} and V_{SSOSC} package balls are unconnected. For future design improvements it is recommended to prepare the PCB like it is shown in the figure below. The capacitance and both resistors need not to be assembled on the PCB but they should be planned for values of about 10?F...100?F for the blocking capacitance and 0?...10? for the resistors.

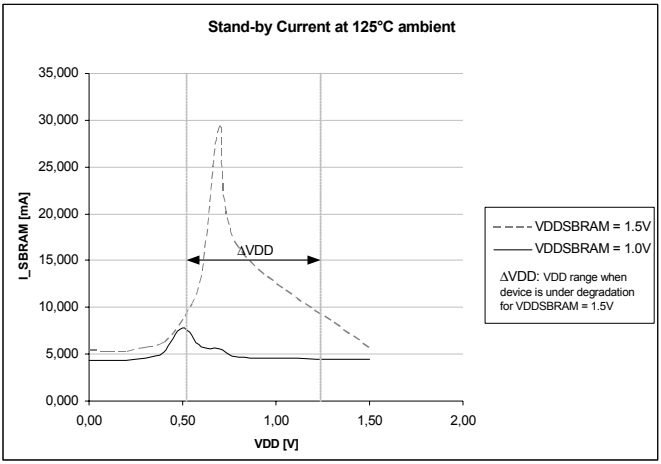
Figure 19 Stand-by current at 125°C ambient

During transition from/to stand-by mode, while increasing or decreasing core power supply (V_{DD}), it may happen, due to cross-current, that I_{SBRAM} reaches high current values.

The worst case takes place when V_{DD} = $V_{DDSBRAM}$/2, specially if $V_{DDSBRAM}$ = 1.5 V (SBRAM power supply for normal operation). In this situation, I_{SBRAM} may reach 29.5 mA (hot at 125°C ambient).
