Errata Sheet

Rel. 1.3, 2011-08-29

Device	**TC1796**
Marking/Step	**EES-BE, ES-BE, BE**
Package	**P-BGA-416, PG-BGA-416**

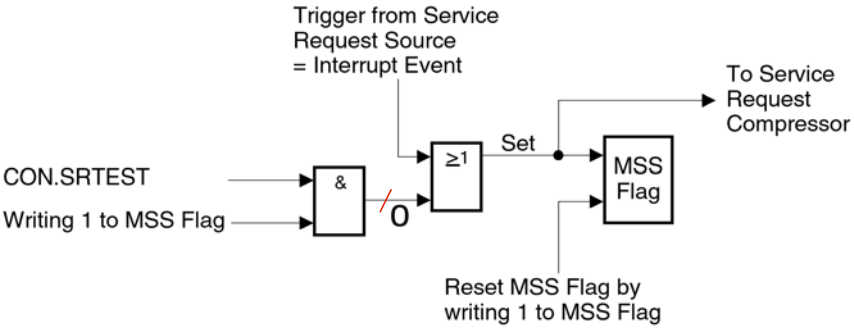
Figure 1

ADC_TC.023 Setting the MSS-flag doesn't generate an interrupt in TEST-MODE

It is possible to generate a software triggered interrupt event in TESTMODE (ADCx_CON.SRTEST=1) by setting one of the bitflags in register ADCx_MSS0/1. Due to the fact, that this mechanism is not working, it is not possible to generate a corresponding interrupt by software.

Workaround

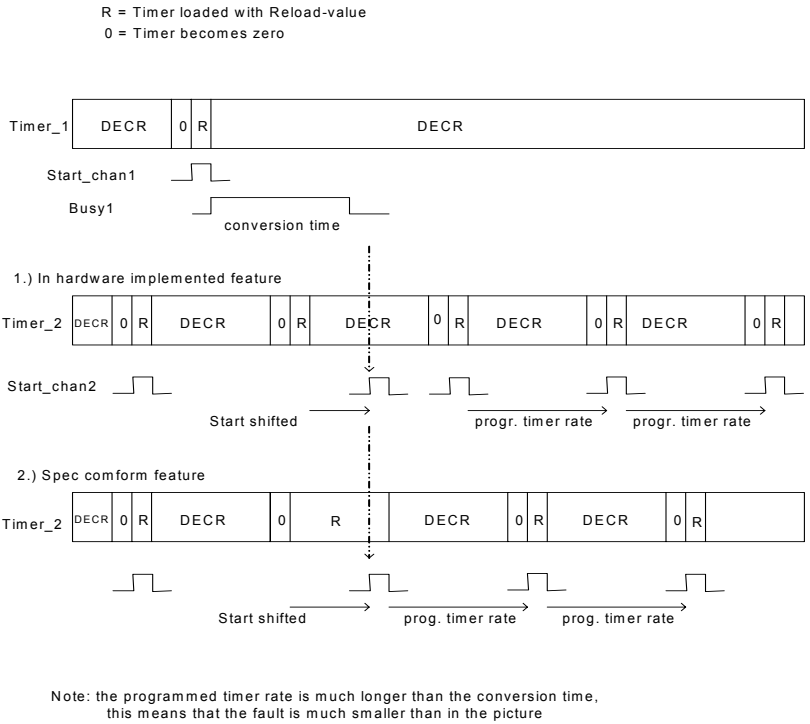
Figure 2 Timing concerning equidistant multiple timers

The correct behavior would be a reload when the requested conversion (of channel_2) is started.

Therefore the start of conversion for channel_2 is delayed by maximum one conversion-time. After this delay it will be continued with equidistant conversion-starts. Please refer to the following figure.

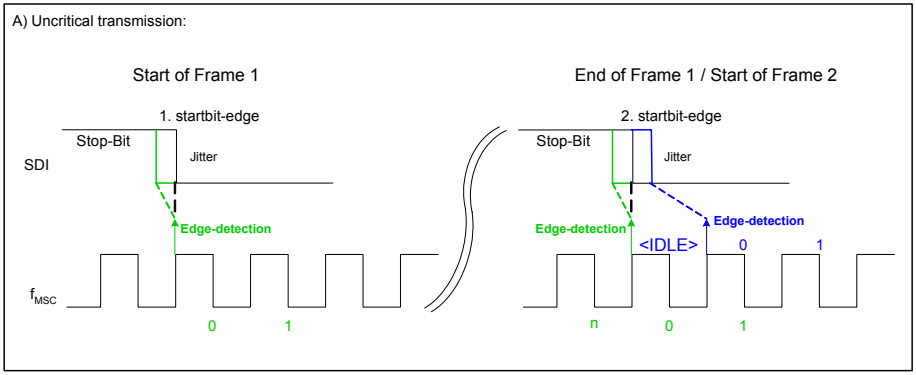
Figure 3 Uncritical transmission

As the falling startbit edge is shifted to the left of the rising clock edge (**Figure 3** left), there occurs a secure detection of the next start-bit edge in the last cycle of the previous frame (here cycle n, **Figure 3** right) independant from the applied jitter to this edge.

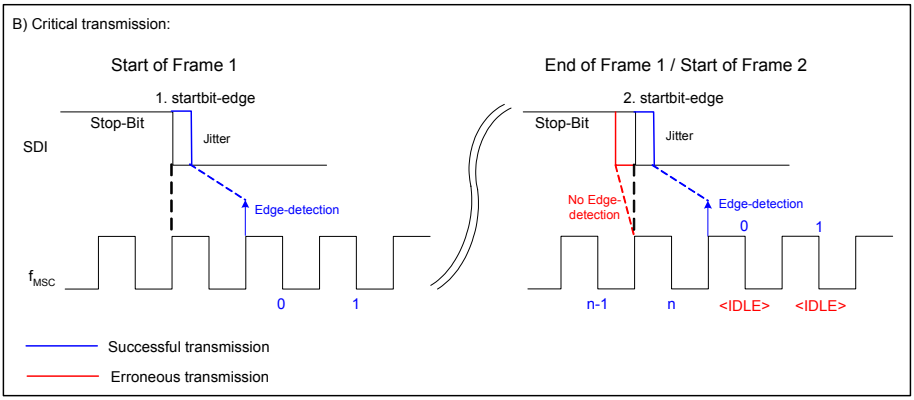
Figure 4 Critical transmission

If the high-low edge of the start-bit in the first frame is just not detected by the near clock-edge (**Figure 4** - left) and the start-bit edge of the second frame is jittering to cycle n-1 (**Figure 4** - right, red coloured), then an erroneous transmission will take place. In this case the state-machine switches to IDLE after the last state n and wakes up on the next falling edge that may be a data-bit recognized as a start-bit. If the start-bit of the second frame is jittering to cycle n (**Figure 4** - right, blue colored), then the state-machine will not switch to IDLE but will start receiving the next frame correctly.

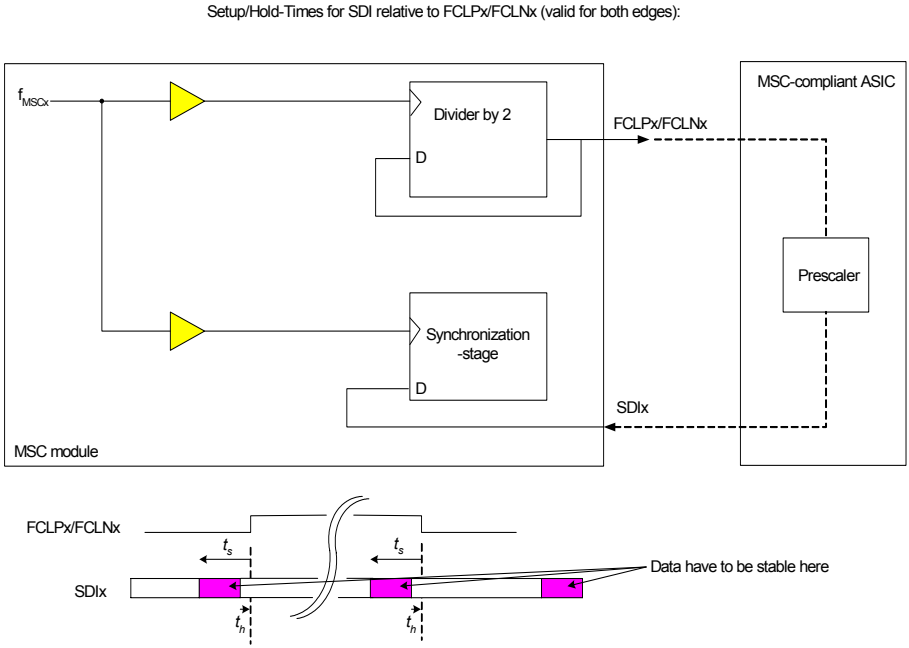
Figure 5 Delay adjustment relative to the module clock

Figure 5 shows the principle blockdiagram of the input synchronization stage of the MSC module.

The delay depends on the maximal skew in the data-stream. For this workaround the downstream clock FCLPx/FCLNx can be measured as reference and the data stream at the input of the upstream channel SDIx has to be adjusted according to the setup- and hold-times of the input-pins SDIx.

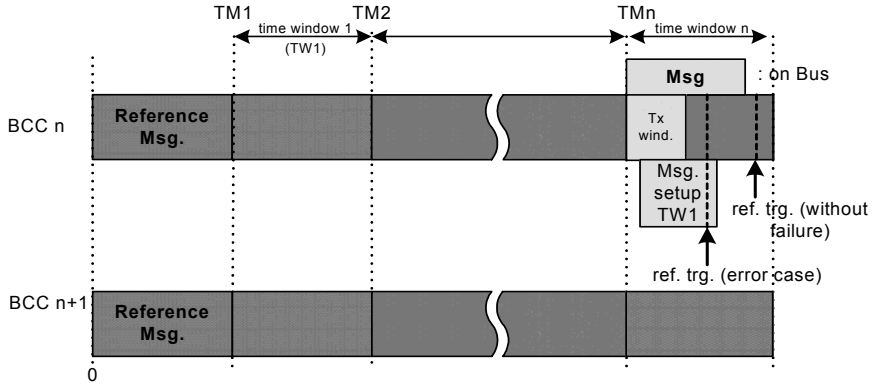
Figure 8

MultiCAN_TC.036 Wrong message may be sent during reference message trigger in a gap

The TTCAN controller is configured as timer master, gap mode has been selected and no message is transferred (reception or transmission) after the transmit enable window in the last time window. With the end of the transmit enable window, the TTCAN logic starts waiting for a reference message trigger to send a reference message. At the beginning of each time window, the TTCAN logic evaluates the scheduler entries for the following time window and prepares the setup of the corresponding message for the next tranfer window. If the reference trigger becomes active after the end of the transmit enable window, but still during the setup phase, the prepared message will be sent out instead of the reference message. After this erroneously sent message, the reference message will be sent out correctly. The error does not occur if the reference trigger becomes active after the end of the setup time.

Workaround

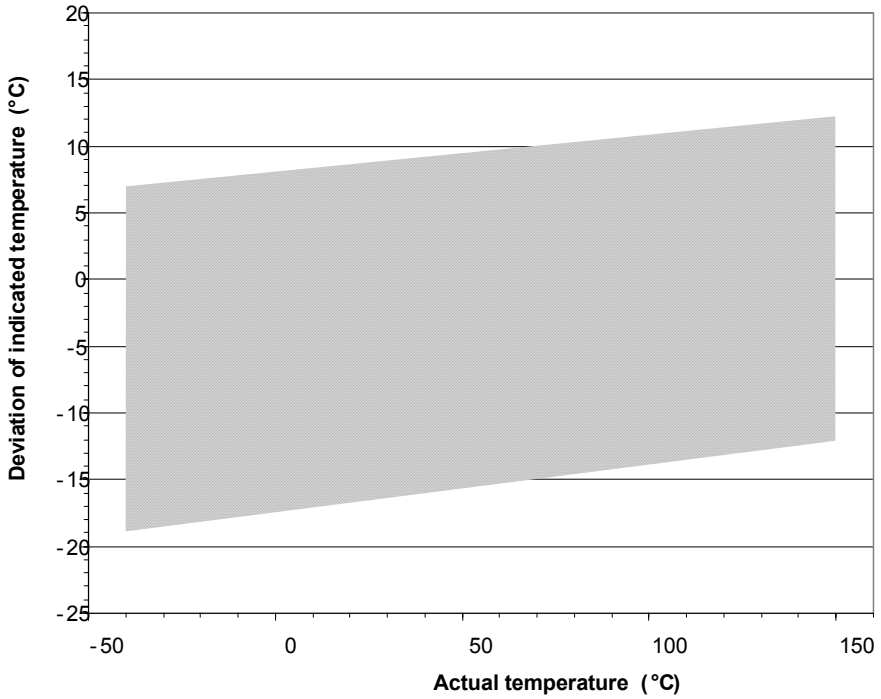
Figure 10 Current accuracy range

The deviation using these formulas is:

- +/-12°C at T_J = 150°C
- +9/-17°C at T_J = 25°C
- +7/-19°C at T_J = -40°C

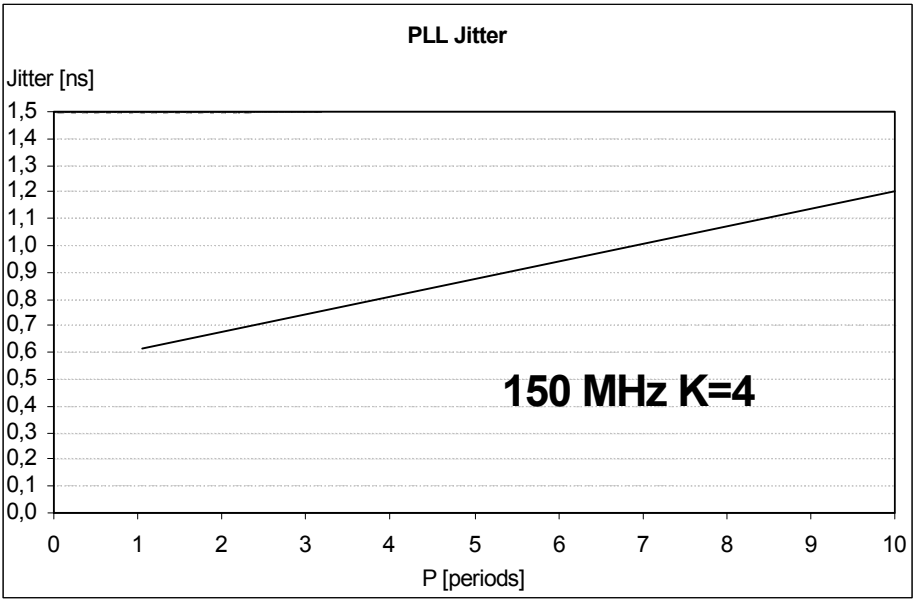
When all listed system preconditions are fulfilled the PLL jitter at 150MHz and K = 4 with K = KDIV +1 is below the marked range as shown in the figures.

Figure 11 Short term PLL Jitter in f_{CPU} clock periods at f_{CPU} = 150 MHz and K = 4

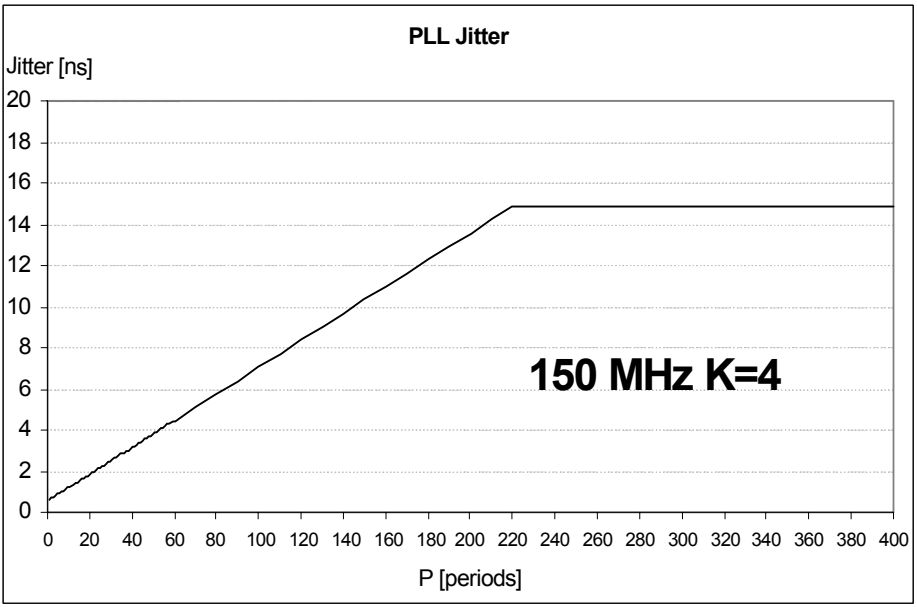
Figure 12 Long term PLL Jitter in f_{CPU} clock periods at f_{CPU} = 150 MHz and K = 4

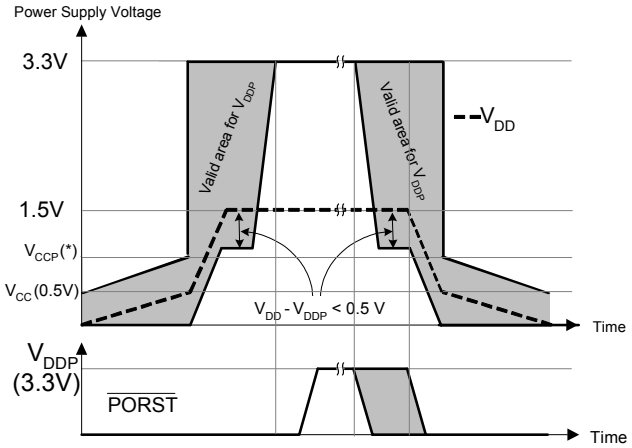
- V_{DDEBU} and all analog voltages (V_{DDOSC3}, V_{DDM}, V_{DDMF}, V_{DDFL3}) must also follow V_{DDP} power-up/down sequence.

- V_{DDAF}, V_{DDOSC} must follow V_{DD} power-up/down sequence.
- The absolute value of the maximum allowed deviation between any two supplies is 0.5 V while the 1.5V supplies are below their specified operating conditions.

Figure 13 Exemplary power-up/down sequence

*Note: V_{CC} and V_{CCP} in **Figure 13** refer to devices with PWR_TC.P009 erratum.*

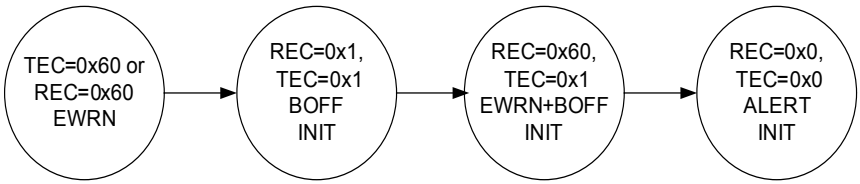
Figure 14 Alert Interrupt Behavior in case of Bus-Off

The MultiCAN module shows the following behavior in case of a bus-off status:

When the threshold for error warning (EWRN) is reached (default value of Error Warning Level EWRN = 0x60), then the EWRN interrupt is issued. The bus-off (BOFF) status is reached if TEC > 255 according to CAN specification, changing the MultiCAN module with REC and TEC to the same value 0x1, setting the INIT bit to 1_B, and issuing the BOFF interrupt. The bus-off recovery phase starts automatically. Every time an idle time is seen, REC is incremented. If REC = 0x60, a combined status EWRN+BOFF is reached. The corresponding interrupt can also be seen as a pre-warning interrupt, that the bus-off recovery phase will be finished soon. When the bus-off recovery phase has finished (128 times idle time have been seen on the bus), EWRN and BOFF are cleared, the ALERT interrupt bit is set and the INIT bit is still set.

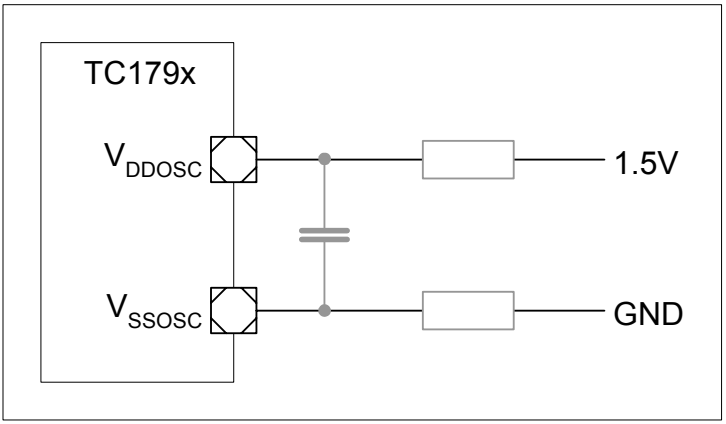
Figure 16

V_{DDOSC} and V_{SSOSC} silicon pads are not connected to their package balls, but V_{DDOSC} is connected to V_{DD} (core supply) and V_{SSOSC} is connected to V_{SS}, in order to reduce short-term jitter. Thus V_{DDOSC} and V_{SSOSC} package balls are unconnected. For future design improvements it is recommended to prepare the PCB like it is shown in the figure below. The capacitance and both resistors need not to be assembled on the PCB but they should be planned for values of about 10?F...100?F for the blocking capacitance and 0?...10? for the resistors.

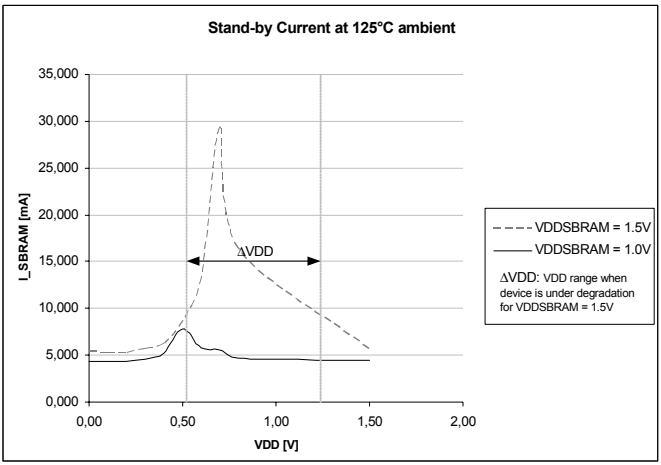
Figure 17 Stand-by current at 125°C ambient

During transition from/to stand-by mode, while increasing or decreasing core power supply (V_{DD}), it may happen, due to cross-current, that I_{SBRAM} reaches high current values.

The worst case takes place when V_{DD} = $V_{DDSBRAM}$/2, specially if $V_{DDSBRAM}$ = 1.5 V (SBRAM power supply for normal operation). In this situation, I_{SBRAM} may reach 29.5 mA (hot at 125°C ambient).
