Errata Sheet

V1.1, 2007-06-21

Device	**XC164CS-16F**
Marking/Step	**(E)ES-BB, BB**
Package	**PG-TQFP-100-5, P-TQFP-100-16**

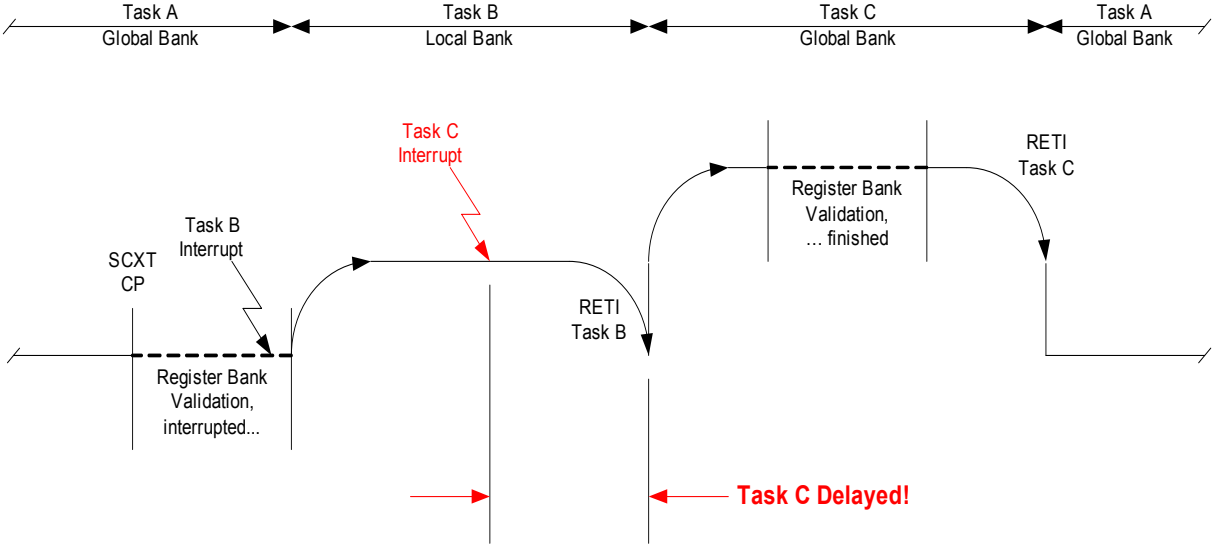
Figure 1 Example for Case 2: Interrupt Service for Task C delayed

- The Context Pointer CP is written to (e.g. by POP, MOV, SCXT .. instructions) within a routine (Task A) that uses a **global** register bank (bit field PSW.BANK = 00_B), i.e. the context for this routine will be modified,
- This context switch procedure (19 cycles) is interrupted by an interrupt request (Task B) which is programmed (with GPRSELx = $1X_B$) to automatically use one of the **local** banks via the bank selection registers BNKSEL0..3 (i.e. the interrupting routine has a priority level ≥12),
- Before the corresponding interrupt service routine is finished, another interrupt request (Task C) occurs which is programmed (with GPRSELx = 00_B) to automatically use the **global** bank via the bank selection registers BNKSEL0..3 (i.e. the interrupting routine has a priority level ≥13)

In this case service of this interrupt request (for Task C) is delayed until bit field PSW.BANK becomes 00_B after executing the RETI instruction at the end of the routine (Task B) using the local bank.
