Errata Sheet

Rel. 1.2, 03.12.2010

Device	**XC835/836MT Series**
Marking/Step	**AB**
Package	**PG-TSSOP-28/DSO-24**

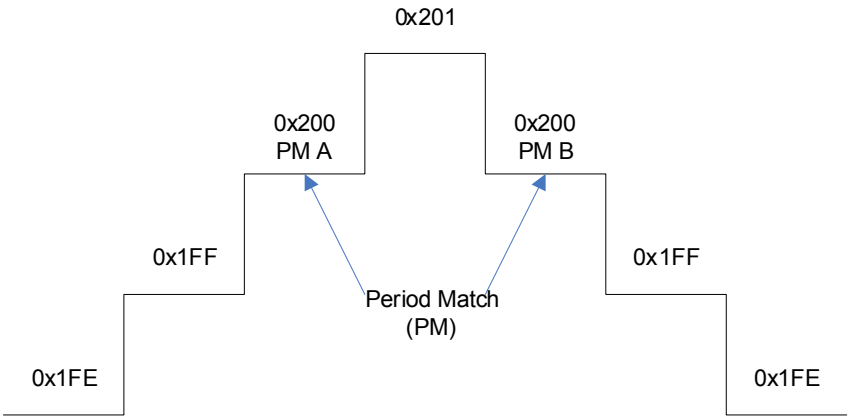
Figure 1 Counting sequence of T12 in center-aligned mode

CCU6_XC8.H002 CCU6 PM event in center-aligned mode

After detecting a period match (PM A) in centre-aligned mode, T12 counts down from PM + 1 as shown below:

This means a second PM event (PM B) will occur during the counting down. If ADC is triggered externally via REQTRxC (T12PM), it will be triggered twice in succession. Depending on how real-time the application code is running as well as the T12 count rate and ADC conversion rate, the application could observe two ADC interrupts - once at PM A and once at PM B.

To avoid triggering twice the ADC interrupts, it is suggested to use REQTRxF from multi-channel mode instead of REQTRxC as the trigger source for ADC. Additional initialization are as follows:

- Configure MCMCTR.SWSEL = 101_B (Transfer on T12 period match)
- Configure MCMCTR.SWSYN = 00_B (Direct transfer)
- Write to MCMOUTSTL = CF_H (To enable multi-Channel PWM pattern on CC6x and COUT6x)
