Errata Sheet

Rel. 1.1, 15.12.2006

Device	**XC866-1FR**
Marking/Step	**EES-AA,ES-AA**
Package	**PG-TSSOP-38**

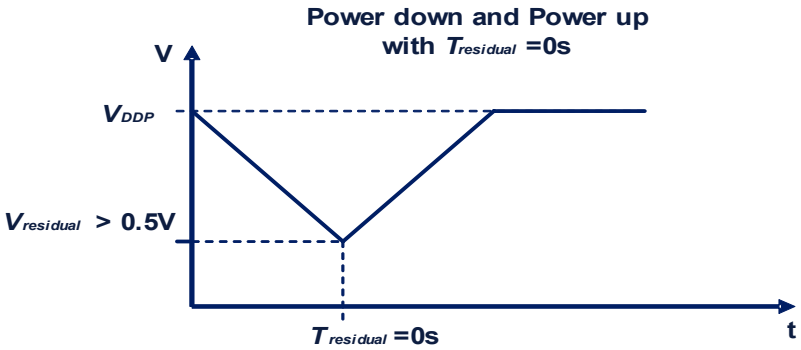
In case of V_{DDP} residual voltage is more than 500mV, the holding time of residal voltage affects the reset toggling issue. **Figure 1** shows the critical cases for power up/power down when the residual voltages is held for some time. **Figure 2** shows the uncritical case for power up and power down when the power up is triggered immediately after power down. In case of a residual voltage due to immediate power up after power down, the users have to contact IFX to ensure no power up failure.

Figure 2 Uncritical Case for Power up/Power down when $V_{residual}$ >500mV

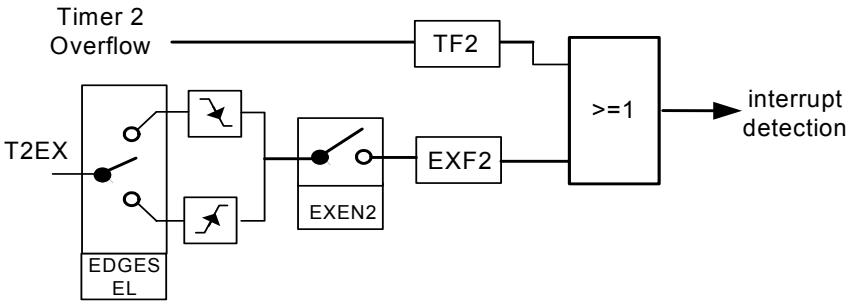
Figure 3

INT_XC8.004 Unable to Detect New Interrupt Request if Any One of Timer 2 Interrupt Flags Is Not Cleared (Unexpectedly)

As illustrated in the simplified figure, the Timer 2 interrupt flags TF2 and EXF2 are combined as one interrupt request output. These flags are located within the Timer 2 kernel, with a single interrupt request line as output from the kernel.

Being of interrupt structure 2, the interrupt request of Timer 2 is detected on the rising edge of a positive pulse.

There is no problem if EXF2 is not enabled by setting bit EXEN2 = 0 i.e. external events are disabled, or if bit DCEN = 1 in auto-reload mode.

Otherwise if EXF2 is enabled, while TF2 is always enabled when Timer 2 is running, there are two suggested workaround:

1. If other events of Timer 2 interrupt node (ET2) need not be enabled for interrupt, disable this interrupt node and use software polling of the flags instead.
2. Before return from interrupt, check again if TF2 or EXF2 is (still) set (due to new request since the last check). If so, jump and execute the ISR routine from start. Exit only when all flags are checked to be cleared. However, dummy interrupt of the node may occur after return from interrupt, and should be ignored. Another drawback is if Timer 2 events are occurring at high rate, the CPU may be 'stuck' in the service routine of the Timer 2 interrupt for a long time.

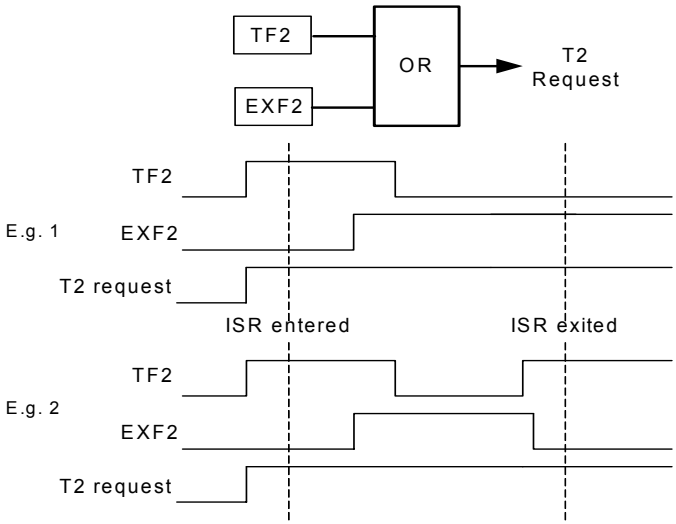
Figure 4

The problem is that it may occur at some point in the application, that any new Timer 2 interrupt request can no longer be detected after a return-from-interrupt (reti) due to service of earlier event(s). This happens when the following conditions are true:

1. Timer 2 events are serviced by interrupt (i.e. flags are checked and cleared only in the interrupt routine ISR),
2. Either TF2 or EXF2 is set at any one time throughout the ISR (even while the other is cleared) such that at least one of the flags is still set after reti, causing the Timer 2 request line, which is an OR-function of the two flags TF2 and EXF2, to remain set throughout the ISR and after reti.

This means, any future Timer 2 TF2 or EXF2 event is not able to cause a rising edge and therefore not able to trigger an interrupt request to the core – as if the Timer 2 interrupts had been disabled, until both EXF2 and TF2 flags are cleared at some time. The clearing of flags would have to be done by user's code additionally outside of the Timer 2 interrupt routine, which is however normally not feasible with an interrupt service scheme.

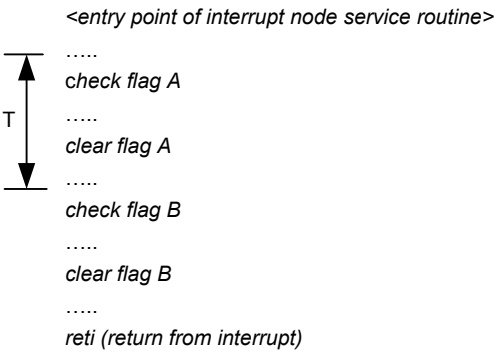
Figure 6

INT_XC8.H001 Interrupt Request With No Interrupt Flag Set

It might occur in the application, that sometimes interrupt requests are serviced, but no active interrupt flags are found. This would happen for those interrupt nodes which is shared by several interrupt sources.

Consider the following interrupt service routine pseudo-code, and scenerio where a interrupt source A event leads to interrupt request of the node and CPU vectors to the interrupt routine. Meanwhile, interrupt source B and its flag becomes active any time in the duration indicated by T:

In this case, flag B will be cleared as a standard procedure by the interrupt routine in the current service of the interrupt node. However, the pending interrupt request for the node remains activated after RETI, as it is only cleared by hardware when CPU acknowledge the interrupt and vectors to the interrupt routine.

This leads to following servicing of the interrupt node again, but potentially no active flag is found, i.e. dummy interrupt service. The point to note is that the interrupt source B is not lost, as it was actually serviced in the current service of the interrupt node.

The recommendation is to ignore these dummy interrupt vectoring.

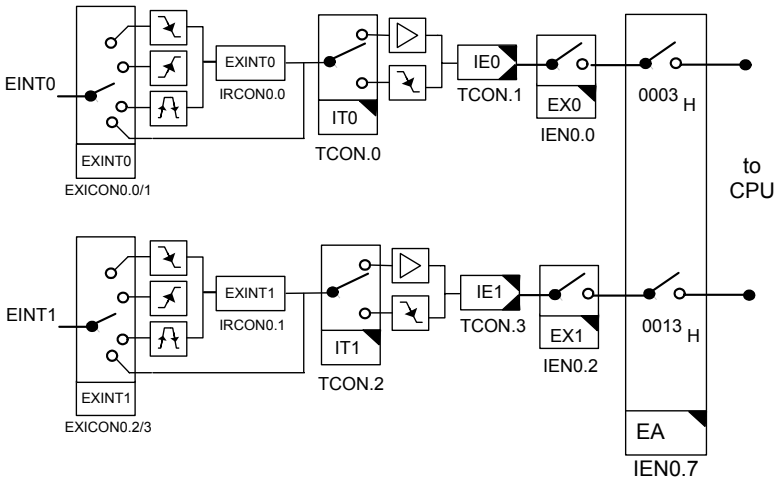
Figure 7

INT_XC8.H003 Interrupt Flags of External Interrupt 0 and 1

External interrupt 0 and 1 may individually be selected via respective bits (EXINTx) in EXICON0 register, to request interrupt on falling edge, rising edge, both edges or to bypass the edge detection.

Edge detection is done in the system unit. If enabled, an active event will set the EXINTx flag and correspondingly set the IEx flag in TCON. It should be noted that after any external interrupt x event, flag EXINTx must be cleared. In case of falling edge as active event, this allows any future active event to be able to set the flag IEx as interrupt request. In case of low level as active event, this prevents unintended recurring triggering of interrupt request.

In case of bypass edge detection, the input is connected directly to the core (bypass the system unit). The flag IEx in TCON will be set on the selected falling edge or low level (at least 2 clock cycles) event. In case of falling edge selected as active event by TCON.ITx, the flag EXINTx is set in addition to the flag IEx. However to use this mode properly, user must not clear the flag EXINTx and if necessary, to only access the flag TCON.IEx (refer to INT_XC8.003).
