Errata Sheet

Rel. 1.3, 28.02.2011

Device	**XC866L-1FR Series**
Marking/Step	**AB**
Package	**PG-TSSOP-38**

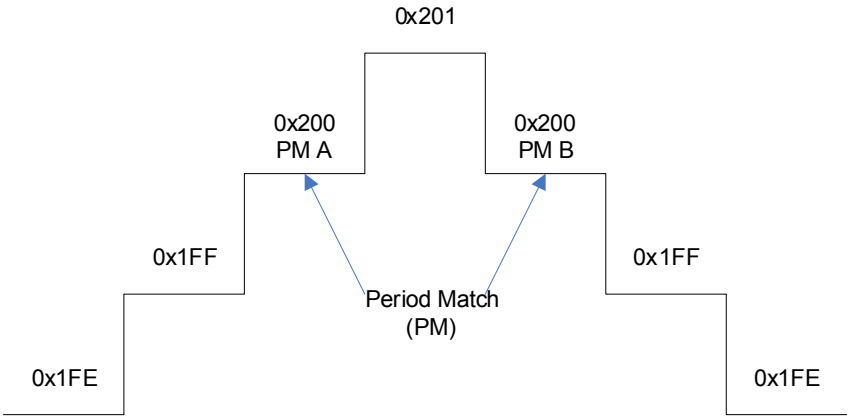
Figure 4 Counting sequence of T12 in center-aligned mode

After detecting a period match (PM A) in centre-aligned mode, T12 counts down from PM + 1 as shown below:

This means a second PM event (PM B) will occur during the counting down. If ADC is triggered externally via ETRx2 (T12PM), it will be triggered twice in succession. Depending on how real-time the application code is running as well as the T12 count rate and ADC conversion rate, the application could observe two ADC interrupts - once at PM A and once at PM B.

To avoid triggering twice the ADC interrupts, it is suggested to use ETRx6 from multi-channel mode instead of ETRx2 as the trigger source for ADC. Additional initialization are as follows:

- Configure MCMCTR.SWSEL = 101_B (Transfer on T12 period match)
- Configure MCMCTR.SWSYN = 00_B (Direct transfer)
- Write to MCMOUTSTL = CF_H (To enable multi-Channel PWM pattern on CC6x and COUT6x)
