Errata Sheet

Rel. 1.1, 17.01.2013

Device	**XC874CM Series**
Marking/Step	**AC**
Package	**PG-VQFN-48**

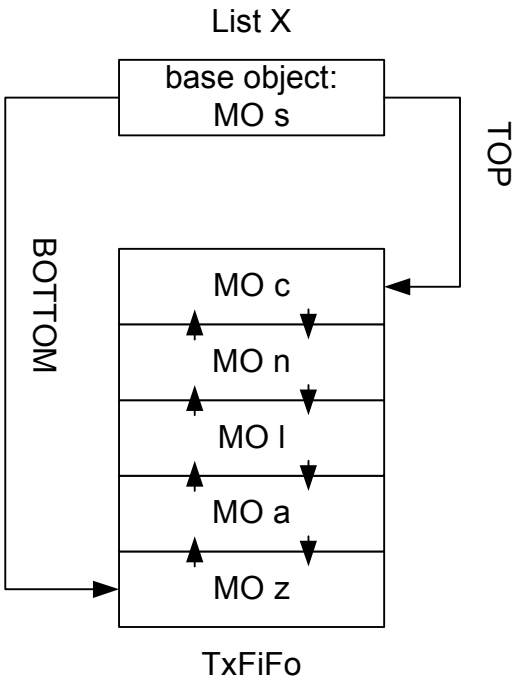
Figure 1 FIFO structure

MultiCAN_TC.029 Tx FIFO overflow interrupt not generated

Specified behaviour

After the successful transmission of a Tx FIFO element, a Tx overflow interrupt is generated if the FIFO base object fulfils these conditions:

- Bit MOFCR.OVIE=1, AND
- MOFGPR.CUR becomes equal to MOFGPR.SEL

Real behaviour

A Tx FIFO overflow interrupt will not be generated after the transmission of the Tx FIFO base object.

If Tx FIFO overflow interrupt needed, take the FIFO base object out of the circular list of the Tx message objects. That is to say, just use the FIFO base object for FIFO control, but not to store a Tx message.

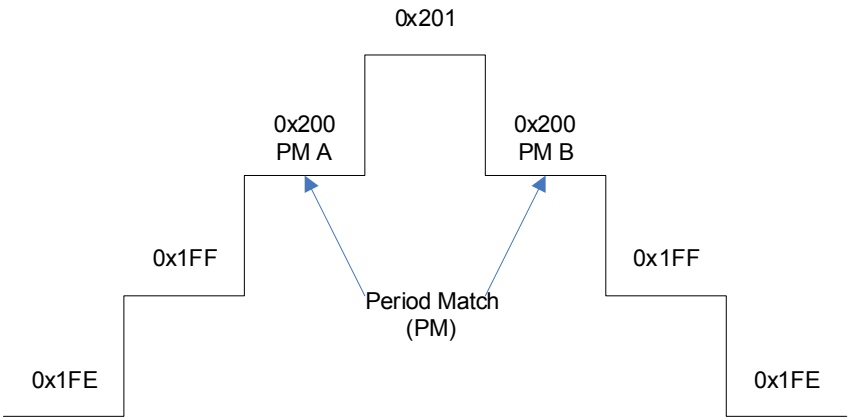
Figure 3 Counting sequence of T12 in center-aligned mode

CCU6_XC8.H002 CCU6 PM event in center-aligned mode

After detecting a period match (PM A) in centre-aligned mode, T12 counts down from PM + 1 as shown below:

This means a second PM event (PM B) will occur during the counting down. If ADC is triggered externally via ETRx2 (T12PM), it will be triggered twice in succession. Depending on how real-time the application code is running as well

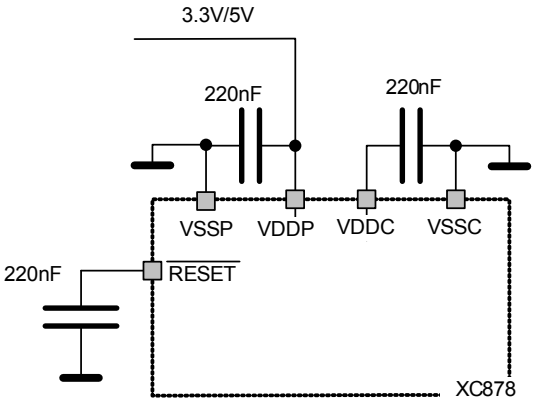
Figure 4 Noise Immunity Enhancement Circuitry

During power up, the EVR functionality may be affected due to injected noise from any functional pin. In order to enhance the noise immunity, the external reset pin RESET must be asserted until VDDC reaches 0.9 * VDDC. The delay of external reset can be realized by an external capacitor at RESET pin. This capacitor value must be selected so that VRESET reaches 0.4 V, but not before VDDC reaches 0.9 * VDDC.

A typical application example is shown in **Figure 4**. A 220 nF capacitor is connected to VDDP pin, VDDC pin and RESET pin. In addition, it is also essential to put it as close as possible to the chip.

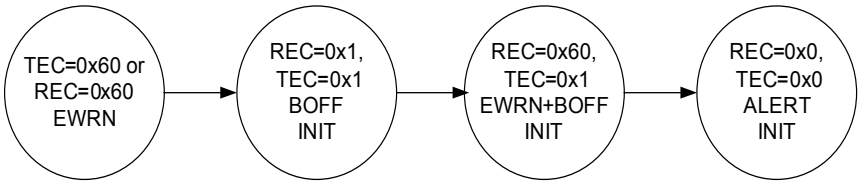
Figure 5 Alert Interrupt Behavior in case of Bus-Off

MultiCAN_AI.H007 Alert Interrupt Behavior in case of Bus-Off

The MultiCAN module shows the following behavior in case of a bus-off status:

When the threshold for error warning (EWRN) is reached (default value of Error Warning Level EWRN = 0x60), then the EWRN interrupt is issued. The bus-off (BOFF) status is reached if TEC > 255 according to CAN specification, changing the MultiCAN module with REC and TEC to the same value 0x1, setting the INIT bit to 1_B, and issuing the BOFF interrupt. The bus-off recovery phase starts automatically. Every time an idle time is seen, REC is incremented. If REC = 0x60, a combined status EWRN+BOFF is reached. The corresponding interrupt can also be seen as a pre-warning interrupt, that the bus-off recovery phase will be finished soon. When the bus-off recovery phase has finished (128 times idle time have been seen on the bus), EWRN and BOFF are cleared, the ALERT interrupt bit is set and the INIT bit is still set.

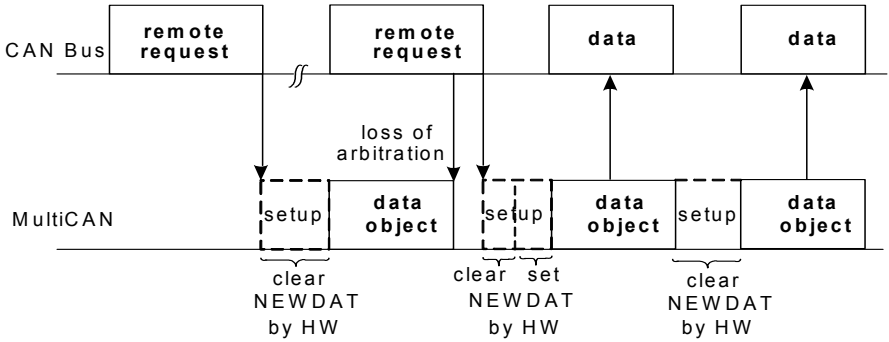
Figure 6 Loss of Arbitration

When the appropriate message object (data frame) triggered by the first remote frame wins the arbitration, it will be sent out and NEWDAT is not reset. This leads to an additional data frame, that will be sent by this message object (clearing NEWDAT).

There will, however, not be more data frames than there are corresponding remote requests.
