Errata Sheet

Rel. 1.3, 24.11.2006

Device	**XC886CM-6FF**
Marking/Step	**ES AB**
Package	**PG-TQFP-48**

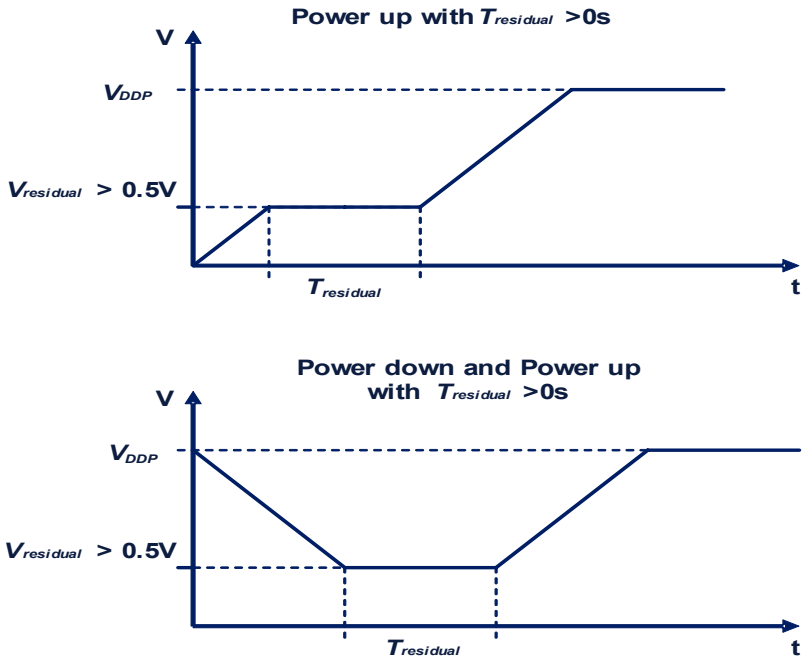
Figure 1 Critical Cases for Power up/ Power down when $V_{residual}$ >500mV

Due to the limitation of the EVR, the reset toggling may occur during the power up. To prevent the reset toggling issue for power up, the following conditions must be met :

1. For power up, the rising time must be less than 2ms/V.
2. The power down time must be more than 0.2ms/V.
3. A permanent V_{DDP} residual voltage is less than 500mV.

In case of V_{DDP} residual voltage is more than 500mV, the holding time of residal voltage affects the reset toggling issue. **Figure 1** shows the critical cases for power up/power down when the residual voltages is held for some time. **Figure 2** shows the uncritical case for power up and power down when the power up is triggered immediately after power down. In case of a residual voltage due to immediate power up after power down, the users have to contact IFX to ensure no power up failure.

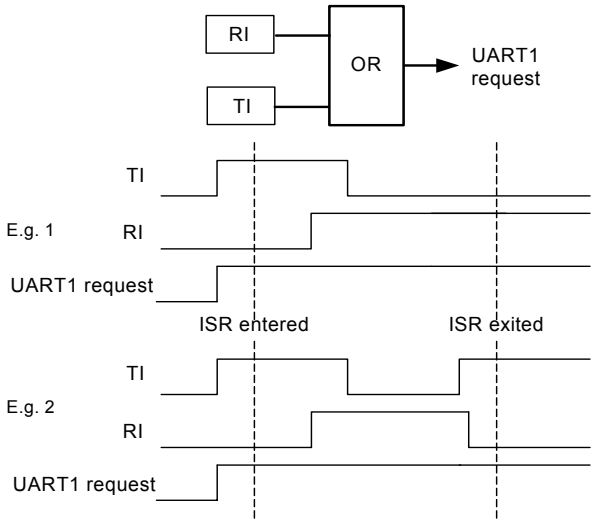
Figure 4

The problem is that it may occur at some point in the application, that any new UART1 interrupt request can no longer be detected after a return-from-interrupt (reti) due to service of earlier event(s). This happens when the following conditions are true:

1. UART1 events are serviced by interrupt (i.e. flags are checked and cleared only in the interrupt routine ISR),
2. Either RI or TI is set at any one time throughout the ISR (even while the other is cleared) such that at least one of the flags is still set after reti, causing the UART1 request line, which is an OR-function of the two flags RI and TI, to remain set throughout the ISR and after reti.

This means, any future UART1 RI or TI event is not able to cause a rising edge and therefore not able to trigger an interrupt request to the core – as if the UART1 interrupts had been disabled, until both RI and TI flags are cleared at some time. The clearing of flags would have to be done by user's code additionally outside of the UART1 interrupt routine, which is however normally not feasible with an interrupt service scheme.

There are two suggested workaround:

1. If other events of interrupt node XINTR8 (EX2) need not be enabled for interrupt, disable this interrupt node and use software polling of the flags instead.
2. Before return from interrupt, check again if RI or TI is (still) set (due to new request since the last check). If so, jump and execute the ISR routine from start. Exit only when all flags are checked to be cleared. However, dummy

interrupt of the node may occur after return from interrupt, and should be ignored. Another drawback is if UART1 events are occurring at high rate, the CPU may be 'stuck' in the service routine of the UART1 interrupt for a long time.

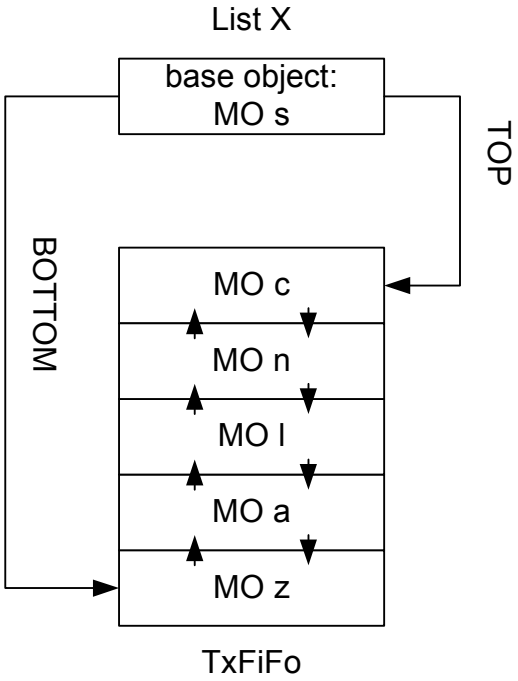
Figure 6 FIFO structure

A Tx FIFO overflow interrupt will not be generated after the transmission of the Tx FIFO base object.

If Tx FIFO overflow interrupt needed, take the FIFO base object out of the circular list of the Tx message objects. That is to say, just use the FIFO base object for FIFO control, but not to store a Tx message.

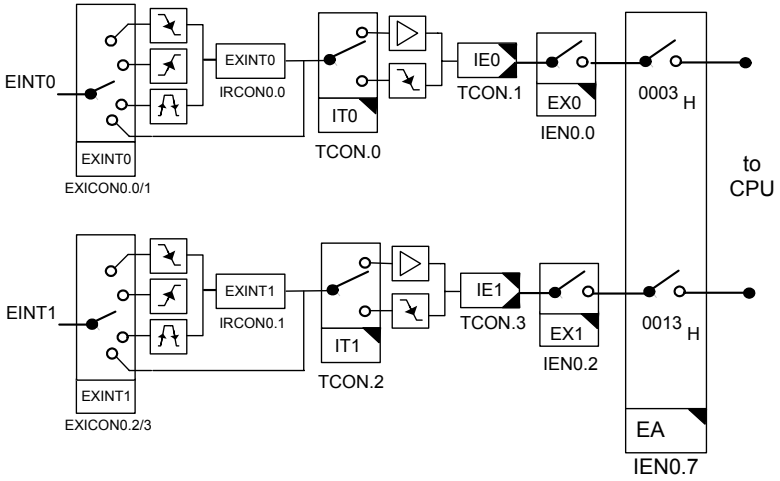
Figure 8

Edge detection is done in the system unit. If enabled, an active event will set the EXINTx flag and correspondingly set the IEx flag in TCON. It should be noted that after any external interrupt x event, flag EXINTx must be cleared. In case of falling edge as active event, this allows any future active event to be able to set the flag IEx as interrupt request. In case of low level as active event, this prevents unintended recurring triggering of interrupt request.

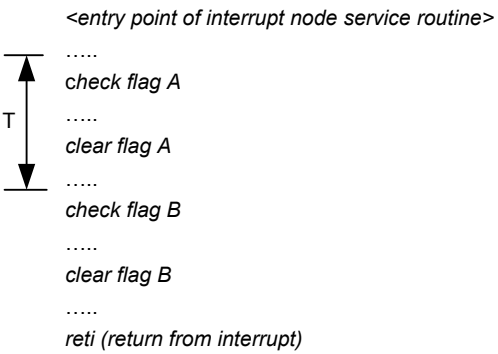
Figure 9

It might occur in the application, that sometimes NMI interrupt requests are serviced, but no active NMI interrupt flags are found.

In this case, NMI flag B will be cleared as a standard procedure by the NMI interrupt routine in the current service. However, the pending interrupt request for the NMI node remains activated after RETI, as it is only cleared by hardware when CPU acknowledge the NMI interrupt and vectors to the NMI service routine.

This leads to following servicing of the NMI interrupt node again, but potentially no active NMI flag is found, i.e. dummy NMI interrupt service. The point to note is that the NMI interrupt source B is not lost, as it was actually serviced in the current service of the NMI interrupt node.

The recommendation is to ignore these dummy NMI interrupt vectoring.

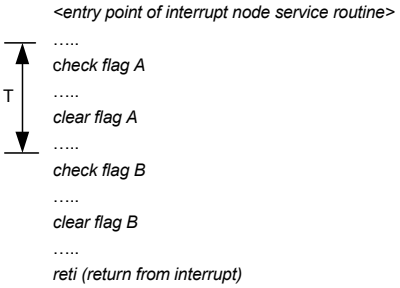
Figure 10

Consider the case where an enabled interrupt node is shared by more than 2 events, and where at least two of the events (A and B) are enabled for interrupt while at least one event (C) is not enabled for interrupt. In this case, flag C is one of the flags listed in above table.

This sets the pending interrupt request while flag B is set.Although event B is serviced and flag B is cleared in the following service routine, on return from interrupt, the pending interrupt request remains activated. This is because event C is not enabled for interrupt (and therefore flag C is neither checked nor cleared in the interrupt routine) while flag C is not qualified.This leads to following servicing of the interrupt node again, but potentially no active flag is found, i.e. dummy interrupt service.To prevent such dummy interrupt vectoring on the above listed interrupt nodes, do not use mixed interrupt servicing and polling scheme, i.e, enable all events of the node for interrupt if interrupt node is enabled.Otherwise if mixed interrupt servicing and polling scheme is to be used, ignore these dummy interrupt vectoring.
