Errata Sheet

Rel. 1.3, 24.11.2006

Device	**XC886CM-8FF**
Marking/Step	**ES AB**
Package	**PG-TQFP-48**

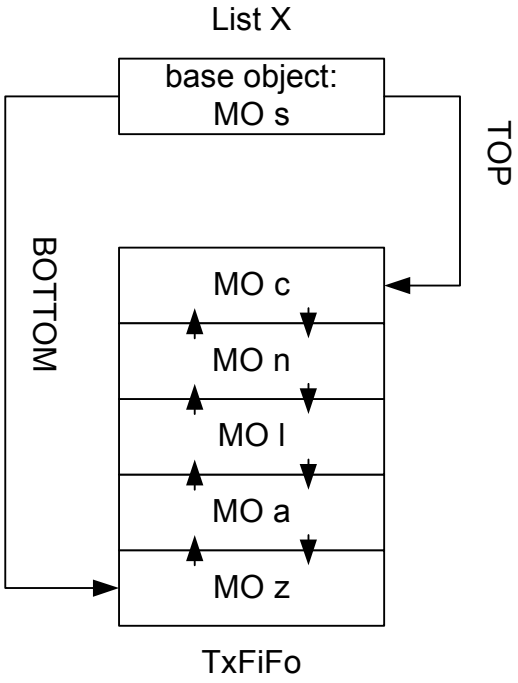
Figure 6 FIFO structure

A Tx FIFO overflow interrupt will not be generated after the transmission of the Tx FIFO base object.

If Tx FIFO overflow interrupt needed, take the FIFO base object out of the circular list of the Tx message objects. That is to say, just use the FIFO base object for FIFO control, but not to store a Tx message.

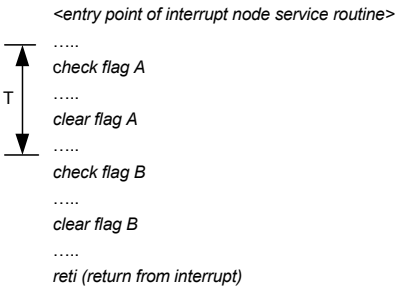
Figure 10

While the interrupt routine is already running due to event A having occurred, event B and C occurs any time in the duration indicated by T:

This sets the pending interrupt request while flag B is set.Although event B is serviced and flag B is cleared in the following service routine, on return from interrupt, the pending interrupt request remains activated. This is because event C is not enabled for interrupt (and therefore flag C is neither checked nor cleared in the interrupt routine) while flag C is not qualified.This leads to following servicing of the interrupt node again, but potentially no active flag is found, i.e. dummy interrupt service.To prevent such dummy interrupt vectoring on the above listed interrupt nodes, do not use mixed interrupt servicing and polling scheme, i.e, enable all events of the node for interrupt if interrupt node is enabled.Otherwise if mixed interrupt servicing and polling scheme is to be used, ignore these dummy interrupt vectoring.
