Errata Sheet

Rel. 1.4, 2016-11

Device	**XMC1100**
Marking/Step	**EES-AB, ES-AB, AB**
Package	**PG-TSSOP-16/38, PG-VQFN-24/40**

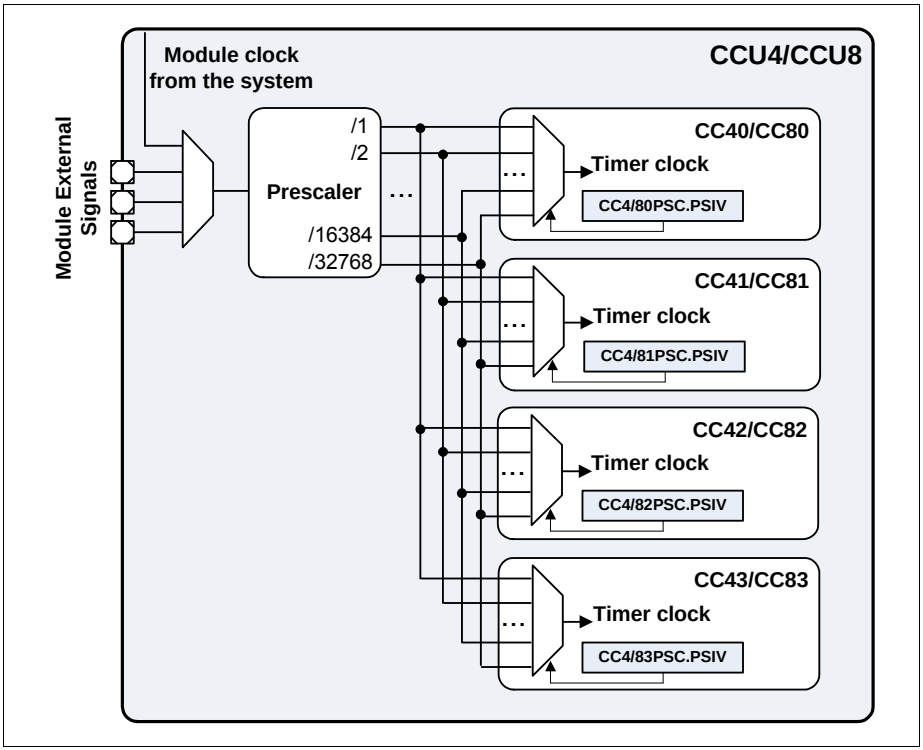
Figure 1 Clock Selection Diagram for CCU4/CCU8

CCU_AI.005 CCU4 and CCU8 External IP clock Usage

Each CCU4/CCU8 module offers the possibility of selecting an external signal to be used as the master clock for every timer inside the module Figure 1. External signal in this context is understood as a signal connected to other module/IP or connected to the device ports.

Currently is only possible to use an external signal as Timer Clock when a division ratio of 2 or higher is selected. When no division is selected (divided by 1), the external signal cannot be used.

This is only applicable if the Module Clock provided by the system (the normal default configuration and use case scenario) is not being used. In the case that the normal clock configured and programmed at system level is being used, there is not any type of constraints.

The user must program the PSIV field of each Timer Slice with a value different from 0000_B - minimum division value is /2.
