Errata Sheet

Rel. 1.4, 2016-11

Device	**XMC1300**
Marking/Step	**EES-AB, ES-AB, AB**
Package	**PG-TSSOP-16/28/38, PG-VQFN-24/40**

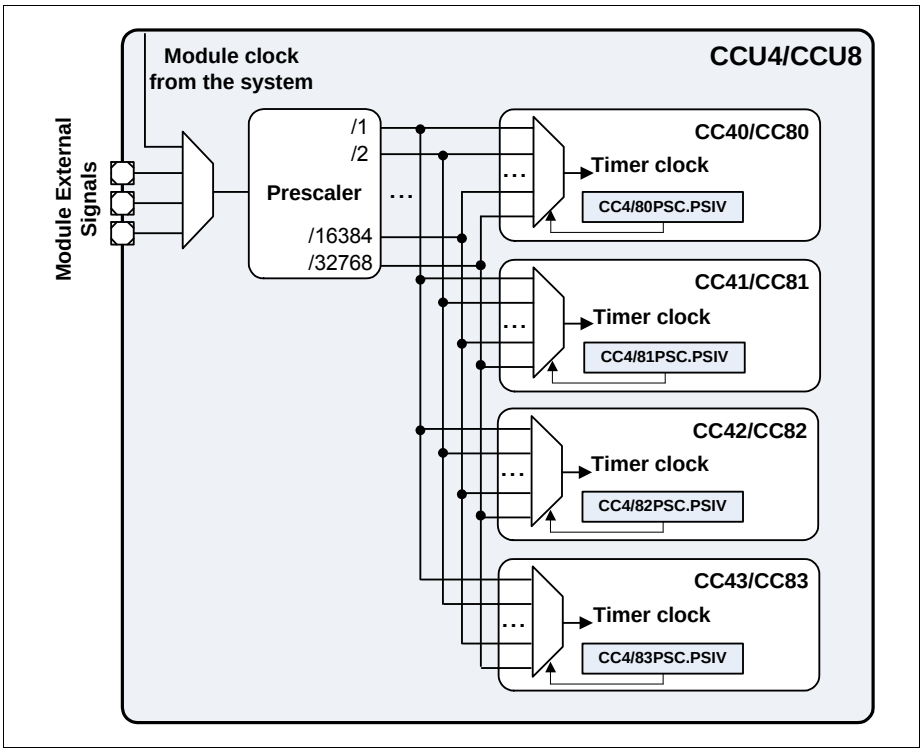
Figure 1 Clock Selection Diagram for CCU4/CCU8

Currently is only possible to use an external signal as Timer Clock when a division ratio of 2 or higher is selected. When no division is selected (divided by 1), the external signal cannot be used.

The user must program the PSIV field of each Timer Slice with a value different from 0000_B - minimum division value is /2.

This is only applicable if the Module Clock provided by the system (the normal default configuration and use case scenario) is not being used. In the case that the normal clock configured and programmed at system level is being used, there is not any type of constraints.

None.

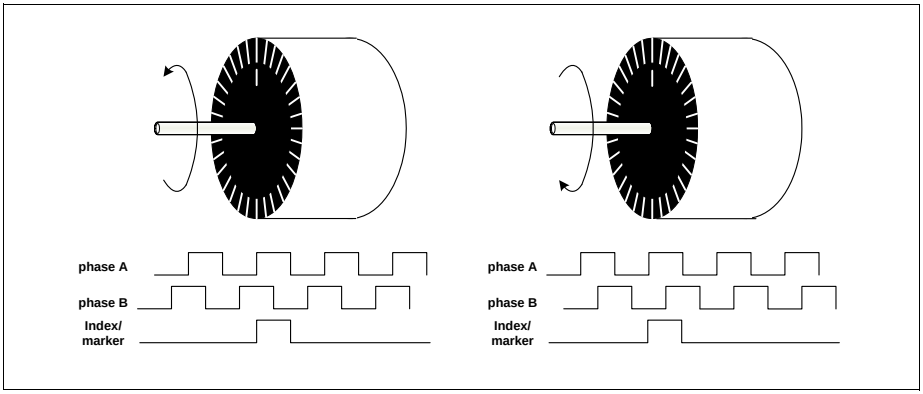
Figure 4 Rotary Encoder outputs - Phase A, Phase B and Index

POSIF_AI.001 Input Index signal from Rotary Encoder is not decoded when the length is 1/4 of the tick period

Each POSIF module can be used as an input interface for a Rotary Encoder. It is possible to configure the POSIF module to decode 3 different signals: Phase A, Phase B (these two signals are 90° out of phase) and Index. The index signal is normally understood as the marker for the zero position of the motor Figure 1.

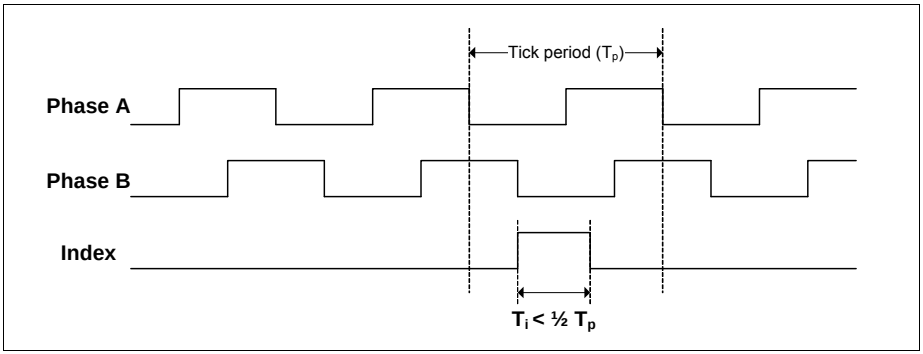
Figure 5 Different index signal types

When the index signal is smaller than 1/2 of the tick period, the POSIF module is not able to decode this signal properly, Figure 2 - notice that the reference edge of the index generation in this figure is the falling of Phase B, nevertheless this is an example and depending on the encoder type, this edge may be one of the other three.

Due to this fact it is not possible to use the POSIF to decode these type of signals (index with duration below 1/2 of the tick period).
