Errata Sheet

Rel. 1.6, 2021-01

Device	**XMC1400**
Marking/Step	**EES-AA, ES-AA, AA**
Package	**PG-VQFN-40/48/64, PG-LQFP-64, PG-TSSOP-38**

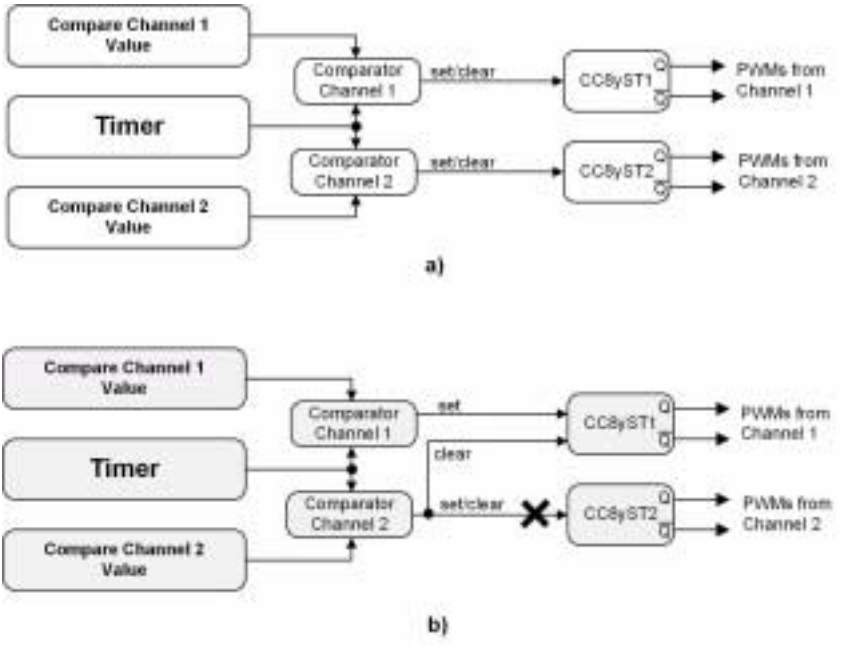
Figure 1 CCU8 simplifier PWM generation scheme - a) normal mode; b) asymmetric mode

CCU8_AI.005 PWM outputs from Compare Channel 2 are disabled in asymmetric mode

The asymmetric mode has a bug, where the PWM signal of Compare Channel 2 is not stored in CC8yST2. This means that from the Compare Channel 2 the timer cannot generate any PWM signal - depicted by the cross on **Figure 1** b).

Note that the asymmetric PWM is still stored in CC8yST1 and can be used normally by the application.

None

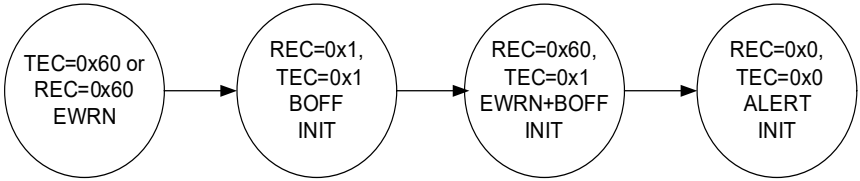
Figure 3 Alert Interrupt Behavior in case of Bus-Off

The MultiCAN module shows the following behavior in case of a bus-off status:

When the threshold for error warning (EWRN) is reached (default value of Error Warning Level EWRN = 0x60), then the EWRN interrupt is issued. The bus-off (BOFF) status is reached if TEC > 255 according to CAN specification, changing the MultiCAN module with REC and TEC to the same value 0x1, setting the INIT bit to 1_B, and issuing the BOFF interrupt. The bus-off recovery phase starts automatically. Every time an idle time is seen, REC is incremented. If REC = 0x60, a combined status EWRN+BOFF is reached. The corresponding interrupt can also be seen as a pre-warning interrupt, that the bus-off recovery phase will be finished soon. When the bus-off recovery phase has finished (128 times idle time have been seen on the bus), EWRN and BOFF are cleared, the ALERT interrupt bit is set and the INIT bit is still set.

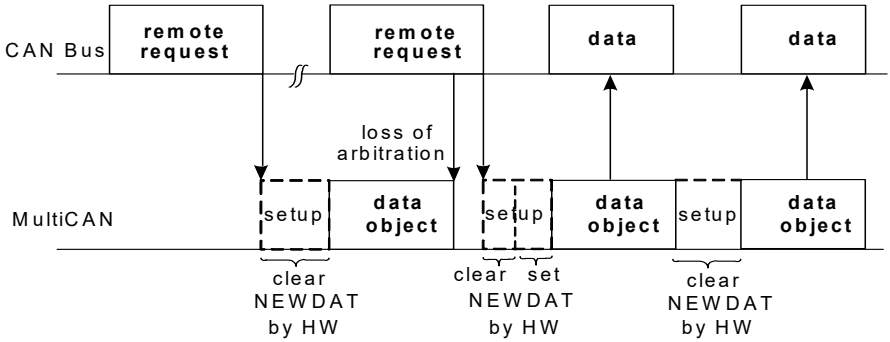
Figure 4 Loss of Arbitration

When the appropriate message object (data frame) triggered by the first remote frame wins the arbitration, it will be sent out and NEWDAT is not reset. This leads to an additional data frame, that will be sent by this message object (clearing NEWDAT).

There will, however, not be more data frames than there are corresponding remote requests.
