XMC4300 errata sheet

Marking/Step: ES-AA, AA

Package: PG-LQFP-100

This document describes the errata for XMC4300 product family.

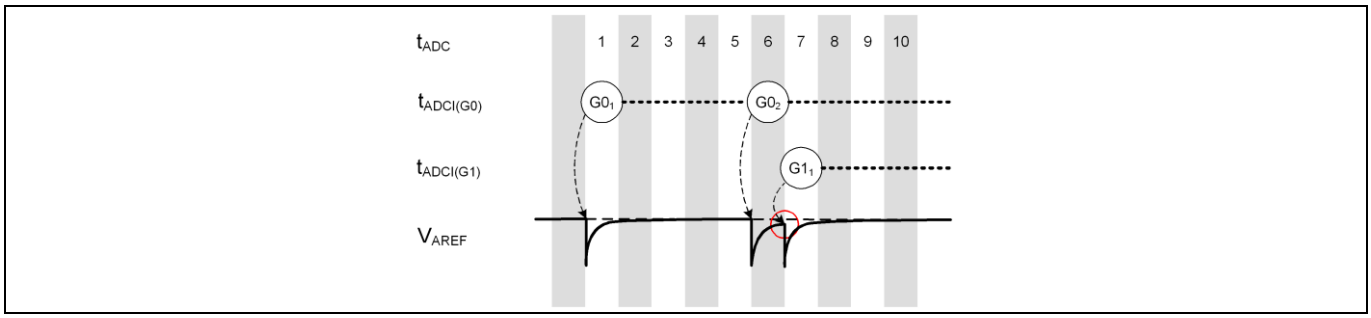
Figure 1 Influence of concurrent conversions on reference voltage

Due to this architecture, the individual prescalers may be displaced by one module clock as shown in the Figure 1 below for $G0_2$ and $G1_1$. In this example the division factor is 5 (DIVA=4).

In cycle 1 only the G0 conversion step is started. At start time the reference voltage is strobed and a certain amount of electric charge (see data sheet parameter Q_{CONV}) is consumed. This causes a drop in the reference voltage level V_{AREF}. Quantity of voltage drop depends on analog voltage level to convert.

In repeated mesurements using the example setup errors up to 25 LSB have been observed in 10-16 of 4096 conversions. Magnitude of the error however depends on the system configuration and load. The workaround therefore should be applied for all applications.

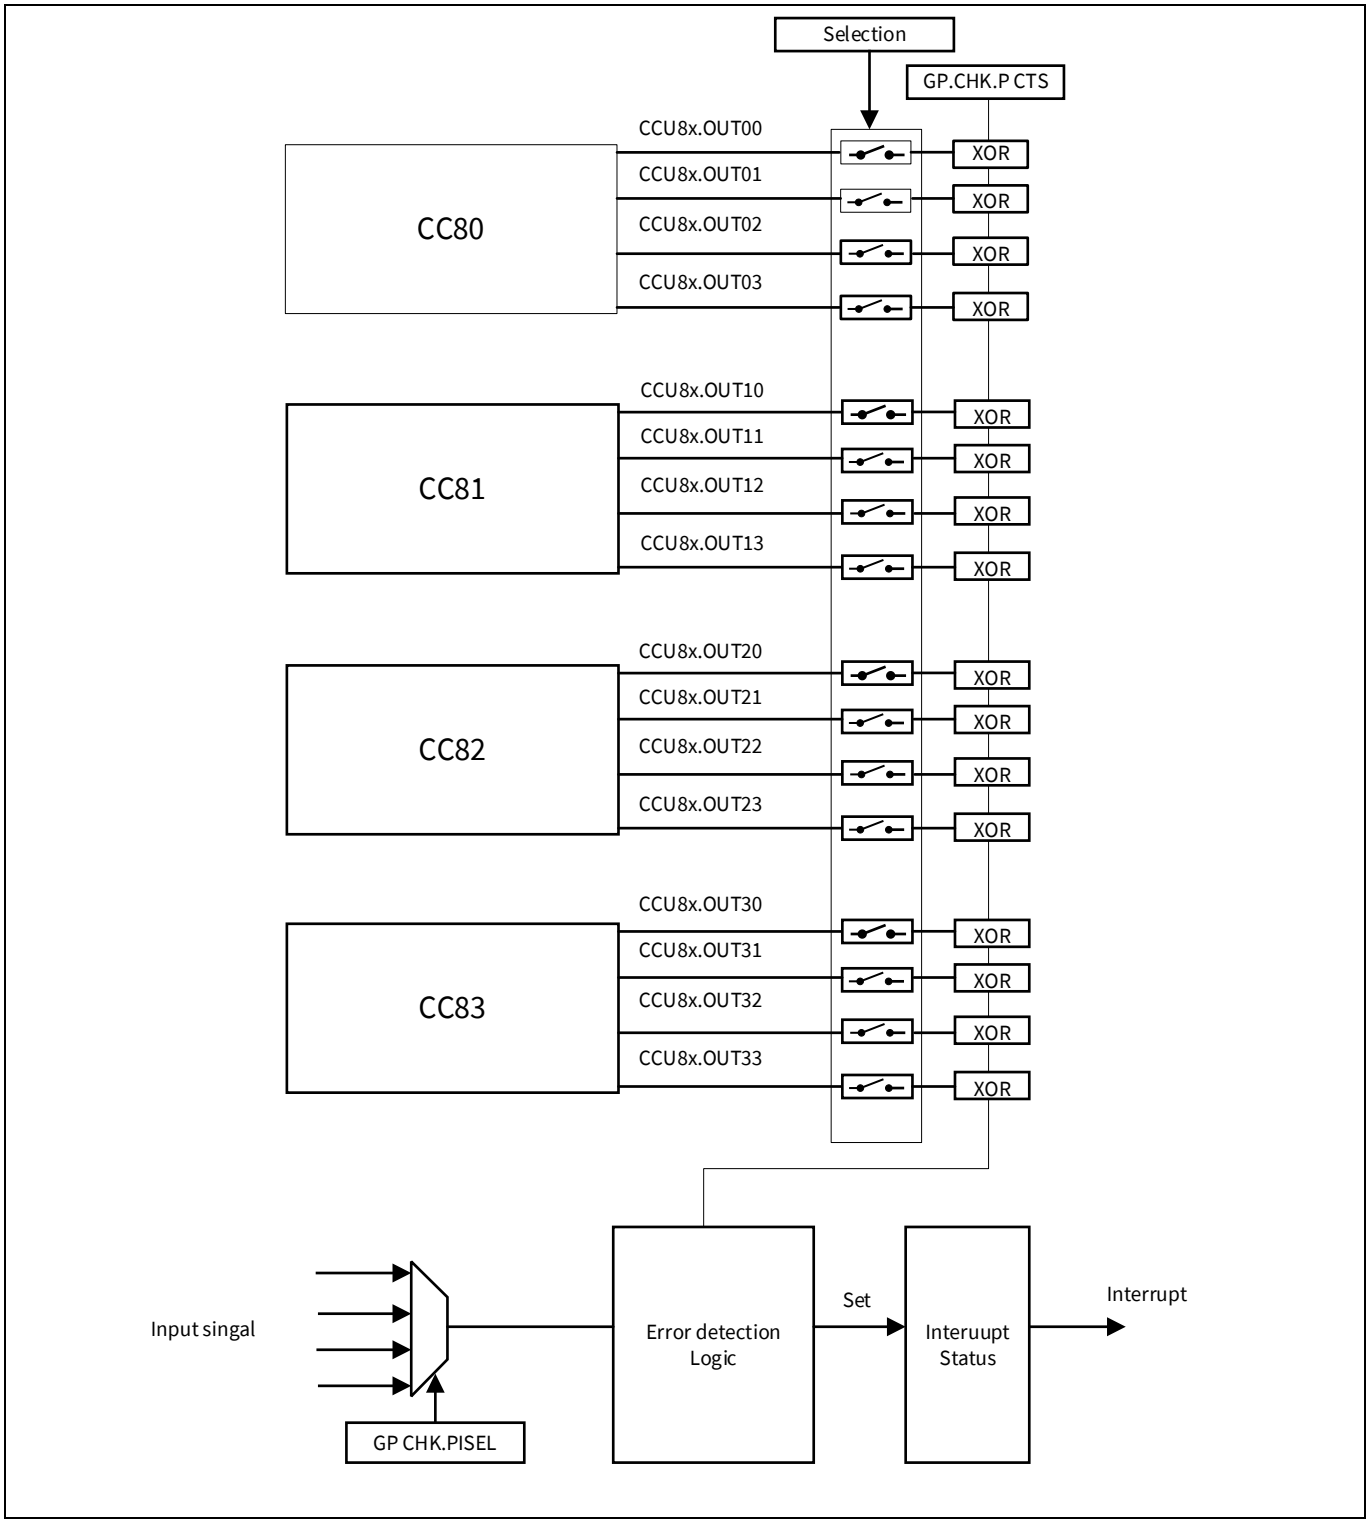
Figure 2 Parity checker diagram

Each CCU8 module also contains a function called parity checker. This parity checker function cross checks the output of a XOR structure versus an input signal, as seen in Figure 2.

This means that if in the previous PWM cycle an error was detected and one interrupt was triggered, the software needs to read back the status register before the end of the immediately next PWM cycle.

This is indeed only necessary if multiple interrupt sources are ORed together in the same interrupt line. If this is not the case and the parity checker error source is the only one associated with an interrupt line, then there is no need to read back the status information. This is due to the fact that only one action can be triggered in the software routine, the one linked with the parity checker error.

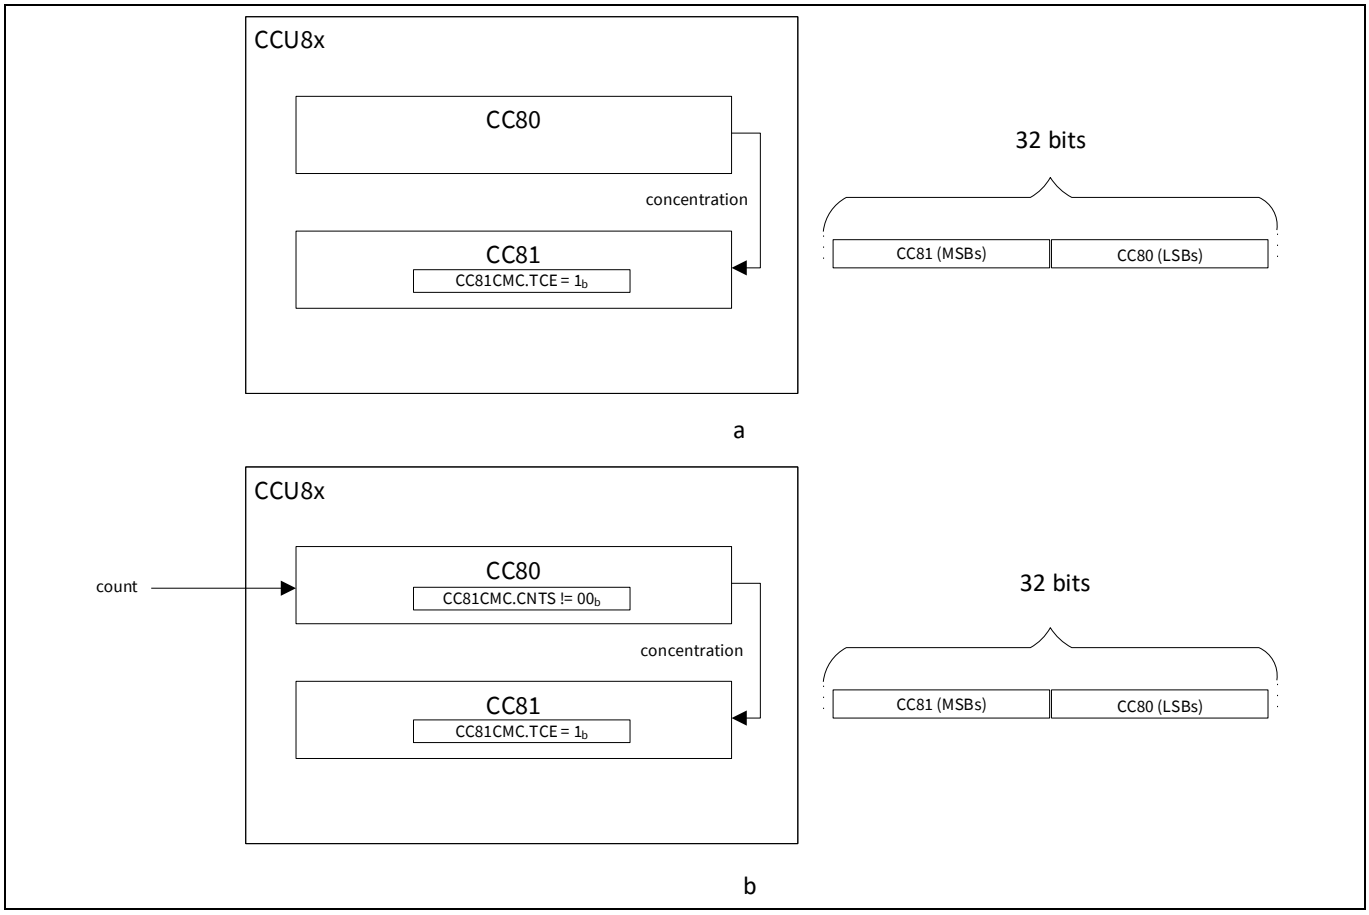
Figure 3 CU8x concatenation feature resource configuration - a) without external count function; b) with external count function

Each CCU8 peripheral contains four sixteen-bit timers. It is possible nevertheless to concatenate multiple timers to achieve a timer/counter with 32, 48 or 64 bits. To enable the concatenation feature, the CC8yCMC.TCE bitfield needs to be set to 1_B - Figure 3 a), where CCU8x represents a CCU8 peripheral instance x, and CC80 and CC81, represents timer 0 and timer 1 respectively (please notice that CC80 and CC81 are just used for simplicity, meaning that this function can be used also with the other timers inside CCU8x).

It is also possible to use an external signal as a count trigger. This means that when using an external count signal, the LSB timer is incremented each time that a transition on this external signal occurs - Figure 3 b), When an external count signal is enabled - by programming the CC8yCMC.CNTS with 01_B, 10_B or 11_B - the concatenation function does not work. One cannot use in parallel the timer concatenation and external count signal features.

Note: On Figure 3, the count signal is used in CCU80 because this timer represents the LSBs. While the count signal could be enabled in the MSB timer (CC81), this does not make sense when the timers are concatenated - because the count should be used to increment the LSB timer. The LSB timer will then be in each wrap around, increment the MSB timer.

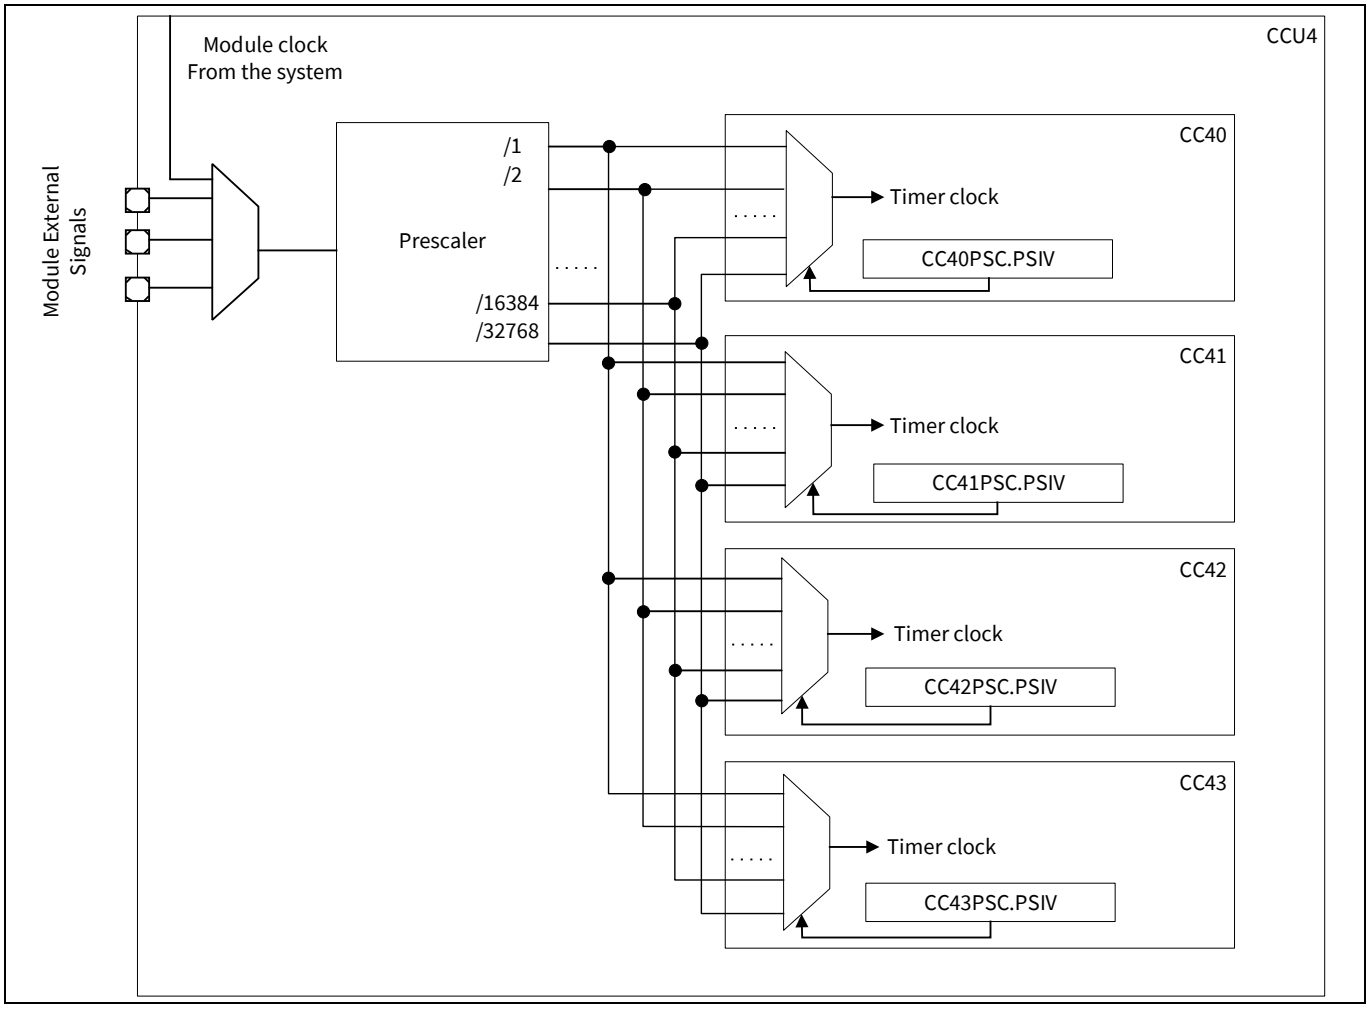
Figure 4 Clock selection diagram for CCU4

Each CCU4 module offers the possibility of selecting an external signal to be used as the master clock for every timer inside the module Figure 4. External signal in this context is understood as a signal connected to other module/IP or connected to the device ports.

This is only applicable if the Module Clock provided by the system (the normal default configuration and use case scenario) is not being used. In the case that the normal clock is configured and programmed at system level is being used, there is not any type of constraints.

One should not also confuse the usage of an external signal as clock for the module with the usage of an external signal for counting. These two features are completely unrelated and there are not any dependencies between both.

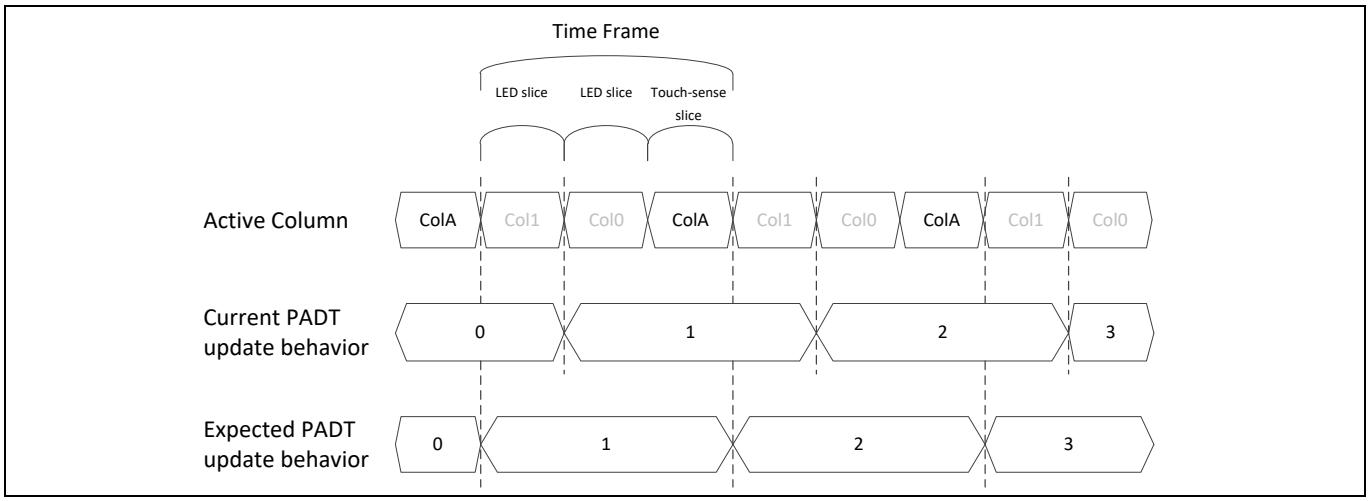
Figure 5 PADT update behavior

The touch-sense pad turn (PADT) value is updated, not at the end of the touch-sense time slice (ColA), but one time slice later, as shown in Figure 5.

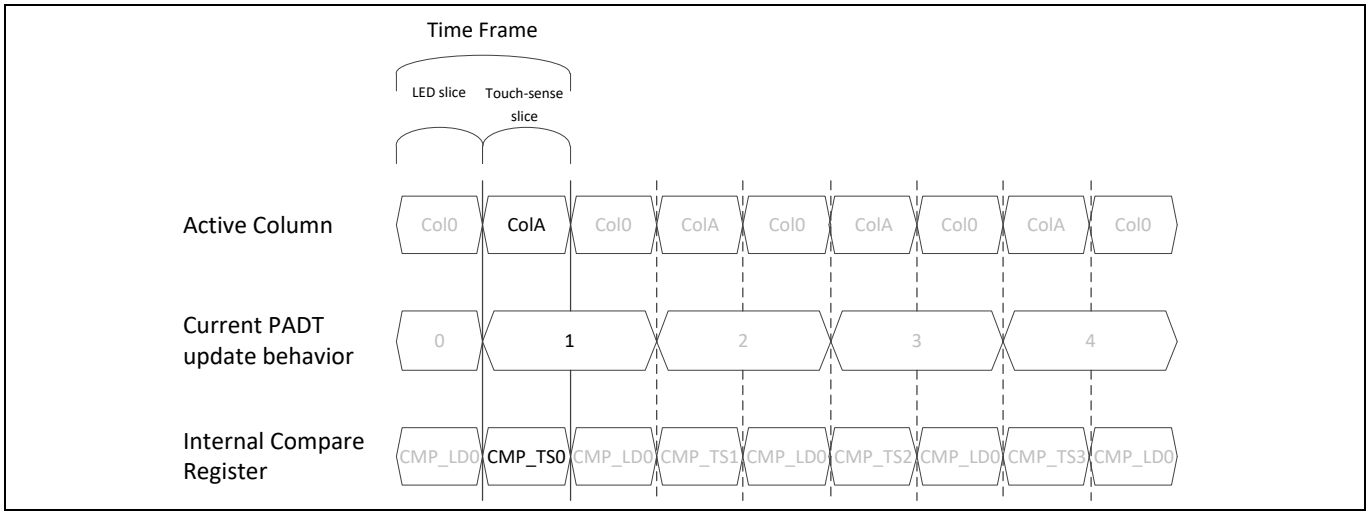
Figure 6 Effect of delay on the update of Internal Compare Register with 1 LED column enabled

If the number of LED columns enabled is smaller than 2, the delay will affect the activation period of the current active pad. At the beginning of every new Col A, the value of the current PADT's compare register is updated to the internal compare register. However, the delay causes the value of the previous PADT's compare register is updated to the internal compare register instead. This means that the current active pad would be activated with the duration of the previous pad's oscillation window, as shown in Figure 6. In addition to this, when no LEDs are enabled, pad turn 0 will prevail for one time slice longer before it gets updated, as shown in Figure 7.

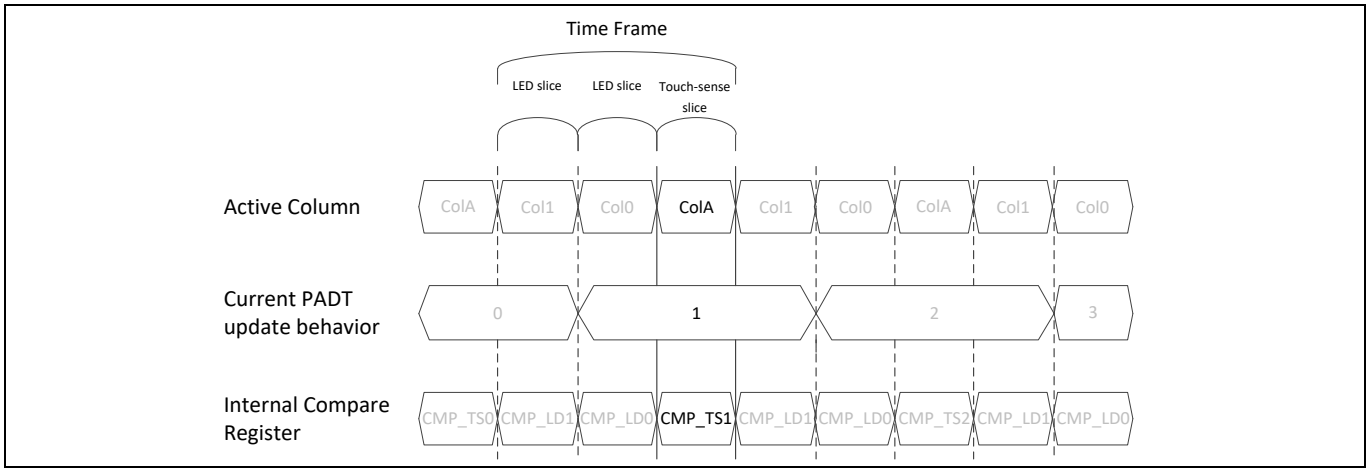
Figure 8 Internal Compare Register updated with correct compare register value with 2 LED columns enabled

If the number of LED columns enabled is 2 or more, the additional LED columns would provide some buffer time for the delay. So, at the start of a new touch-sense time slice, the update of PADT value would have taken place. Hence, the current active PADT compare register value is updated to the internal compare register, as shown in Figure 8.

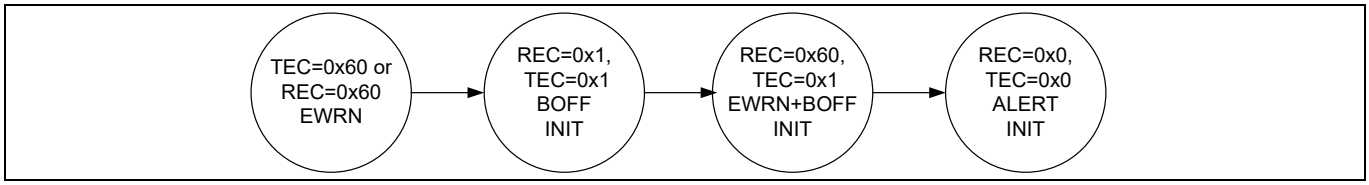
Figure 10 Alert interrupt behavior in case of Bus-Off

When the threshold for error warning (EWRN) is reached (default value of Error Warning Level EWRN = 0x60), then the EWRN interrupt is issued. The bus-off (BOFF) status is reached if TEC > 255 according to CAN specification, changing the MultiCAN module with REC and TEC to the same value 0x1, setting the INIT bit to 1_B, and issuing the BOFF interrupt. The bus-off recovery phase starts automatically. Every time an idle time is seen, REC is incremented. If REC = 0x60, a combined status EWRN+BOFF is reached. The corresponding interrupt can also be seen as a pre-warning interrupt, that the bus-off recovery phase will be finished soon. When the bus-off recovery phase has finished (128 times idle time have been seen on the bus), EWRN and BOFF are cleared, the ALERT interrupt bit is set and the INIT bit is still set.

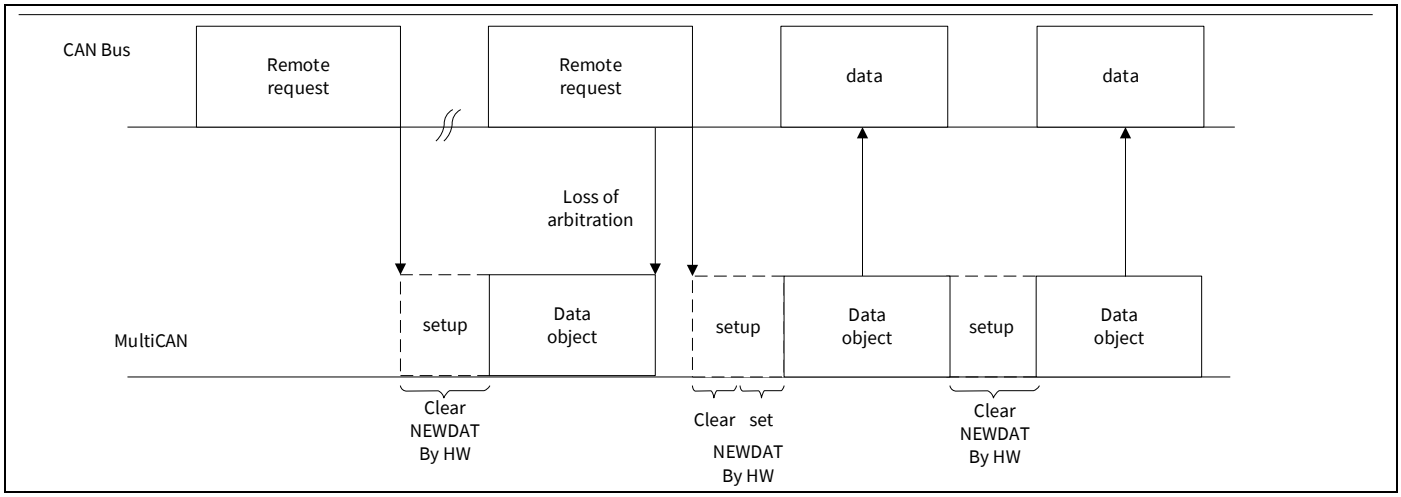
Figure 11 Loss of arbitration

When the appropriate message object (data frame) triggered by the first remote frame wins the arbitration, it will be sent out and NEWDAT is not reset. This leads to an additional data frame, that will be sent by this message object (clearing NEWDAT).

There will, however, not be more data frames than there are corresponding remote requests.

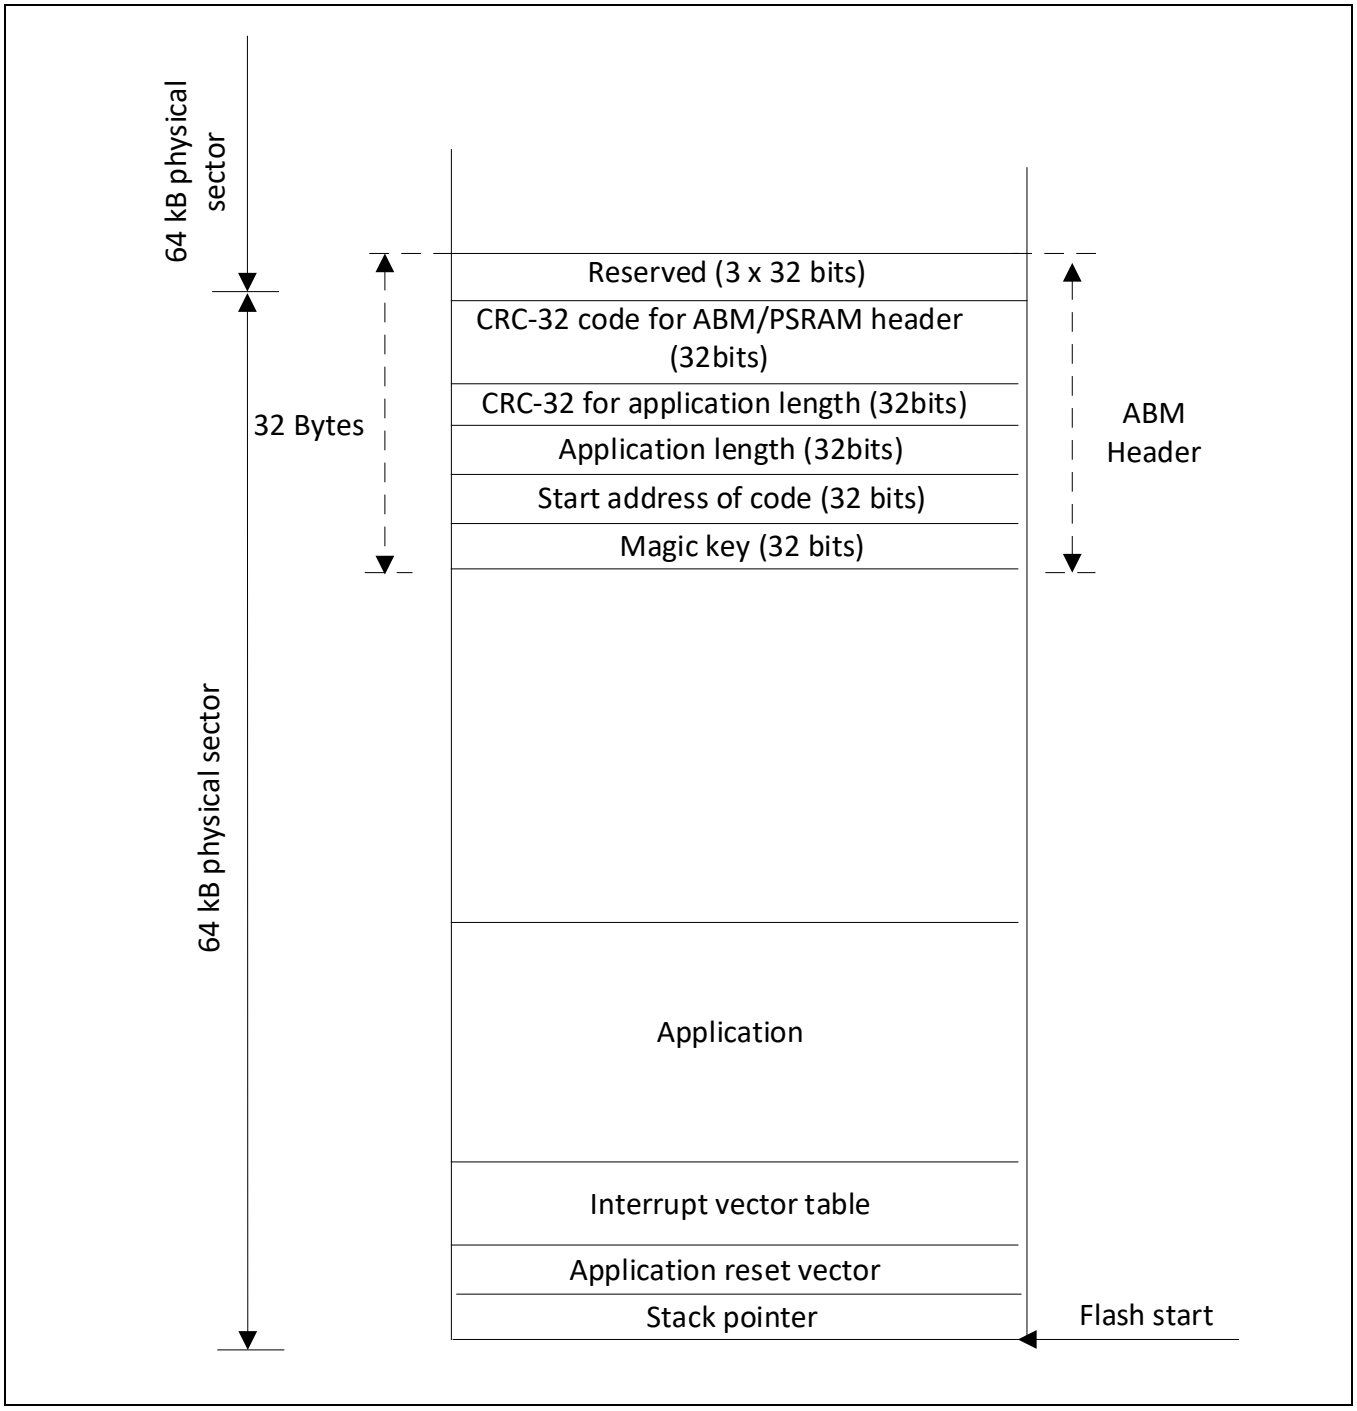
Figure 12 ABM/PSRAM header - Location of reserved bytes

The reference manual specifies PSRAM/ABM Header of 32 byte size. Only for 20 byte of these 32 bytes the functionality is defined. The remaining 12bytes are reserved. Inside the chapter for Startup modes of the reference manual only the functional bytes are specified but not the location of the reserved bytes.

The following Figure 12 provides a detailed view of the location of the reserved bytes:
