Device	XMC4100/XMC4200
Marking/Step	EES-AA, ES-AA
Package	PG-VQFN-48, PG-LQFP-64

Document ID is **02530AERRA**.

This “Errata Sheet” describes product deviations with respect to the user documentation listed below.

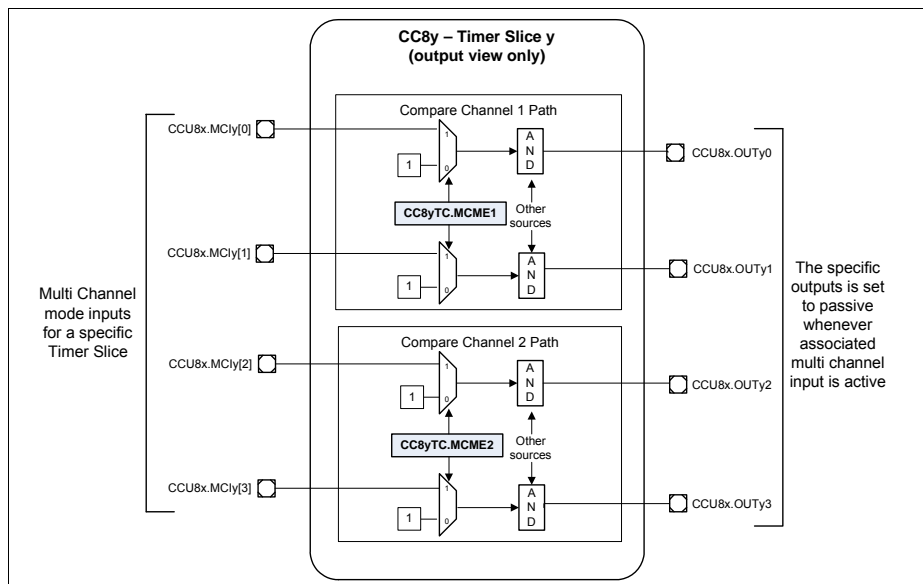
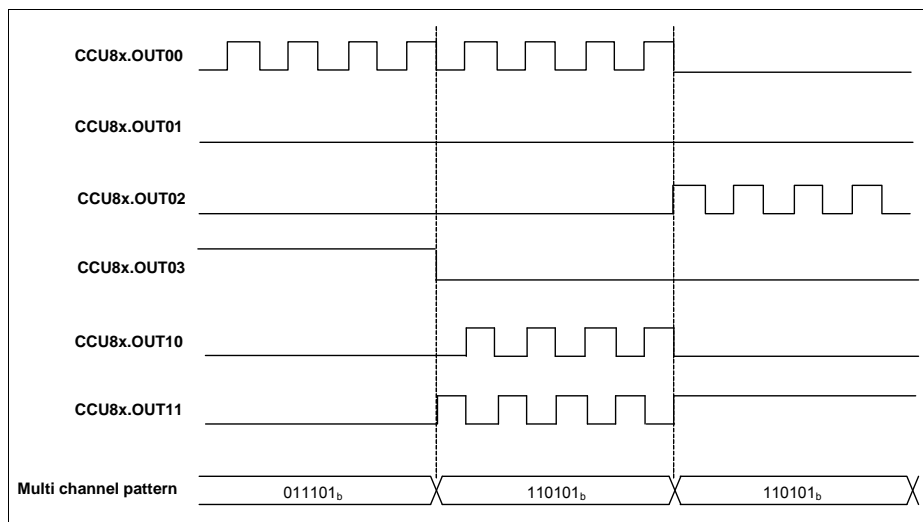
Figure 4 Multi Channel Mode diagram

A glitch is present at the PWM outputs whenever the dead time of the specific compare channel is enabled - CC8yDTC.DTE1 and/or CC8yDTC.DTE2 set to 1_B (each compare channel has a separate dead time function) - and the specific multi channel pattern for the channel is 01_B or 10_B.

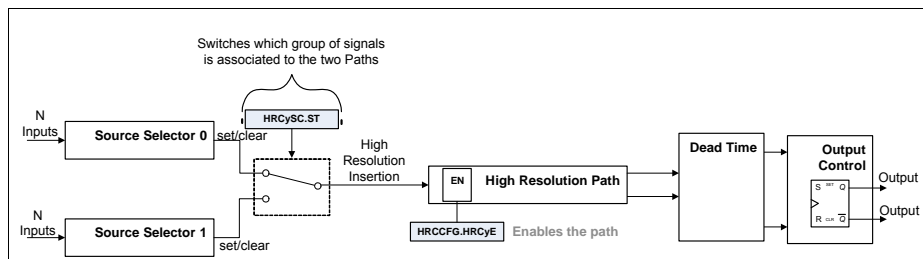
Figure 10 HRC with only one path enabled and two Source Selectors

This scenario where only one path is enabled but both Source Selectors are being used, and by being used is understood that signals are being actively decoded from the Source Selectors (input signals for the Source Selectors are being updated) is depicted on [Figure 10](#) - in this example the High Resolution Path is the one being used.

In the above scenario, every time that the HRCyST.ST bitfield is 1_B , the Source Selector 1 is the one that has control over the PWM signal. Whenever the HRCyST.ST bitfield is 0_B is the Source Selector 0 that has control over the PWM signal.

If the described condition occurs, then the signal generated by Source Selector 1 is lost and the PWM signal is not handled properly - **Figure 11**.
