Device	XMC4400
Marking/Step	ES-BA, BA
Package	PG-LQFP-64/100

Document ID is **118/17**.

This “Errata Sheet” describes product deviations with respect to the user documentation listed below.

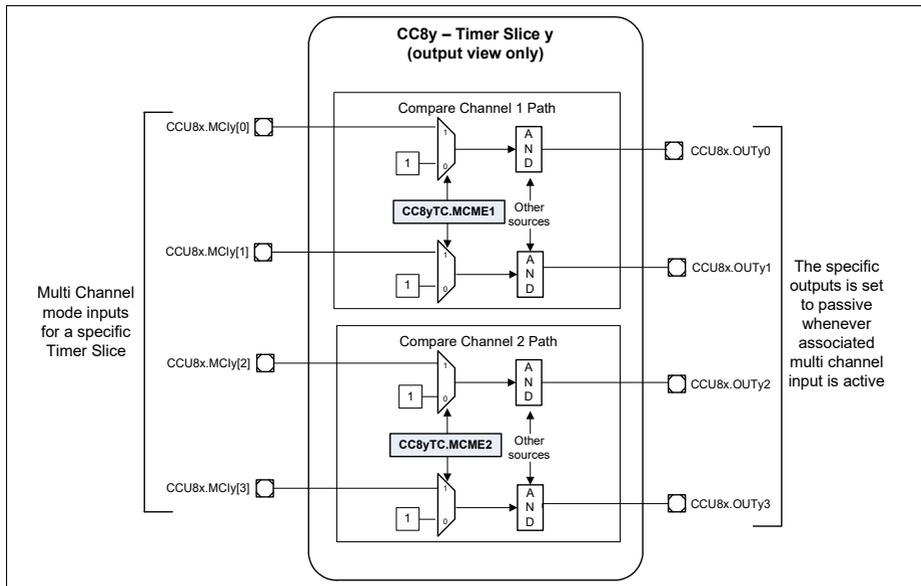
Figure 3 Multi Channel Mode diagram

A normal use case is the parallel control of the PWM output for BLDC motor control. In Figure 2, we can see the Multi Channel Pattern being updated synchronously to the PWM signals. Whenever a multi channel input is active (in this case 0), the specific output is set into passive level (the level in which the external switch is OFF).

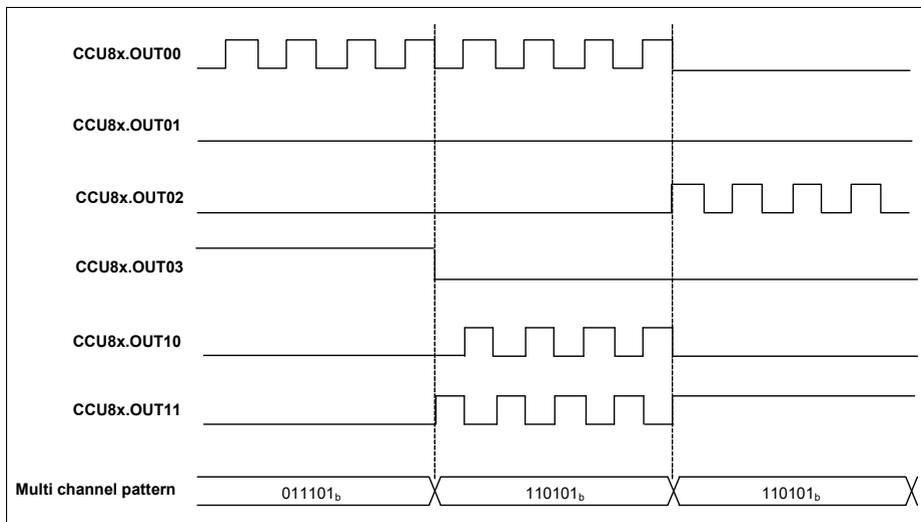
Figure 4 Multi Channel Mode applied to several CCU8 outputs

A glitch is present at the PWM outputs whenever the dead time of the specific compare channel is enabled - CC8yDTC.DTE1 and/or CC8yDTC.DTE2 set to 1_B (each compare channel has a separate dead time function) - and the specific multi channel pattern for the channel is 01_B or 10_B.

The effect of this glitch can be seen in Figure 3. The duration of the PWM glitch has the same length has the dead time value programmed into the CC8yDC1R.DT1F field (for compare channel 1) or into the CC8yDC1R.DT2F.

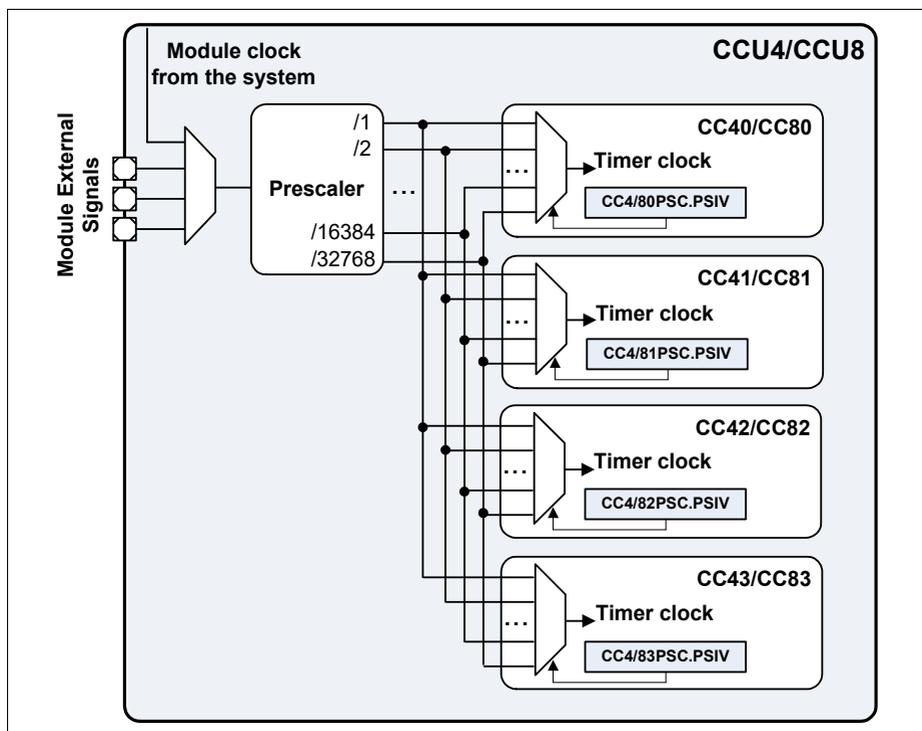
Figure 8 Clock Selection Diagram for CCU4/CCU8

This is only applicable if the Module Clock provided by the system (the normal default configuration and use case scenario) is not being used. In the case that the normal clock configured and programmed at system level is being used, there is not any type of constraints.

One should not also confuse the usage of an external signal as clock for the module with the usage of an external signal for counting. These two features are completely unrelated and there are not any dependencies between both.

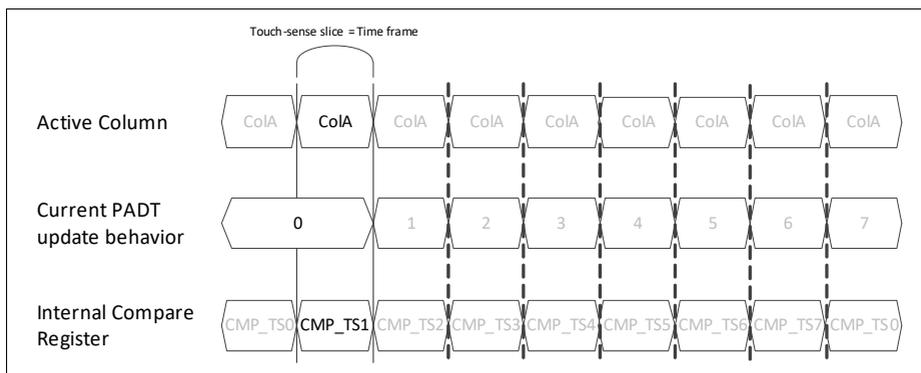
Figure 11 Pad turn 0 prevails for one time slice longer when no LEDs are enabled

If the number of LED columns enabled is smaller than 2, the delay will affect the activation period of the current active pad. At the beginning of every new Col A, the value of the current PADT's compare register is updated to the internal compare register. However, the delay causes the value of the previous PADT's compare register is updated to the internal compare register instead. This means that the current active pad would be activated with the duration of the previous pad's oscillation window ([Figure 10](#)). In addition to this, when no LEDs are enabled, pad turn 0 will prevail for one time slice longer before it gets updated ([Figure 11](#)).

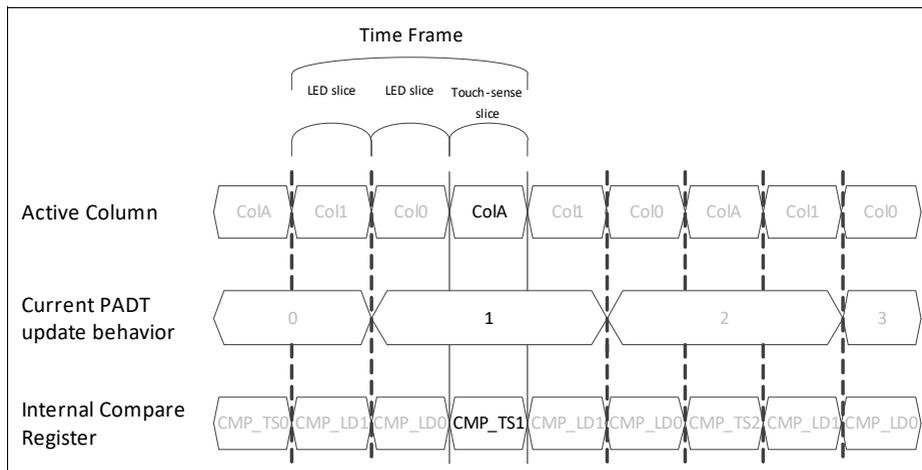
Figure 12 Internal Compare Register updated with correct compare register value with 2 LED columns enabled

If the number of LED columns enabled is 2 or more, the additional LED columns would provide some buffer time for the delay. So, at the start of a new touch-sense time slice, the update of PADT value would have taken place. Hence, the current active PADT compare register value is updated to the internal compare register (**Figure 12**).

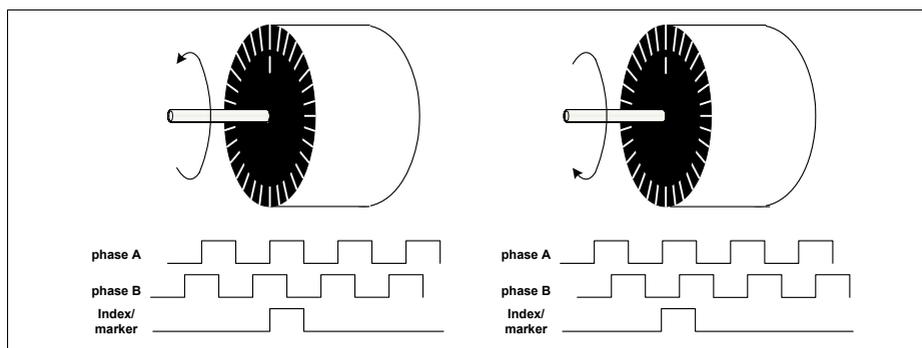
Figure 14 Rotary Encoder outputs - Phase A, Phase B and Index

Each POSIF module can be used as an input interface for a Rotary Encoder. It is possible to configure the POSIF module to decode 3 different signals: Phase A, Phase B (these two signals are 90° out of phase) and Index. The index signal is normally understood as the marker for the zero position of the motor Figure 1.

When the index signal is smaller than 1/2 of the tick period, the POSIF module is not able to decode this signal properly, Figure 2 - notice that the reference edge of the index generation in this figure is the falling of Phase B, nevertheless this is an example and depending on the encoder type, this edge may be one of the other three.

To make usage of the Index signal, when the length of this signal is less than 1/2 of the tick period, one should connect it directly to the specific counter/timer. This connection should be done at port level of the device (e.g. connecting the device port to the specific Timer/Counter(s)), Figure 3.

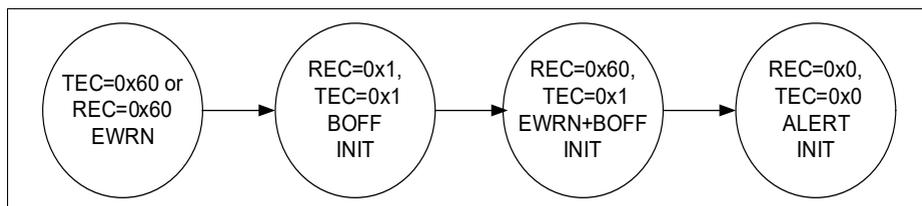
Figure 17 Alert Interrupt Behavior in case of Bus-Off

The MultiCAN module shows the following behavior in case of a bus-off status:

When the threshold for error warning (EWRN) is reached (default value of Error Warning Level EWRN = 0x60), then the EWRN interrupt is issued. The bus-off (BOFF) status is reached if $TEC > 255$ according to CAN specification, changing the MultiCAN module with REC and TEC to the same value 0x1, setting the INIT bit to 1_B , and issuing the BOFF interrupt. The bus-off recovery phase starts automatically. Every time an idle time is seen, REC is incremented. If REC = 0x60, a combined status EWRN+BOFF is reached. The corresponding interrupt can also be seen as a pre-warning interrupt, that the bus-off recovery phase will be finished soon. When the bus-off recovery phase has finished (128 times idle time have been seen on the bus), EWRN and BOFF are cleared, the ALERT interrupt bit is set and the INIT bit is still set.
