Device	TC1762
Marking/Step	EES-AA, ES-AA, AA
Package	PG-LQFP-176-2

## 01742AERRA

This Errata Sheet describes the deviations from the current user documentation.

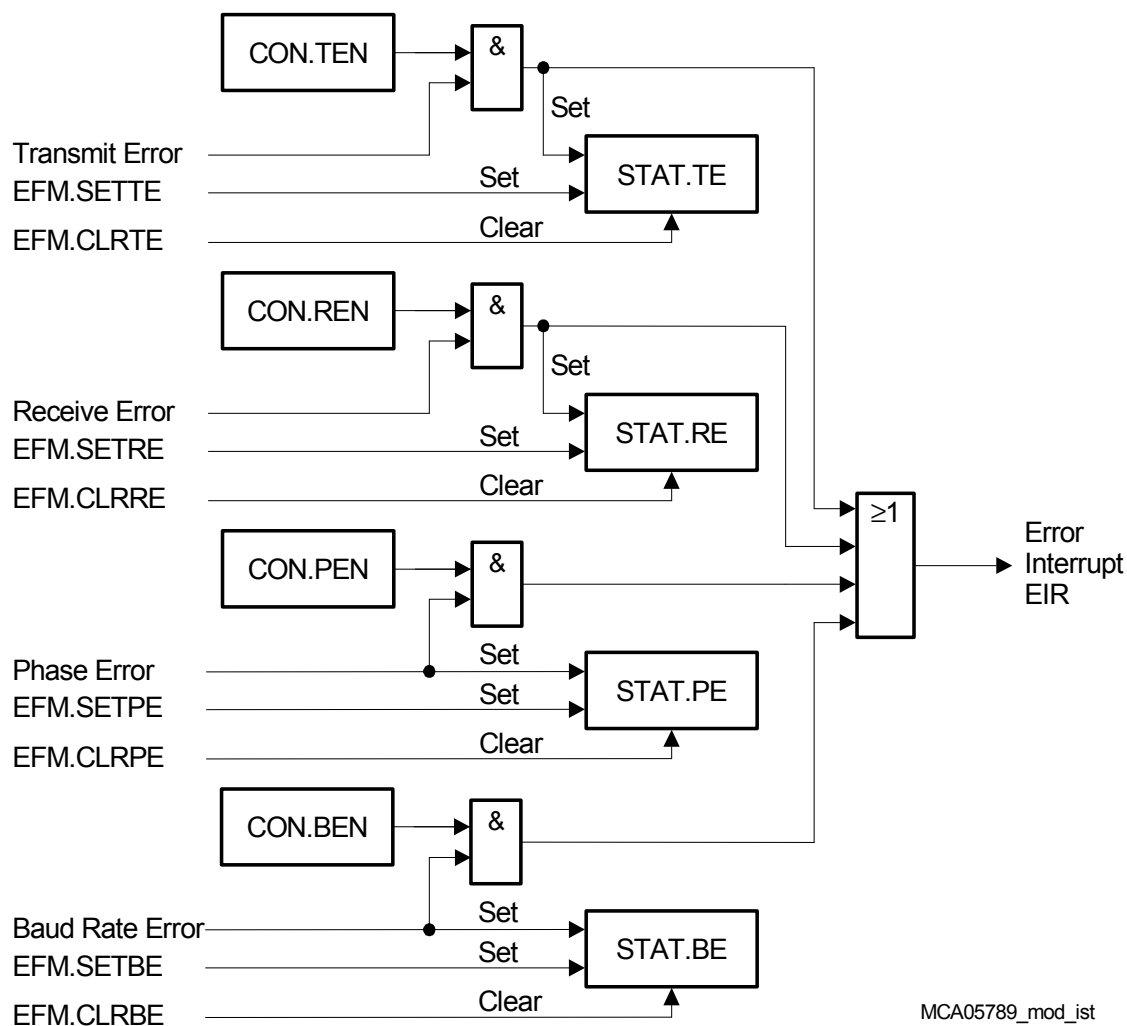
**Figure 9 SSC Error Interrupt Control**

The SSC is able to detect four different error conditions. Receive Error and Phase Error are detected in all modes, while Transmit Error and Baud Rate Error apply to Slave Mode only. In case of a Transmit Error or Receive Error, the respective error flags are set and the error interrupt requests will be generated by activating the EIR line only if the corresponding error enable bits have been set. In case of a Phase Error or Baud Rate Error, the respective error flags are always set and the error interrupt requests will be generated by activating the EIR line only if the corresponding error enable bit has been set. The error interrupt handler may then check the error flags to determine the cause of the error interrupt. The error flags are not reset automatically, but must be cleared via register EFM after servicing. This allows servicing of some error conditions via interrupt, while others may be polled by software. The error status flags can be set and reset by software via the error flag modification register EFM.

A **Receive Error** (Master or Slave Mode) is detected when a new data frame is completely received, but the previous data was not read out of the receive buffer register RB. If enabled via CON.REN, this condition sets the error flag STAT.RE and activates the error interrupt request line EIR. The old data in the receive buffer RB will be overwritten with the new value and is unretrievably lost.

A **Phase Error** (Master or Slave Mode) is detected when the incoming data at pin MRST (Master Mode) or MTSR (Slave Mode), sampled with the same frequency as the module clock, changes between one cycle before and two cycles after the latching edge of the shift clock signal SCLK. This condition sets the error status flag STAT.PE and, if enabled via CON.PEN, the error interrupt request line EIR.

A **Baud Rate Error** (Slave Mode) is detected when the incoming clock signal deviates from the programmed baud rate (shift clock) by more than 100%, meaning it is either more than double or less than half the expected baud rate. This condition sets the error status flag `STAT.BE` and, if enabled via `CON.BEN`, the EIR line. Using this error detection capability requires that the slave's shift clock generator is programmed to the same baud rate as the master device. This feature detects false additional pulses or missing pulses on the clock line (within a certain frame).

A **Transmit Error** (Slave Mode) is detected when a transfer was initiated by the master (shift clock becomes active), but the transmit buffer `TB` of the slave was not updated since the last transfer. If enabled via `CON.TEN`, this condition sets the error status flag `STAT.TE` and activates the EIR line. If a transfer starts while the transmit buffer is not updated, the slave will shift out the 'old' contents of the shift register, which is normally the data received during the last transfer. This may lead to the corruption of the data on the transmit/receive line in half-

*Note: The error interrupt handler must clear the associated (enabled) error flag(s) to prevent repeated interrupt requests. The setting of an error flag by software does not generate an interrupt request.*

*Note: A slave with push/pull output drivers not selected for transmission will normally have its output drivers switched off. However, to avoid possible conflicts or misinterpretations, it is recommended to always load the slave's transmit buffer prior to any transfer.*

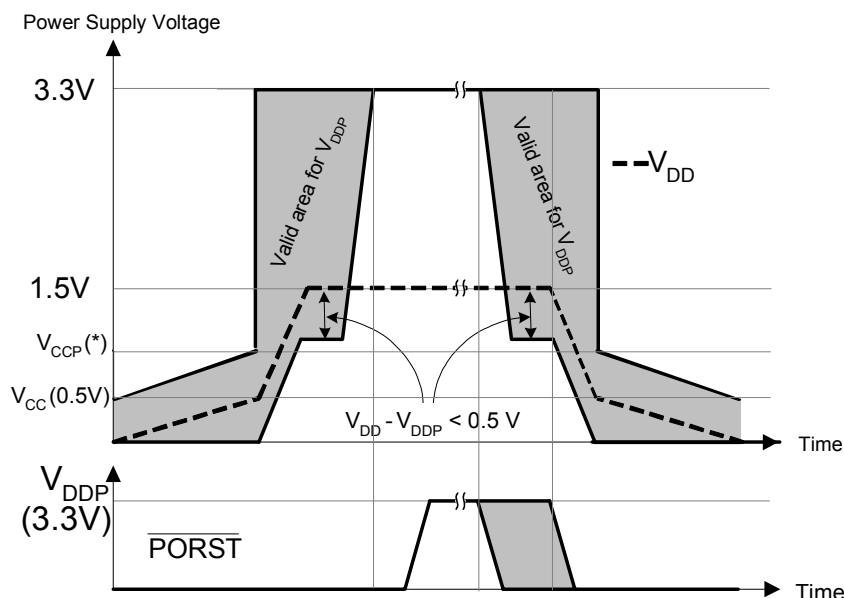
**Figure 11 Exemplary power-up/down sequence**

- All analog voltages ( $V_{DDOSC3}$ ,  $V_{DDM}$ ,  $V_{DDMF}$ ,  $V_{DDFL3}$ ) must also follow  $V_{DDP}$  power-up/down sequence.
- $V_{DDAF}$ ,  $V_{DDOSC}$  must follow  $V_{DD}$  power-up/down sequence.
- The absolute value of the maximum allowed deviation between any two supplies is 0.5 V while the 1.5V supplies are below their specified operating conditions.

*Note:  $V_{CC}$  and  $V_{CCP}$  in [Figure 11](#) refer to devices with *PWR\_TC.P009* erratum.*
