Device TC1766
Marking/Step ES-BD, BD
Package PG-LQFP-176-2

02967AERRA

This Errata Sheet describes the deviations from the current user documentation.

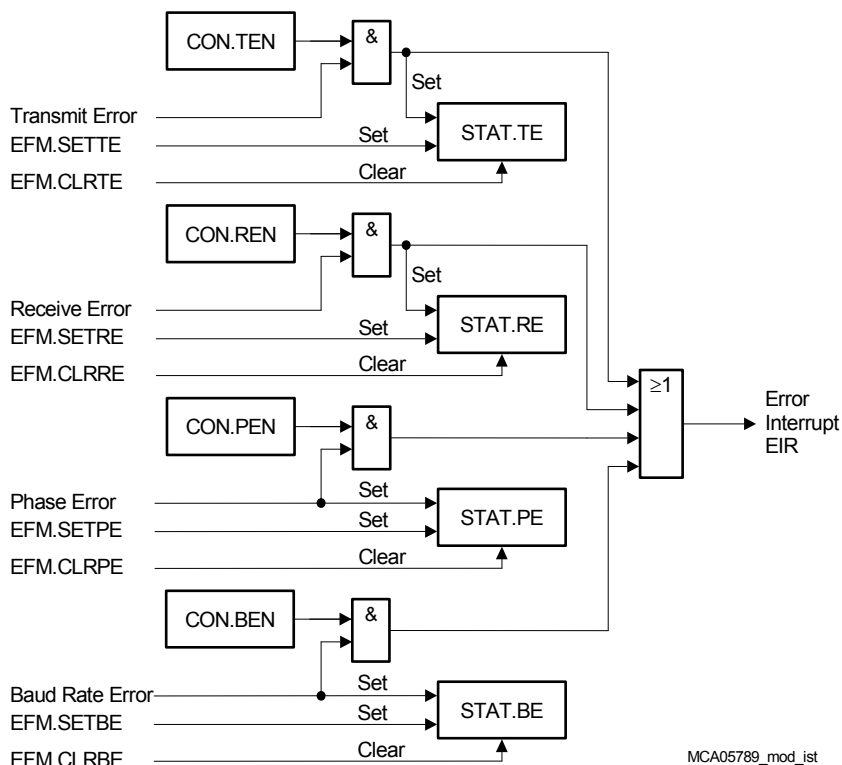
Figure 8 SSC Error Interrupt Control

The SSC is able to detect four different error conditions. Receive Error and Phase Error are detected in all modes, while Transmit Error and Baud Rate Error apply to Slave Mode only. In case of a Transmit Error or Receive Error, the respective error flags are set and the error interrupt requests will be generated by activating the EIR line only if the corresponding error enable bits have been set. In case of a Phase Error or Baud Rate Error, the respective error flags are always set and the error interrupt requests will be generated by activating the EIR line only if the corresponding error enable bit has been set. The error interrupt handler may then check the error flags to determine the cause of the error interrupt. The error flags are not reset automatically, but must be cleared via register `EFM` after servicing. This allows servicing of some error conditions via interrupt, while others may be polled by software. The error status flags can be set and reset by software via the error flag modification register `EFM`.

Note: The error interrupt handler must clear the associated (enabled) error flag(s) to prevent repeated interrupt requests. The setting of an error flag by software does not generate an interrupt request.

A **Receive Error** (Master or Slave Mode) is detected when a new data frame is completely received, but the previous data was not read out of the receive buffer register RB. If enabled via CON.REN, this condition sets the error flag STAT.RE and activates the error interrupt request line EIR. The old data in the receive buffer RB will be overwritten with the new value and is unretrievably lost.
