Device TC1796
Marking/Step EES-BC, ES-BC, BC
Package P-BGA-416, PG-BGA-416

02131AERRA

This Errata Sheet describes the deviations from the current user documentation.

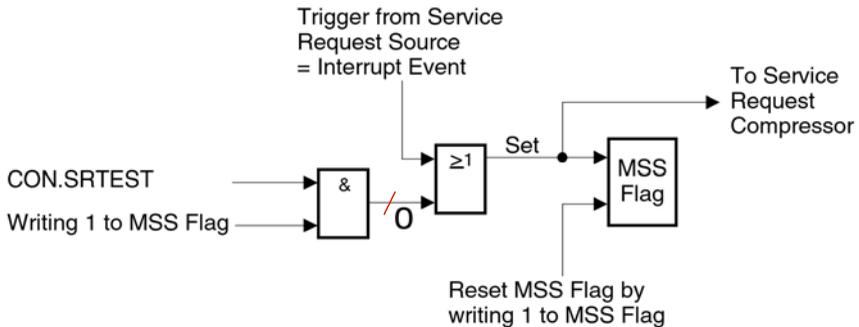
Figure 1

ADC_TC.023 Setting the MSS-flag doesn't generate an interrupt in TEST-MODE

It is possible to generate a software triggered interrupt event in TESTMODE (ADCx_CON.SRTEST=1) by setting one of the bitflags in register ADCx_MSS0/1. Due to the fact, that this mechanism is not working, it is not possible to generate a corresponding interrupt by software.

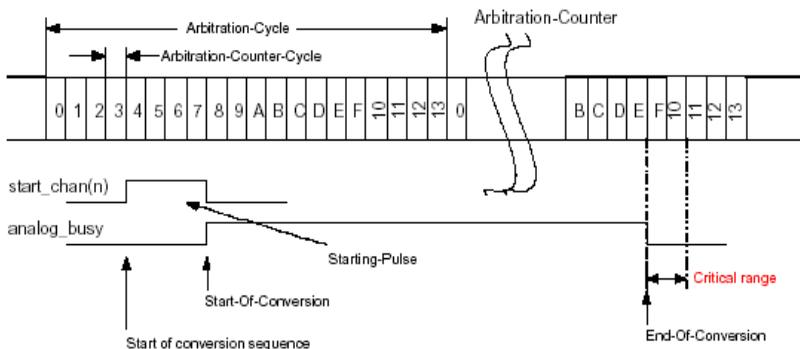
Figure 2

For details about the conversion sequence, please refer to the figure below:

- Fractional divider can only be used with the following settings:
 - `FDR.STEP` = 1006...1023 for normal divider mode
 - `FDR.STEP` = 57...1023 for fractional divider mode
- "Synchronized conversion and cancel-sync-repeat functionality" must not be enabled.
 - `CHCONn.SYM` != b"10"
- "Cancel, Inject and Repeat Enable" must not be enabled.
 - `CHIN.CIREN` = 0.

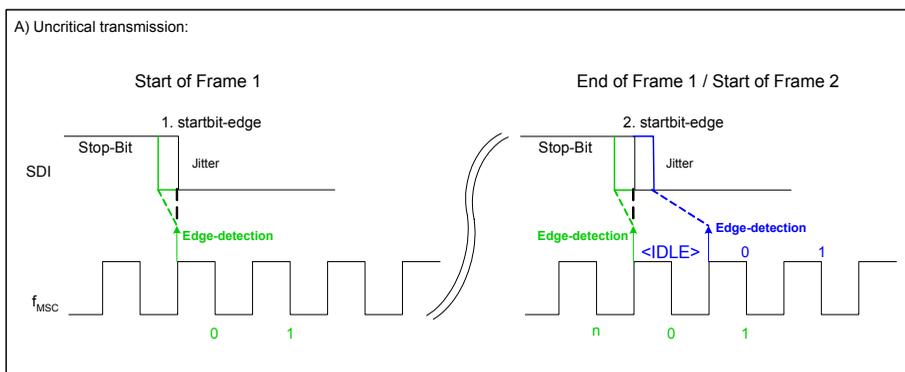
Figure 5 Uncritical transmission

As the falling startbit edge is shifted to the left of the rising clock edge (Figure 5 left), there occurs a secure detection of the next startbit edge in the last cycle of the previous frame (here cycle n, Figure 5 right) independent from the applied jitter to this edge.

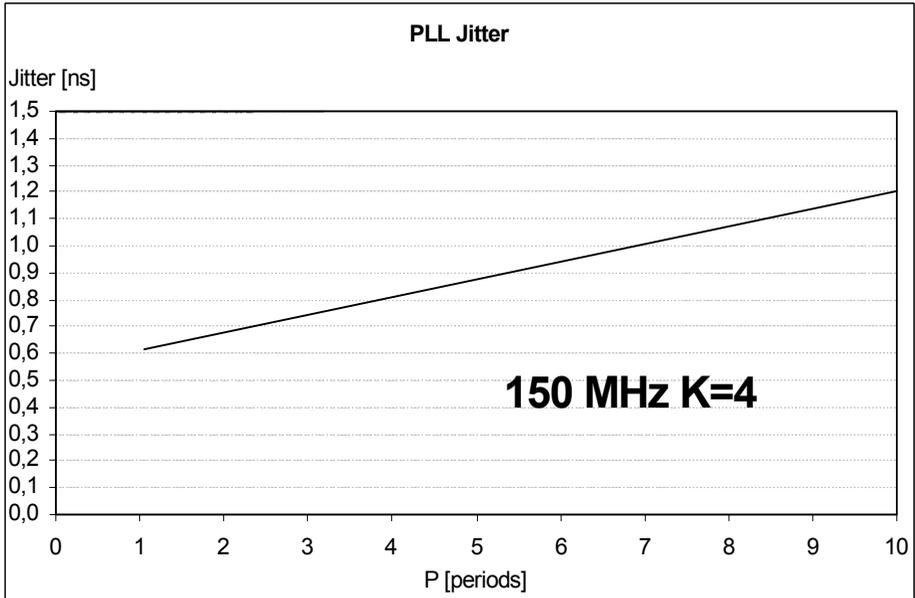
Figure 13 Short term PLL Jitter in f_{CPU} clock periods at $f_{\text{CPU}} = 150 \text{ MHz}$ and $K = 4$

When all listed system preconditions are fulfilled the PLL jitter at 150MHz and $K = 4$ with $K = KDIV + 1$ is below the marked range as shown in the figures.

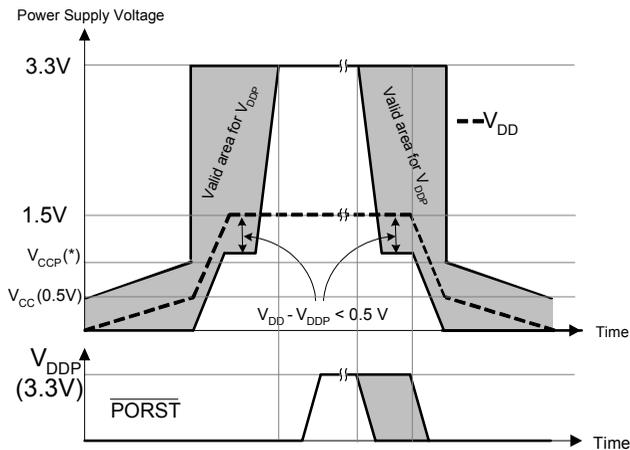
Figure 15 Exemplary power-up/down sequence

As per Data Sheet, $V_{DD} - V_{DDP} < 0.5\text{ V}$ has to be valid at any time in order to avoid increased latch-up risk. The figure below shows the possible V_{DDP} values as shaded region for an exemplary V_{DD} ramp. Moreover, the following rules apply:

- V_{DDEBU} and all analog voltages (V_{DDOSC3} , V_{DDM} , V_{DDMF} , V_{DDFL3}) must also follow V_{DDP} power-up/down sequence.
- V_{DDAF} , V_{DDOSC} must follow V_{DD} power-up/down sequence.
- The absolute value of the maximum allowed deviation between any two supplies is 0.5 V while the 1.5V supplies are below their specified operating conditions.

Note: V_{CC} and V_{CCP} in Figure 15 refer to devices with PWR_TC.P009 erratum.

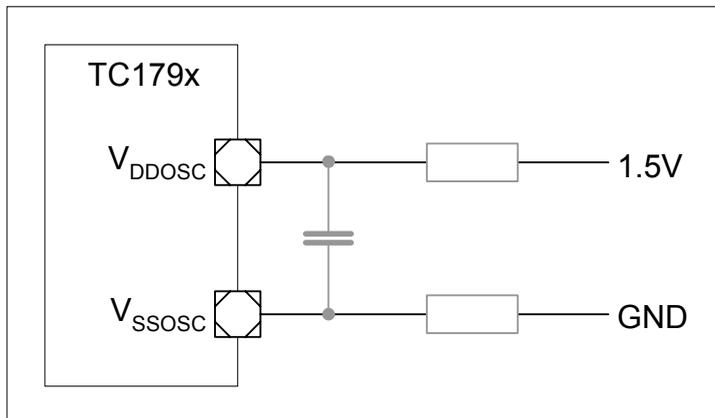
Figure 18

PLL_TC.H004 V_{DDOSC} and V_{SSOSC} bonding change

V_{DDOSC} and V_{SSOSC} silicon pads are not connected to their package balls, but V_{DDOSC} is connected to V_{DD} (core supply) and V_{SSOSC} is connected to V_{SS} , in order to reduce short-term jitter. Thus V_{DDOSC} and V_{SSOSC} package balls are unconnected. For future design improvements it is recommended to prepare the PCB like it is shown in the figure below. The capacitance and both resistors need not to be assembled on the PCB but they should be planned for values of about 10?F...100?F for the blocking capacitance and 0?...10? for the resistors.
