Device **XC886CM-8FF**
Marking/Step **EES AA**
Package **PG-TQFP-48**

This Errata Sheet describes the deviations from the current user documentation.

Current Documentation

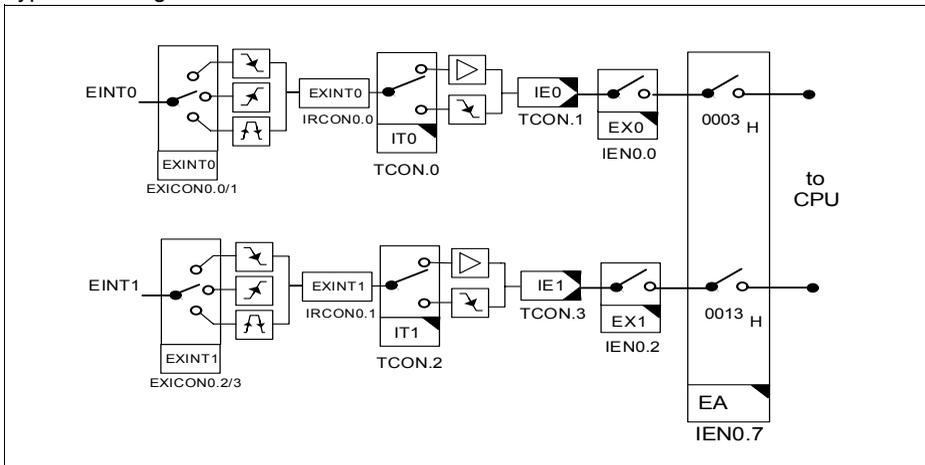
INT_XC8.H003 Interrupt Flags of External Interrupt 0 and 1

External interrupt 0 and 1 may individually be selected via respective bits (EXINTx) in EXICON0 register, to request interrupt on falling edge, rising edge, both edges or to bypass the edge detection.

Edge detection is done in the system unit. If enabled, an active event will set the EXINTx flag and correspondingly set the IEx flag in TCON. It should be noted that after any external interrupt x event, flag EXINTx must be cleared. In case of falling edge as active event, this allows any future active event to be able to set the flag IEx as interrupt request. In case of low level as active event, this prevents unintended recurring triggering of interrupt request.

In case of bypass edge detection, the input is connected directly to the core (bypass the system unit). The flag IEx in TCON will be set on the selected falling edge or low level (at least 2 clock cycles) event. In case of falling edge selected as active event by TCON.ITx, the flag EXINTx is set in addition to the flag IEx.
