Device	XMC4400
Marking/Step	EES-AA, ES-AA
Package	PG-LQFP-64/100

Document ID is **02512AERRA**.

This “Errata Sheet” describes product deviations with respect to the user documentation listed below.

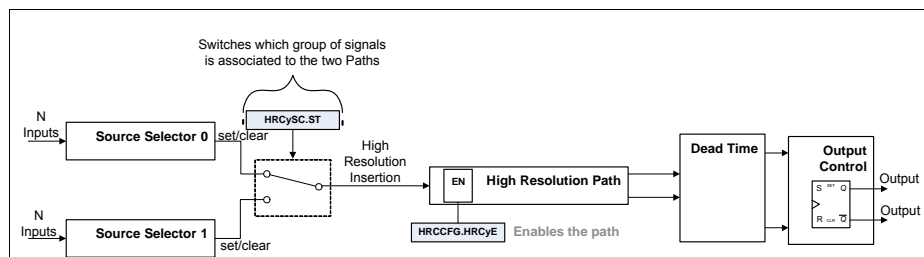
Figure 10 HRC with only one path enabled and two Source Selectors

This scenario where only one path is enabled but both Source Selectors are being used, and by being used is understood that signals are being actively decoded from the Source Selectors (input signals for the Source Selectors are being updated) is depicted on **Figure 10** - in this example the High Resolution Path is the one being used.

In the above scenario, every time that the HRCyST.ST bitfield is 1_B , the Source Selector 1 is the one that has control over the PWM signal. Whenever the HRCyST.ST bitfield is 0_B is the Source Selector 0 that has control over the PWM signal.

If the described condition occurs, then the signal generated by Source Selector 1 is lost and the PWM signal is not handled properly - **Figure 11**.

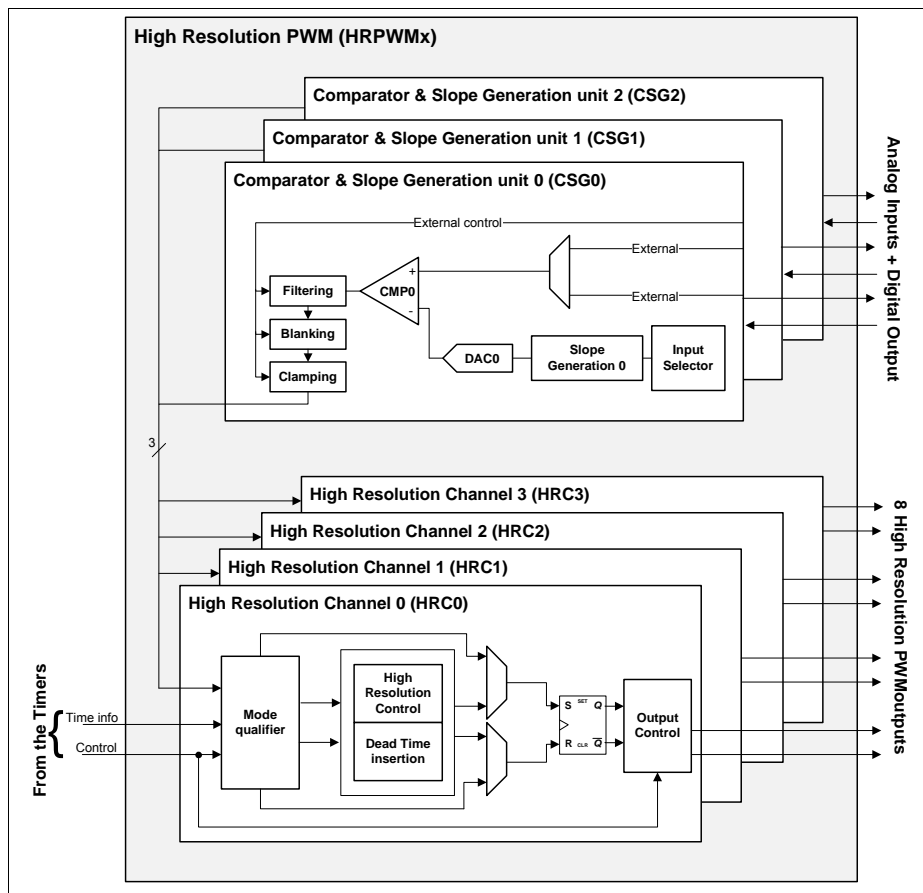
Figure 12 High Resolution Channel (HRC) simplified block diagram

Also due to power connection issues, the HRC sub modules can have the following problems:

- High Resolution Channel 3 may stop working due to internal voltage drop.
- Generation of the 150 ps resolution of all the HRCs may not ramp up properly during module initialization (temperature dependency). If this happens, then all the HRC channels are not able to generate a 150 ps resolution. The proper ramp can be checked by polling the HRGHRS.HRGR bitfield.

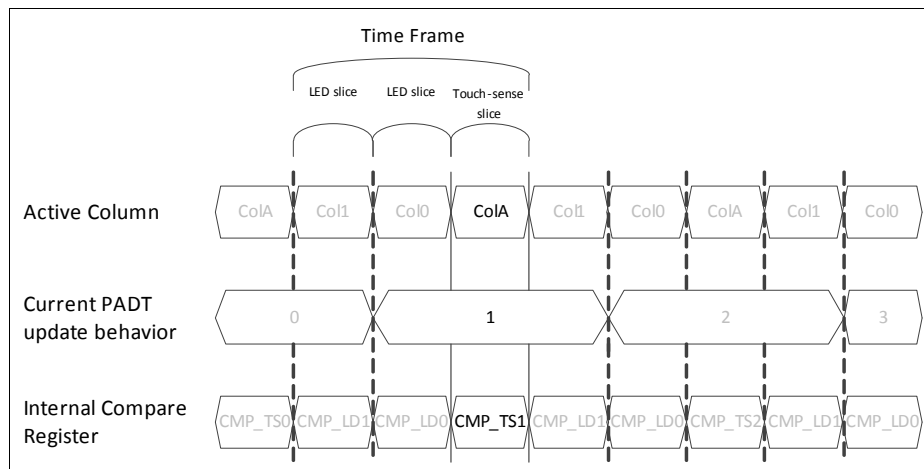
Figure 16 Internal Compare Register updated with correct compare register value with 2 LED columns enabled

If the number of LED columns enabled is 2 or more, the additional LED columns would provide some buffer time for the delay. So, at the start of a new touch-sense time slice, the update of PADT value would have taken place. Hence, the

current active PADT compare register value is updated to the internal compare register (**Figure 16**).

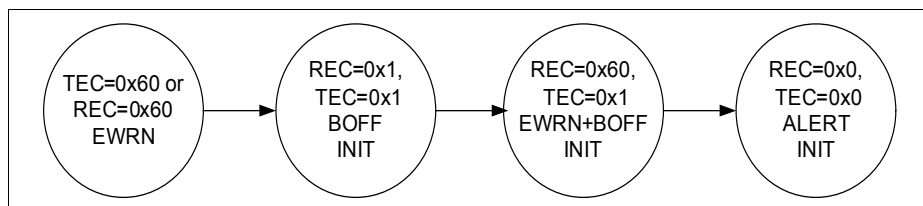
Figure 21 Alert Interrupt Behavior in case of Bus-Off

When the threshold for error warning (EWRN) is reached (default value of Error Warning Level EWRN = 0x60), then the EWRN interrupt is issued. The bus-off (BOFF) status is reached if $TEC > 255$ according to CAN specification, changing the MultiCAN module with REC and TEC to the same value 0x1, setting the INIT bit to 1_B, and issuing the BOFF interrupt. The bus-off recovery phase starts automatically. Every time an idle time is seen, REC is incremented.

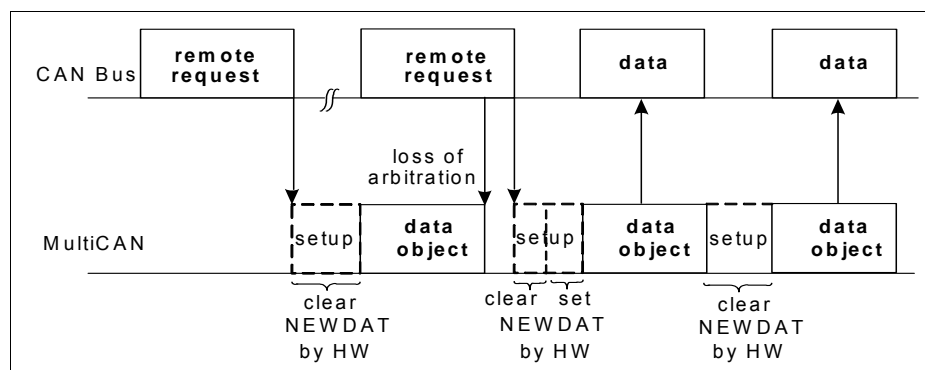
Figure 22 Loss of Arbitration

When the appropriate message object (data frame) triggered by the first remote frame wins the arbitration, it will be sent out and **NEWDAT** is not reset. This leads to an additional data frame, that will be sent by this message object (clearing **NEWDAT**).

There will, however, not be more data frames than there are corresponding remote requests.
