Device	XMC4500
Marking/Step	ES-AB, AB
Package	PG-LQFP-100/144, PG-LFBGA-144

Document ID is **082/18**.

This “Errata Sheet” describes product deviations with respect to the user documentation listed below.

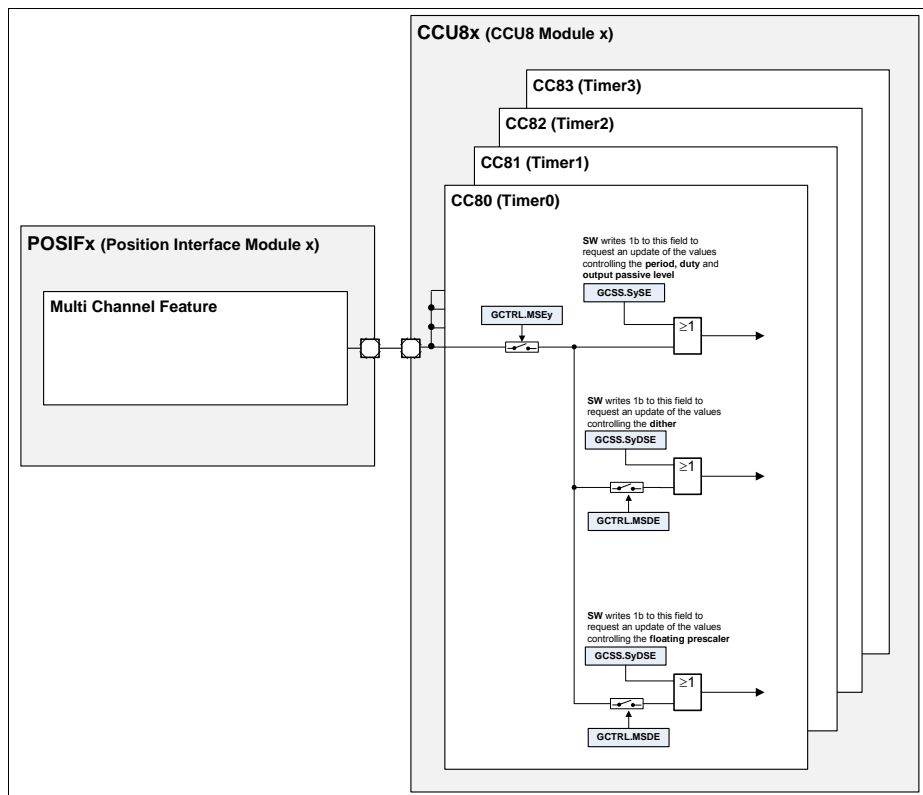
**Figure 3 Value update trigger connection between CCU8x and POSIFx**

Each CCU8 Module Slice contains 4 identical timers (CC80, CC81, CC82 and CC83). There is the possibility of updating the values controlling the duty cycle, period, output passive level, dither and floating prescaler on-the-fly of each and every timer, with a SW request. The update request of these values can also be done via an external trigger that is connected to the POSIFx module Figure 1. An update action of any of these values is named as “shadow transfer”.

The signal between the POSIFx and CCU8x module is used to handshake a concurrent update between several registers, contained in the two modules. The output signal of the POSIFx is named as POSIFx.OUT6 while the input signal on the CCU8x side is named as CCU8x.MCSS.

On Figure 2, we see an example how this trigger is used to update at the same time the duty cycle value of a timer inside the CCU8x and the multi channel pattern inside the POSIFx (the multi channel pattern can affect the CCU8x timer outputs therefore a synchronous update of all the values solves possible output glitches on the generated PWM signals).

On Figure 2, the SW has updated the next values for the duty cycle on a CCU8x Timer (it can be also for the period, output passive level and clock prescaler). After that it updates also the next value of the multi channel pattern inside the POSIFx module. After that, the POSIF reaches an internal state (dictated by specific conditions) where an update of the values is needed. It generates a trigger signal to the CCU8x Timer to signalize that an update of the duty cycle

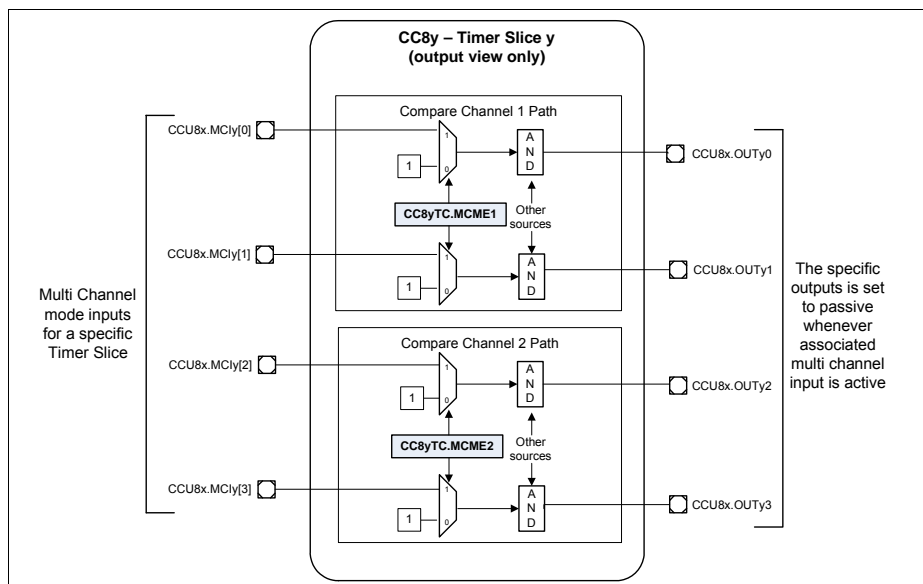
**Figure 6 Multi Channel Mode diagram**

The Multi Channel mode is normally used to modulate in parallel several PWM outputs (a complete CCU8 - up to 16 PWM signals can be modulated in parallel).

A normal use case is the parallel control of the PWM output for BLDC motor control. In Figure 2, we can see the Multi Channel Pattern being updated synchronously to the PWM signals. Whenever a multi channel input is active (in this case 0), the specific output is set into passive level (the level in which the external switch is OFF).

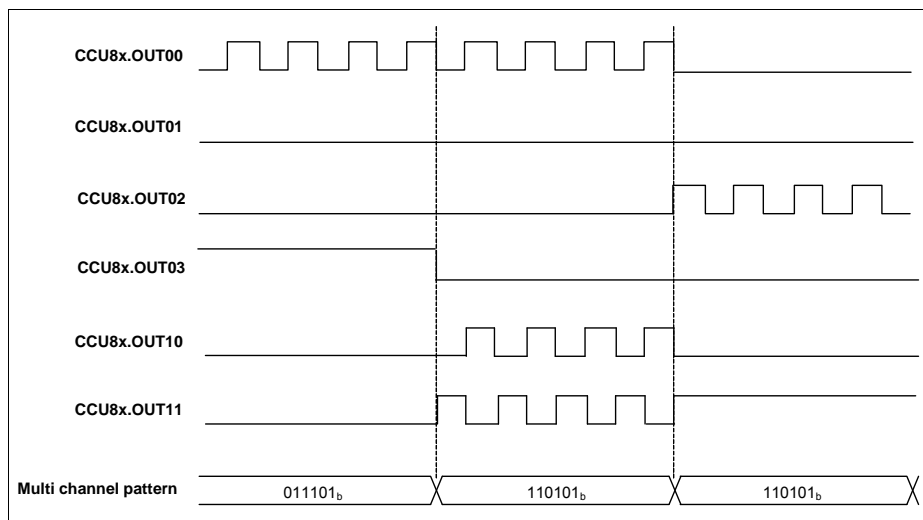
**Figure 7 Multi Channel Mode applied to several CCU8 outputs**

A glitch is present at the PWM outputs whenever the dead time of the specific compare channel is enabled - CC8yDTC.DTE1 and/or CC8yDTC.DTE2 set to  $1_B$  (each compare channel has a separate dead time function) - and the specific multi channel pattern for the channel is  $01_B$  or  $10_B$ .

The effect of this glitch can be seen in Figure 3. The duration of the PWM glitch has the same length has the dead time value programmed into the CC8yDC1R.DT1F field (for compare channel 1) or into the CC8yDC1R.DT2F.

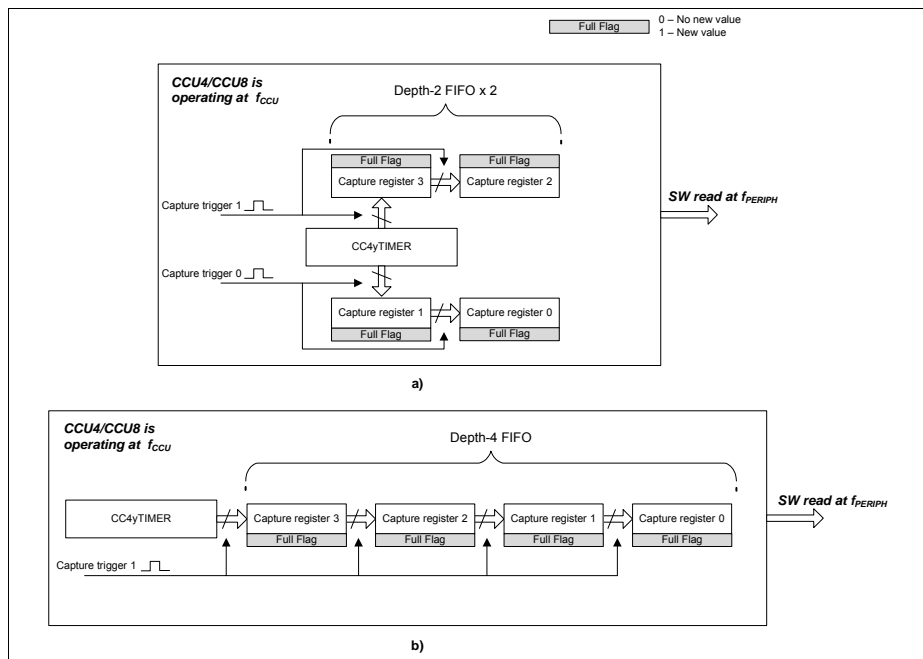
**Figure 11 Capture Modes Structure - a) Depth-2 x2 Capture; b) Depth-4 Capture**

Each CCU4/CCU8 Timer Slice contains a Full Flag field in every capture register. The structure of the different capture modes for each Timer Slice can be seen in [Figure 11](#).

When a capture event collides with a read back on the data bus, the proper data is read by the software, but this data is shifted to the immediately capture register and the associated full flag is set, [Figure 12](#) - for simplification purposes a 2 depth capture scheme is shown.

Referring to [Figure 12](#), it can be understood that the proper data is sent to the software when it reads back the capture register 1, nevertheless this same data is shifted to the next capture register (capture register 0) and the full flag of this register is set.

After this if the software reads back capture register 0, a value is going to be returned with a full flag set (indicating that this is a new value - that has not yet been read, which is not true).

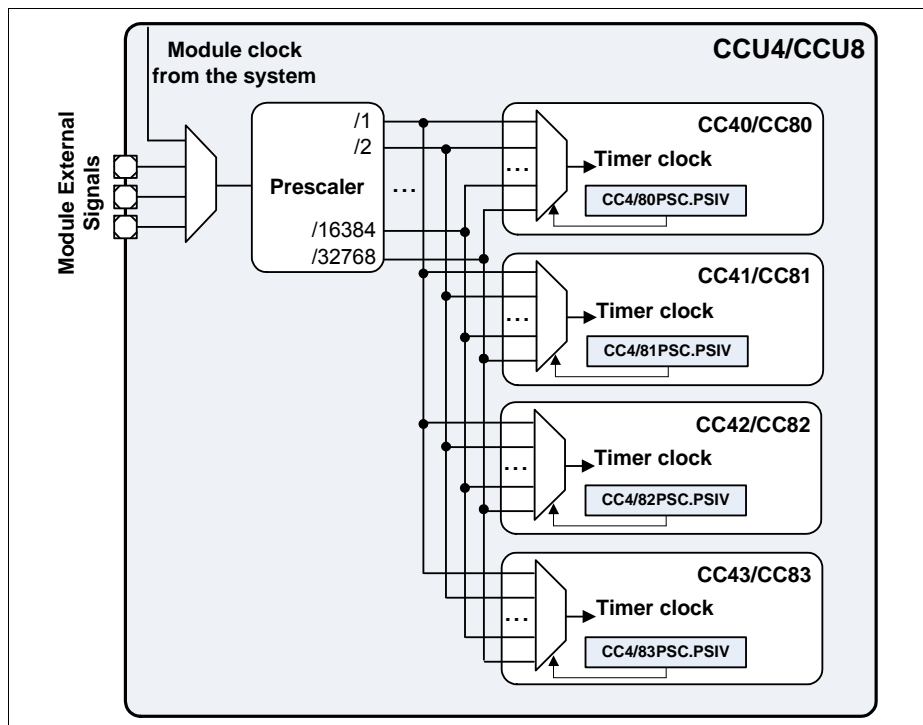
**Figure 14** Clock Selection Diagram for CCU4/CCU8

This is only applicable if the Module Clock provided by the system (the normal default configuration and use case scenario) is not being used. In the case that the normal clock configured and programmed at system level is being used, there is not any type of constraints.

One should not also confuse the usage of an external signal as clock for the module with the usage of an external signal for counting. These two features are completely unrelated and there are not any dependencies between both.

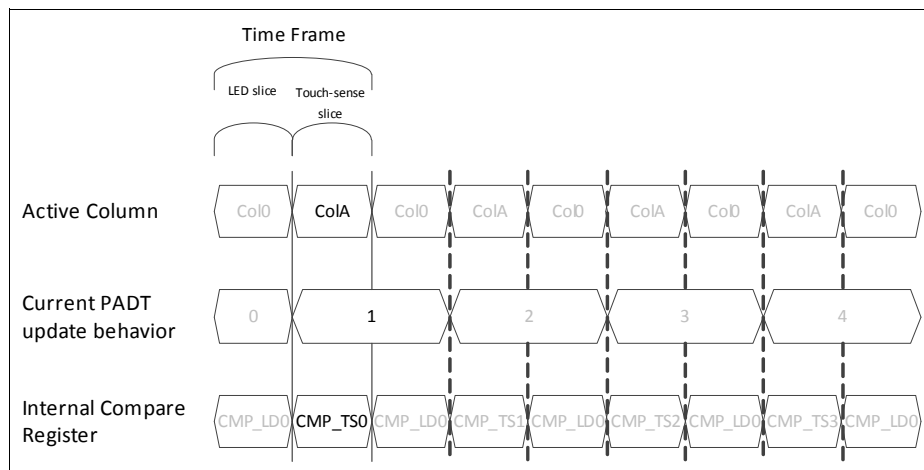
**Figure 16 Effect of delay on the update of Internal Compare Register with 1 LED column enabled**

If the number of LED columns enabled is smaller than 2, the delay will affect the activation period of the current active pad. At the beginning of every new Col A, the value of the current PADT's compare register is updated to the internal compare register. However, the delay causes the value of the previous PADT's compare register is updated to the internal compare register instead. This means that the current active pad would be activated with the duration of the previous pad's oscillation window ([Figure 16](#)). In addition to this, when no LEDs are enabled, pad turn 0 will prevail for one time slice longer before it gets updated ([Figure 17](#)).
