# AURIX™ TC37x errata sheet

**Marking/Step: (E)ES-AA, AA**

## About this document

This document describes the deviations of the device from the current user documentation, to support the assessment of the effects of these deviations on your custom hardware and software implementations.

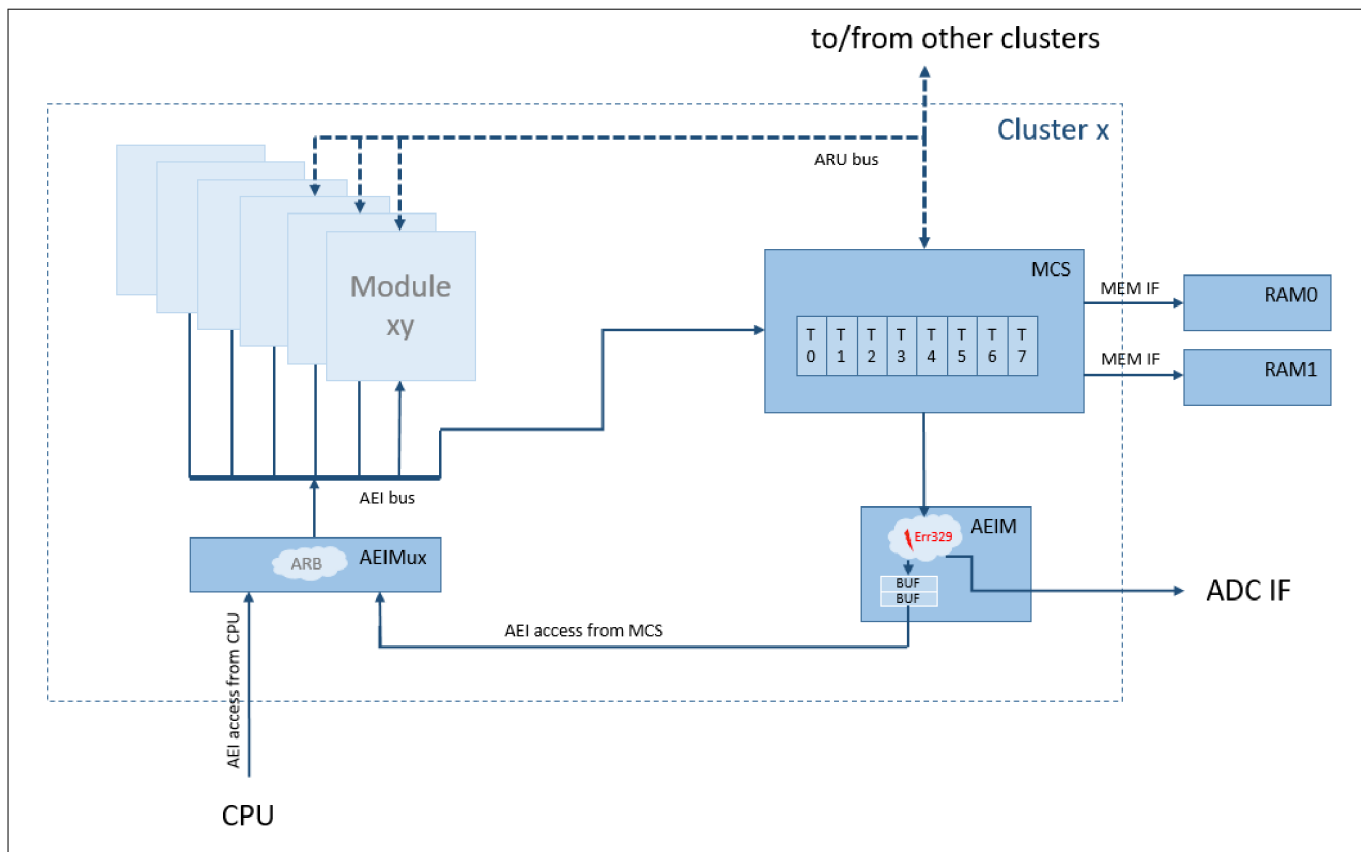
As an AEI bus access of a given MCS thread can be delayed either due to an ongoing AEI bus access from CPU or a multi cycle AEI access from another MCS thread, the AEIM contains buffers to store MCS bus accesses to AEI that cannot be served immediately.

As accesses to ADC from MCS point of view are not different from AEI bus accesses, these ADC accesses are forwarded to the AEIM in the same way and on the same interfaces as MCS accesses to the AEI bus. The AEIM will identify the ADC accesses by their targeted address space and forward them to the GTM external ADC. As ADC accesses will always be served with zero wait time, these ADC accesses are not routed through the AEIM buffers.

In [Figure 6](#), a potential risk for the occurrence of problem GTM\_AI.329 is illustrated. Here the first buffer of the AEIM (green) is still waiting for the access to the AEI bus while a second AEI bus access from MCS arrives at the AEIM (yellow access path). Under certain, but for the user unpredictable timing conditions, this second AEI bus access arriving at the AEIM can trigger the misbehavior described in problem GTM\_AI.329.
