AURIX™ TC37xEXT errata sheet

Marking/Step: (E)ES-AB, AB

About this document

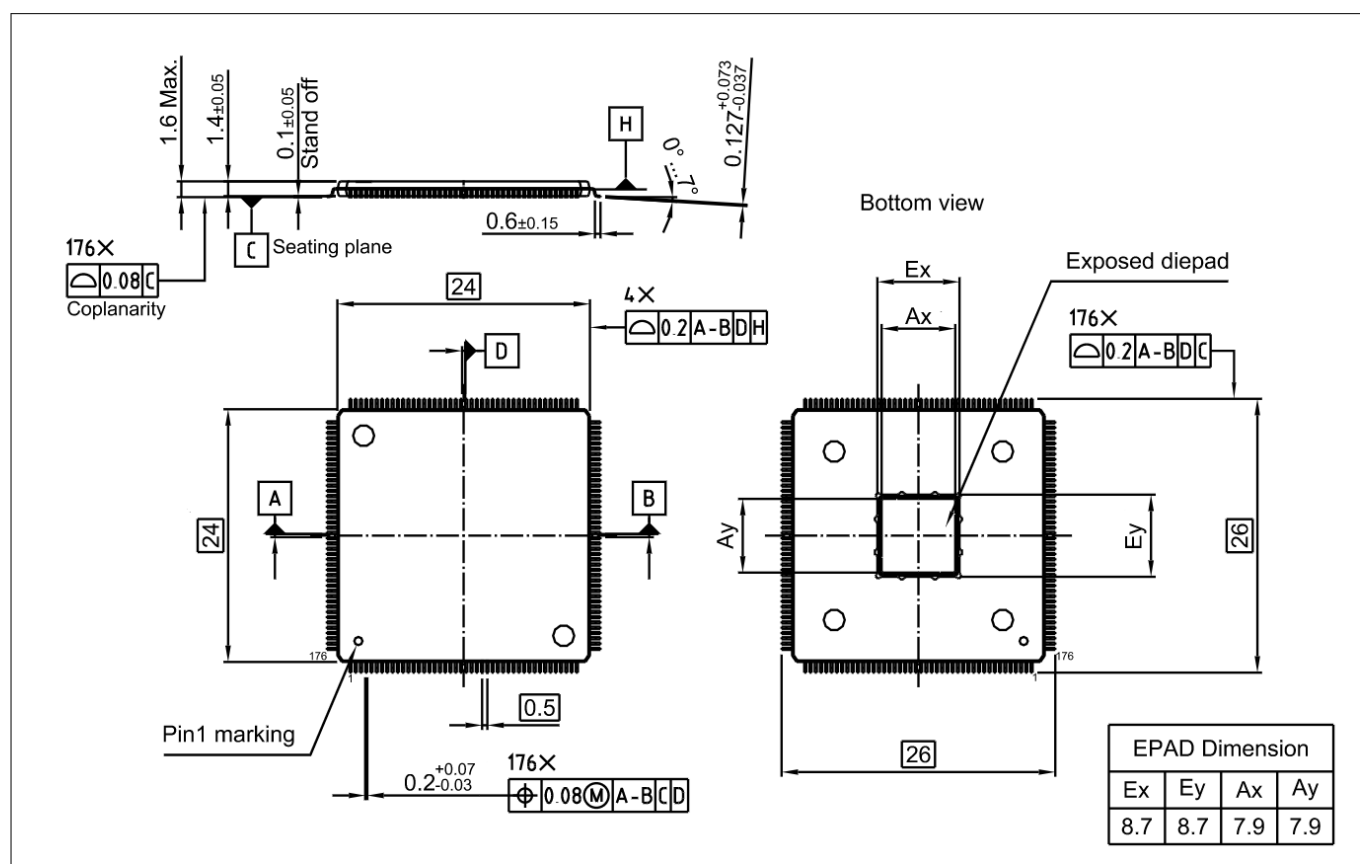
Figure 13 Package Outlines LQFP-176 for TC37xEXT

Note: For the exposed diepad of the LQFP-176 package of the TC37xEXT, structural corner protrusions have to be considered for purposes of system design and integration with a maximum boundary of 9.4 mm.

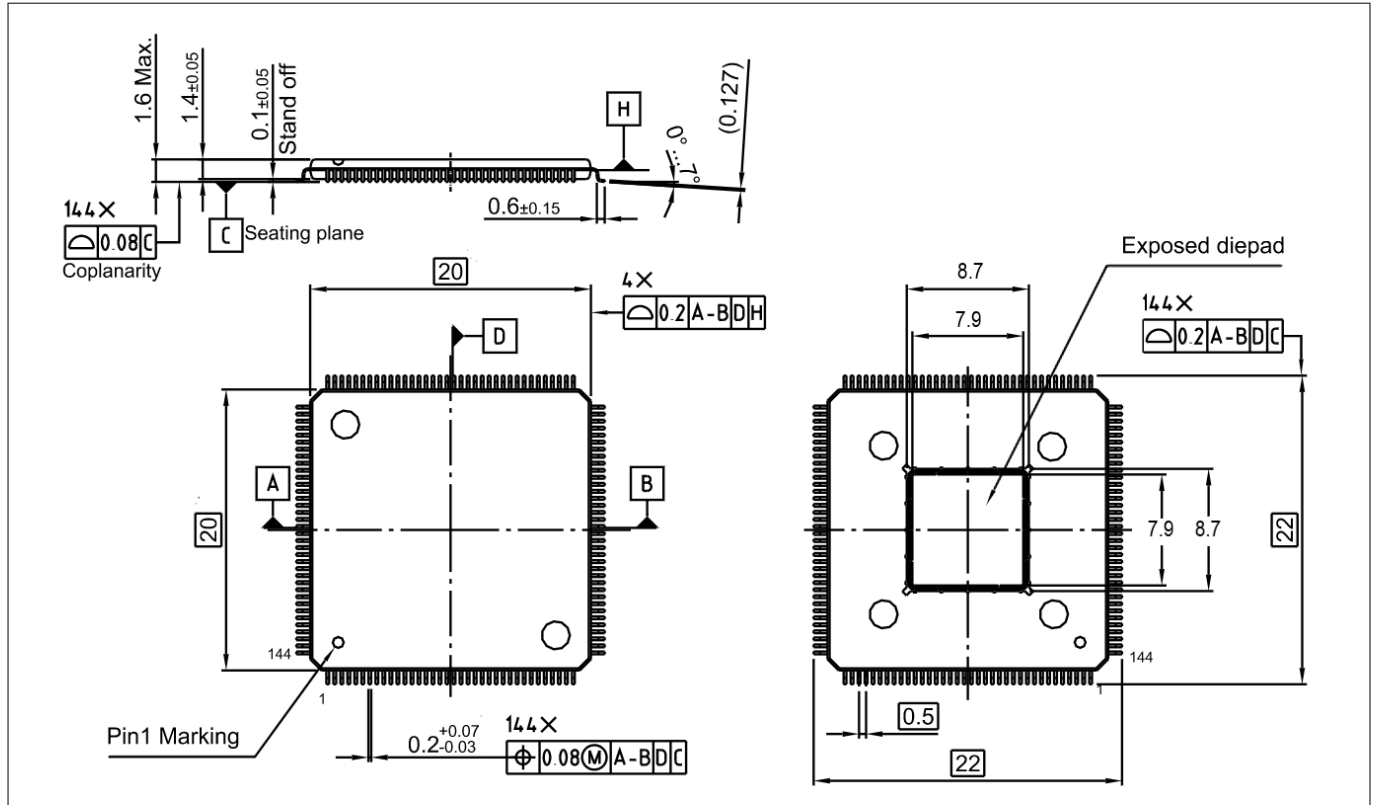
Figure 14 Package Outlines LQFP-144 for TC37xEXT

Note: For the exposed diepad of the LQFP-144 package of the TC37xEXT, structural corner protrusions have to be considered for purposes of system design and integration with a maximum boundary of 9.4 mm.
