# AURIX™ TC26x errata sheet

**Marking/Step: ES-BC, BC**

10504AERRA

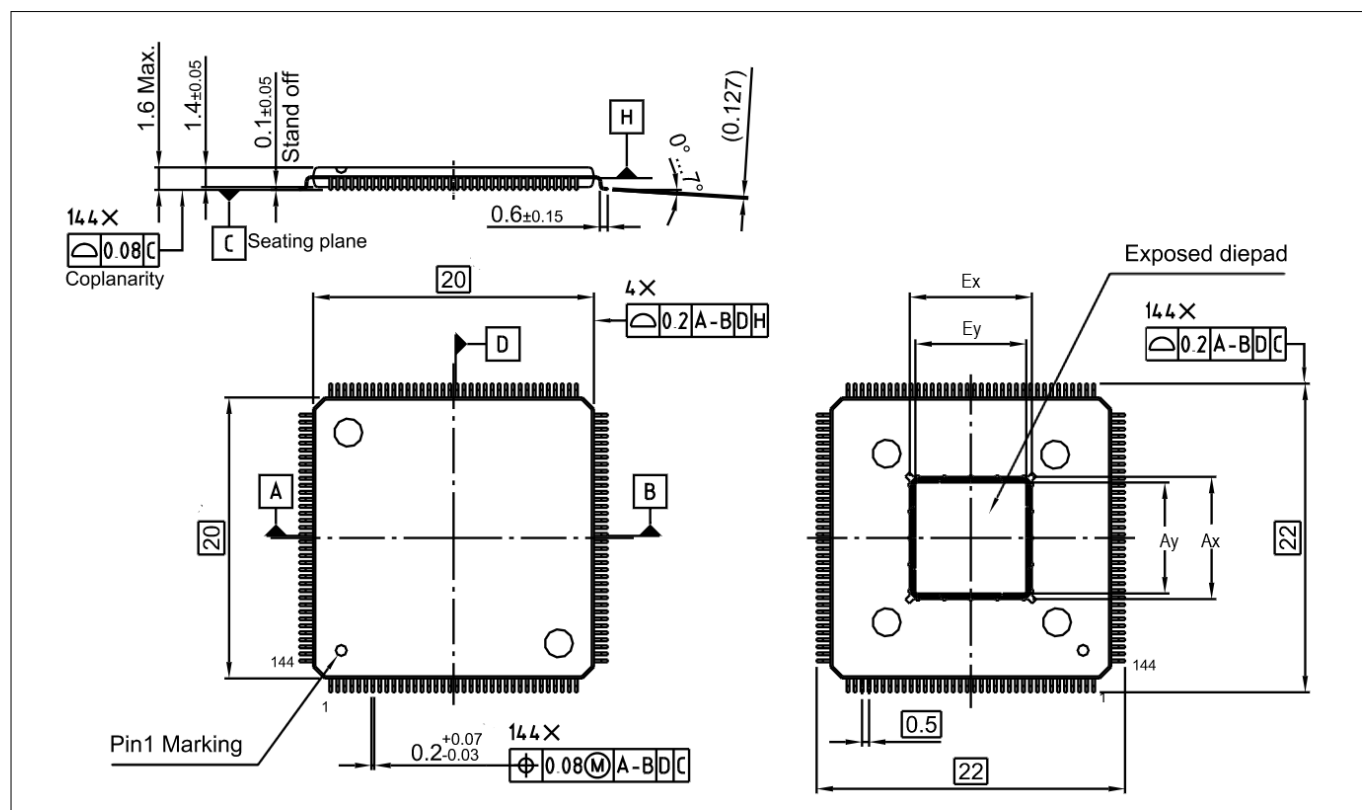
**Figure 16** Package Outlines LQFP-144 for TC26x

**Note:** For the exposed diepad of the LQFP-144 package of the TC26x, structural corner protrusions have to be considered for purposes of system design and integration with a maximum boundary of 8.0 mm for TC26x devices with feature package D and DC (square Epad), and of 8.9 mm (in x direction) and 9.5 mm (in y direction) for TC26x devices with feature package DA.

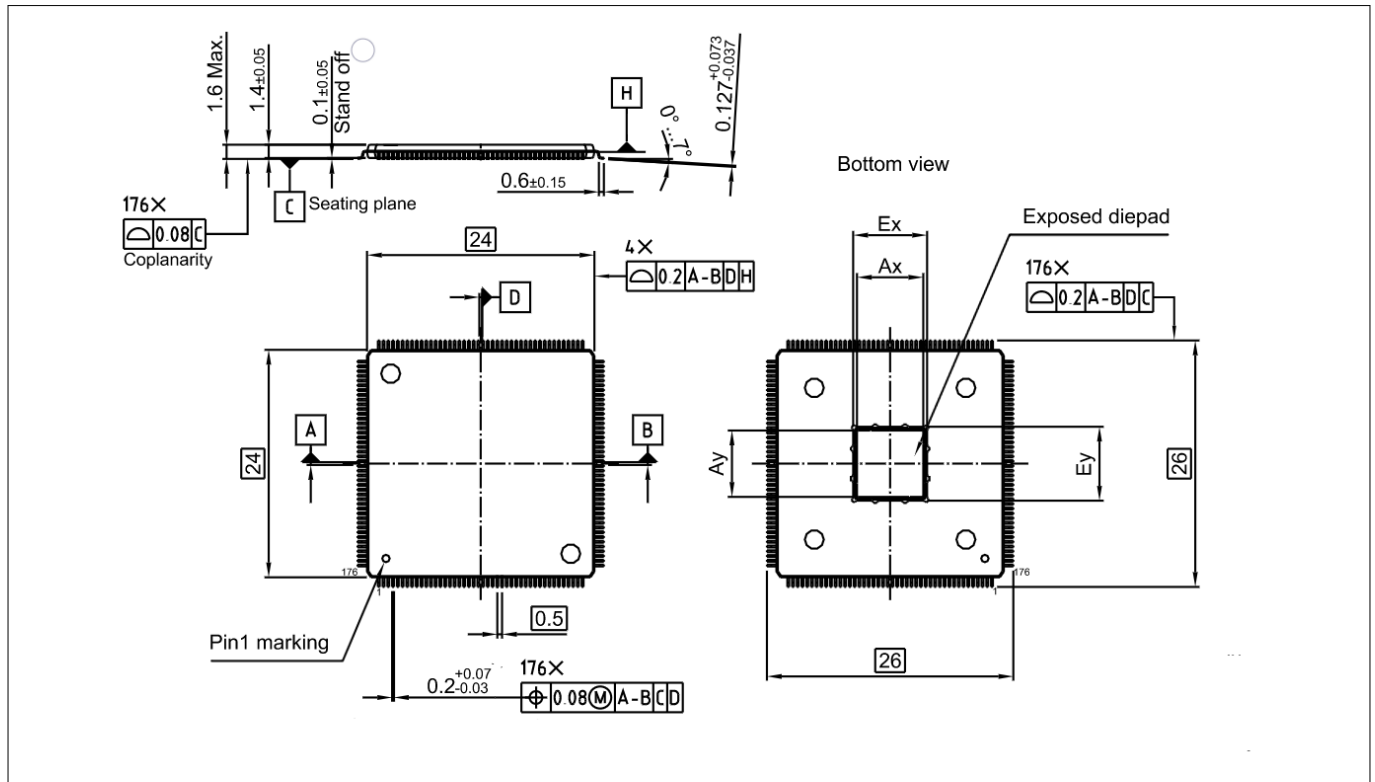
**Figure 17** Package Outlines LQFP-176 for TC26x

**Note:** For the exposed diepad of the LQFP-176 package of the TC26x, structural corner protrusions have to be considered for purposes of system design and integration with a maximum boundary of 8.0 mm for TC26x devices with feature package D and DC (square Epad), and of 8.9 mm (in x direction) and 9.5 mm (in y direction) for TC26x devices with feature package DA.
