Device	XMC4500
Marking/Step	ES-AC, AC
Package	PG-LQFP-100/144, PG-LFBGA-144

Document ID is **116/17**.

This “Errata Sheet” describes product deviations with respect to the user documentation listed below.

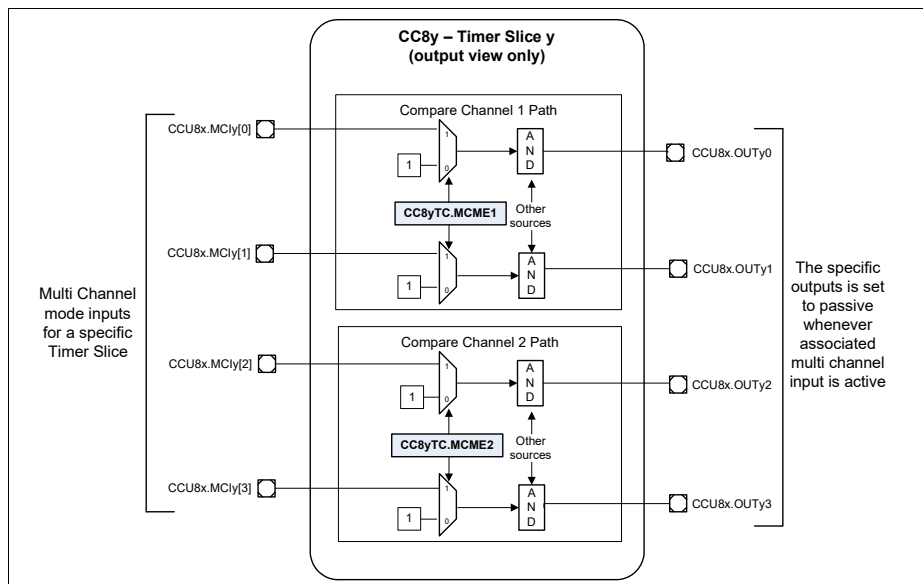
Figure 5 Multi Channel Mode diagram

After enabled, the Multi Channel mode is then controlled by several input signals, one signal per output. Whenever an input is active, the specific PWM output is set to passive level - Figure 1.

A normal use case is the parallel control of the PWM output for BLDC motor control. In Figure 2, we can see the Multi Channel Pattern being updated synchronously to the PWM signals. Whenever a multi channel input is active (in this case 0), the specific output is set into passive level (the level in which the external switch is OFF).

A glitch is present at the PWM outputs whenever the dead time of the specific compare channel is enabled - CC8yDTC.DTE1 and/or CC8yDTC.DTE2 set to 1_B (each compare channel has a separate dead time function) - and the specific multi channel pattern for the channel is 01_B or 10_B.

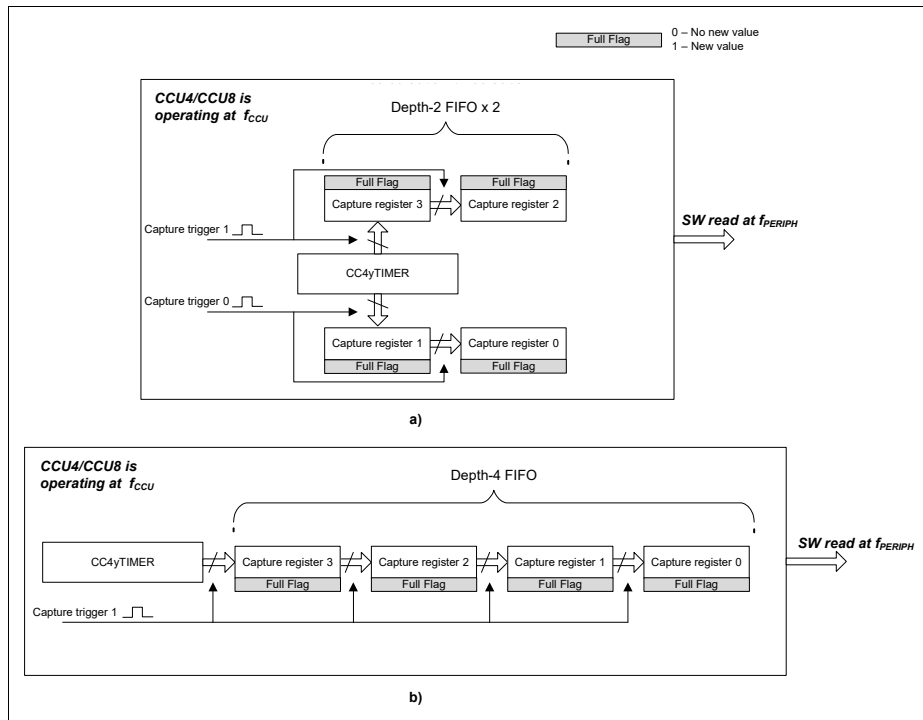
Figure 9 Capture Modes Structure - a) Depth-2 x2 Capture; b) Depth-4 Capture

Each CCU4/CCU8 timer slice contains a “Full Flag” field in every capture register. The structure of the different capture modes for each timer slice can be seen in [Figure 9](#).

When the peripheral bus clock frequency is smaller than the CCU4/CCU8 module clock frequency, $f_{\text{periph}} < f_{\text{CCU}}$, the read back of the full flag is inconsistent. Sometimes it returns the information that a new value has been captured and sometimes it does not.

Note: The capture interrupt is generated correctly.

To do this, the following SCU (System Control Unit) registers should be set with values that force this condition: CCUCLKCR.CCUDIV, CPUCLKCR.CPUDIV and PBCLKCR.PBDIV.

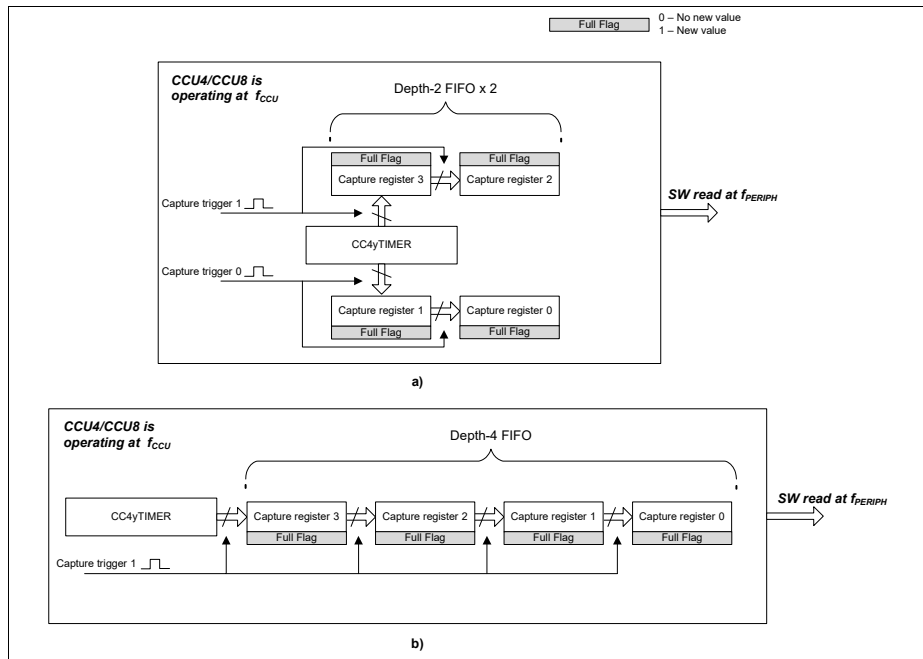
Figure 10 Capture Modes Structure - a) Depth-2 x2 Capture; b) Depth-4 Capture

Each CCU4/CCU8 Timer Slice contains a Full Flag field in every capture register. The structure of the different capture modes for each Timer Slice can be seen in [Figure 10](#).

When a capture event collides with a read back on the data bus, the proper data is read by the software, but this data is shifted to the immediately capture register and the associated full flag is set, [Figure 11](#) - for simplification purposes a 2 depth capture scheme is shown.

Referring to [Figure 11](#), it can be understood that the proper data is sent to the software when it reads back the capture register 1, nevertheless this same data is shifted to the next capture register (capture register 0) and the full flag of this register is set.

After this if the software reads back capture register 0, a value is going to be returned with a full flag set (indicating that this is a new value - that has not yet been read, which is not true).

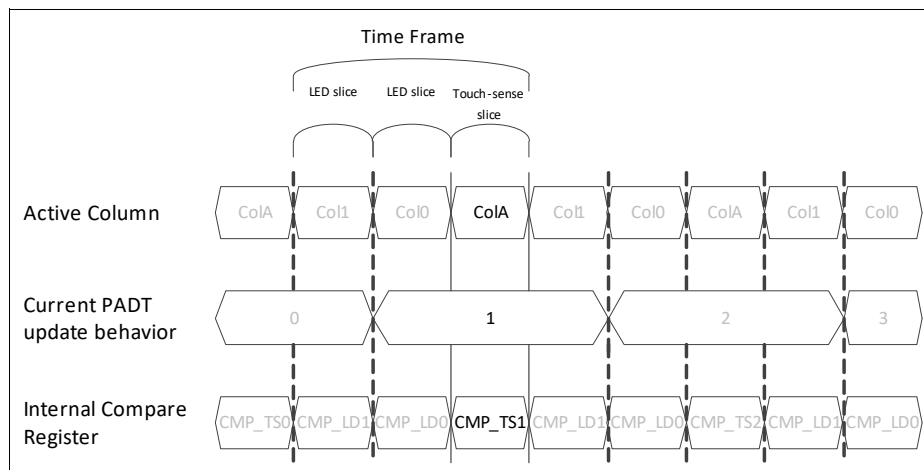
Figure 17 Internal Compare Register updated with correct compare register value with 2 LED columns enabled

If the number of LED columns enabled is 2 or more, the additional LED columns would provide some buffer time for the delay. So, at the start of a new touch-sense time slice, the update of PADT value would have taken place. Hence, the current active PADT compare register value is updated to the internal compare register ([Figure 17](#)).

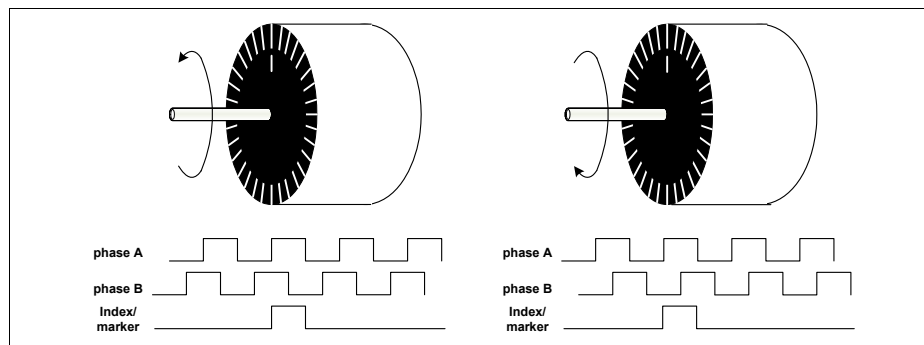
Figure 19 Rotary Encoder outputs - Phase A, Phase B and Index

Each POSIF module can be used as an input interface for a Rotary Encoder. It is possible to configure the POSIF module to decode 3 different signals: Phase

A, Phase B (these two signals are 90° out of phase) and Index. The index signal is normally understood as the marker for the zero position of the motor Figure 1.

When the index signal is smaller than 1/2 of the tick period, the POSIF module is not able to decode this signal properly, Figure 2 - notice that the reference edge of the index generation in this figure is the falling of Phase B, nevertheless this is an example and depending on the encoder type, this edge may be one of the other three.
