Device **C164CI-8E**
Marking/Step **Step ES-CB, CB**
Package **C-MQFP, P-MQFP-80**

This Errata Sheet describes the deviations from the current user documentation.

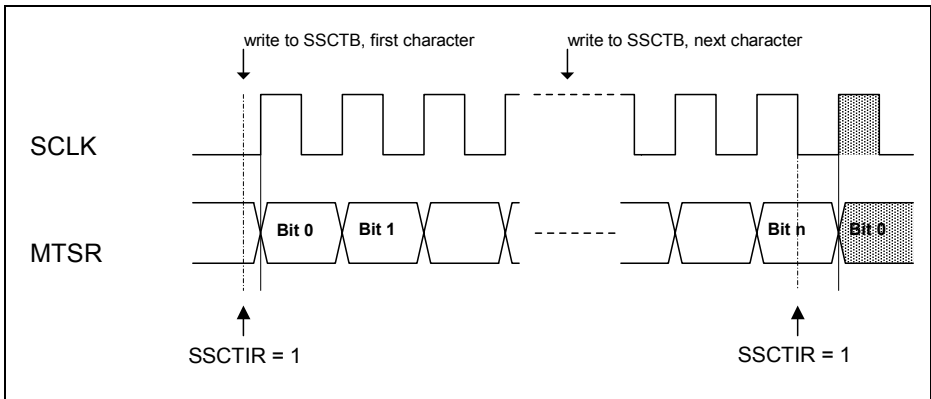
Figure 2 SSCTB Timing

When SSCTB has been written while the transmit shift register was empty (and the SSC is enabled), flag SSCTIR is set to '1' directly after completion of the write operation, independent of the selected baud rate. When the transmit shift register is not empty when SSCTB was written, SSCTIR is set to '1' after the last latching edge of SCLK (= 1/2 bit time before the first shifting edge of the next character). See also e.g. C167CR User's Manual V3.1, p. 12-5.

The following diagram shows these relations in an example for a data transfer in master mode with SSCPO = 0 and SSCPH = 0. It is assumed that the transmit shift register is empty at the time the first character is written to SSCTB:

Typically, in interrupt driven systems, no problems are expected from the modified timing of flag SSCTIR. However, when flag SSCTIR is polled by software in combination with other flags which are set/cleared at the end or at the beginning of a transfer (e.g. SSCBSY), the modified timing may have an effect.
