<b>Device</b>	<b>C164CI-8R, C164SI-8R, C164CL-8R, C164SL-8R, C164xy-L</b>
<b>Marking/Step</b>	<b>(E)ES-AC, AC</b>
<b>Package</b>	<b>P-MQFP-80-1 (C-MQFP-80: EES-AC only)</b>

This Errata Sheet describes the deviations from the current user documentation. The module oriented classification and numbering system uses an ascending sequence over several derivatives, including already solved deviations. So gaps inside this enumeration can occur.

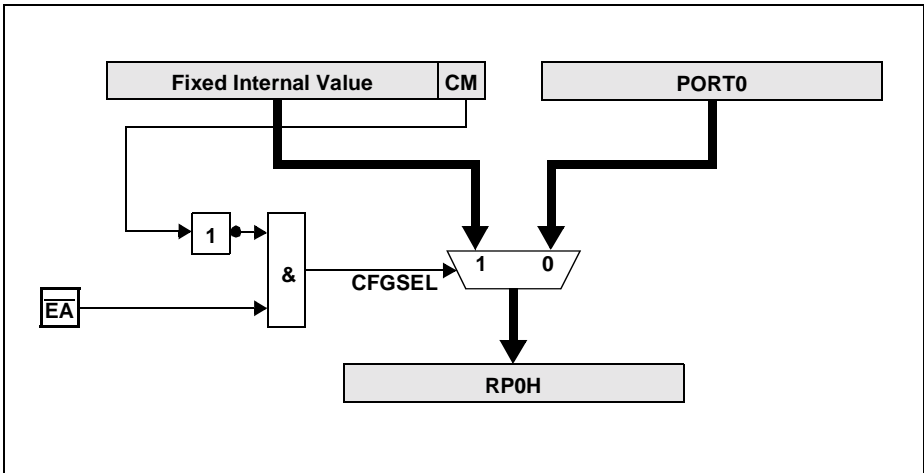
**Figure 2 Reset Configuration Source Selection**

In contrast to the user's manual in the C164CI-8R the register RSTCON is not available. After single-chip mode reset the register RP0H is not set to the described default value but shows the configuration defined in the ROM mask (Configuration Byte) as follows.

For a single-chip mode reset (indicated by  $\overline{EA} = 1$ ) the configuration via PORT0 can be replaced by a fixed configuration value. This fixed configuration value is hardwired and is selectable for each ROM mask. In this case PORT0 needs no external circuitry (pullups/pulldowns) and also the internal configuration pullups are not activated.

The logic described in the figure above controls the reset configuration source (see signal CFGSEL) in the following way:

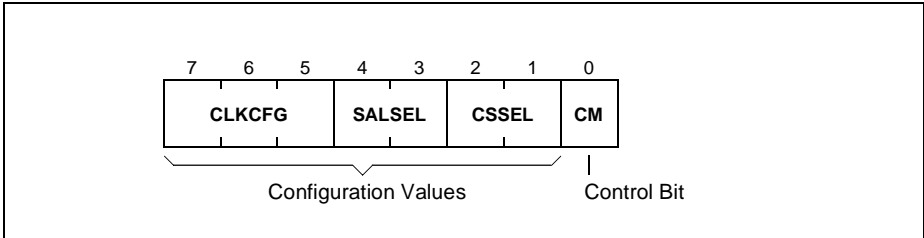
**Figure 3 Internal Reset Configuration Byte**

The fixed internal value and the compatibility mode control bit CM for the Single-Chip reset are specified by a byte value described below. This byte value shall be stored at location 00'003E<sub>H</sub> within the user ROM code.
