Device	C164CI-8R, C164SI-8R, C164CL-8R, C164SL-8R, C164xy-L
Marking/Step	(E)ES-CA, CA, CA+
Package	P-MQFP-80

This Errata Sheet describes the deviations from the current user documentation.

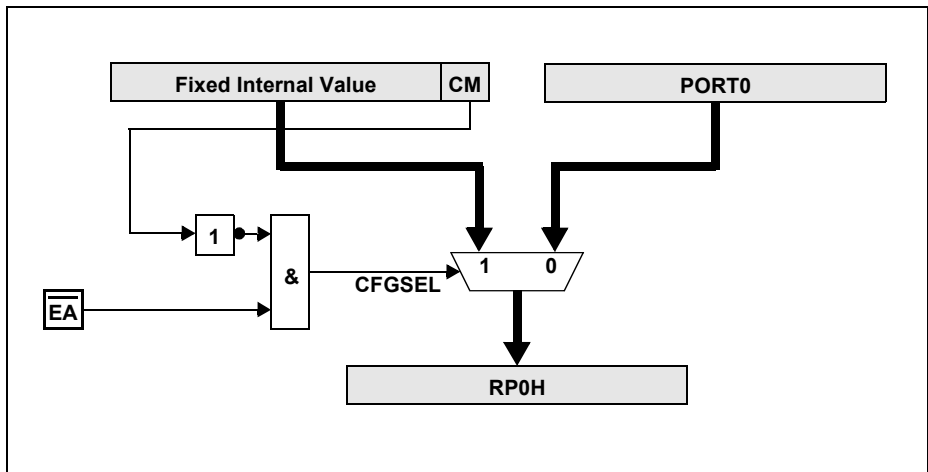
Figure 3 Reset Configuration Source Selection

In contrast to the user's manual in the C164CI-8R the register RSTCON is not available. After single-chip mode reset the register RP0H is not set to the described default value but shows the configuration defined in the ROM mask (Configuration Byte) as follows.

For a single-chip mode reset (indicated by $\overline{EA} = 1$) the configuration via PORT0 can be replaced by a fixed configuration value. This fixed configuration value is hardwired and is selectable for each ROM mask. In this case PORT0 needs no external circuitry (pullups/pulldowns) and also the internal configuration pullups are not activated.

The logic described in the figure above controls the reset configuration source (see signal CFGSEL) in the following way:

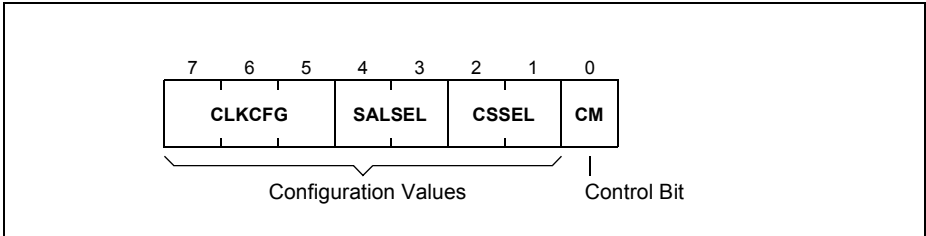
Figure 4 Internal Reset Configuration Byte

The fixed internal value and the compatibility mode control bit CM for the Single-Chip reset are specified by a byte value described below. This byte value shall be stored at location 00'003E_H within the user ROM code.
