# AURIX™ TC36x errata sheet

Marking/Step: (E)ES-AA, AA

## About this document

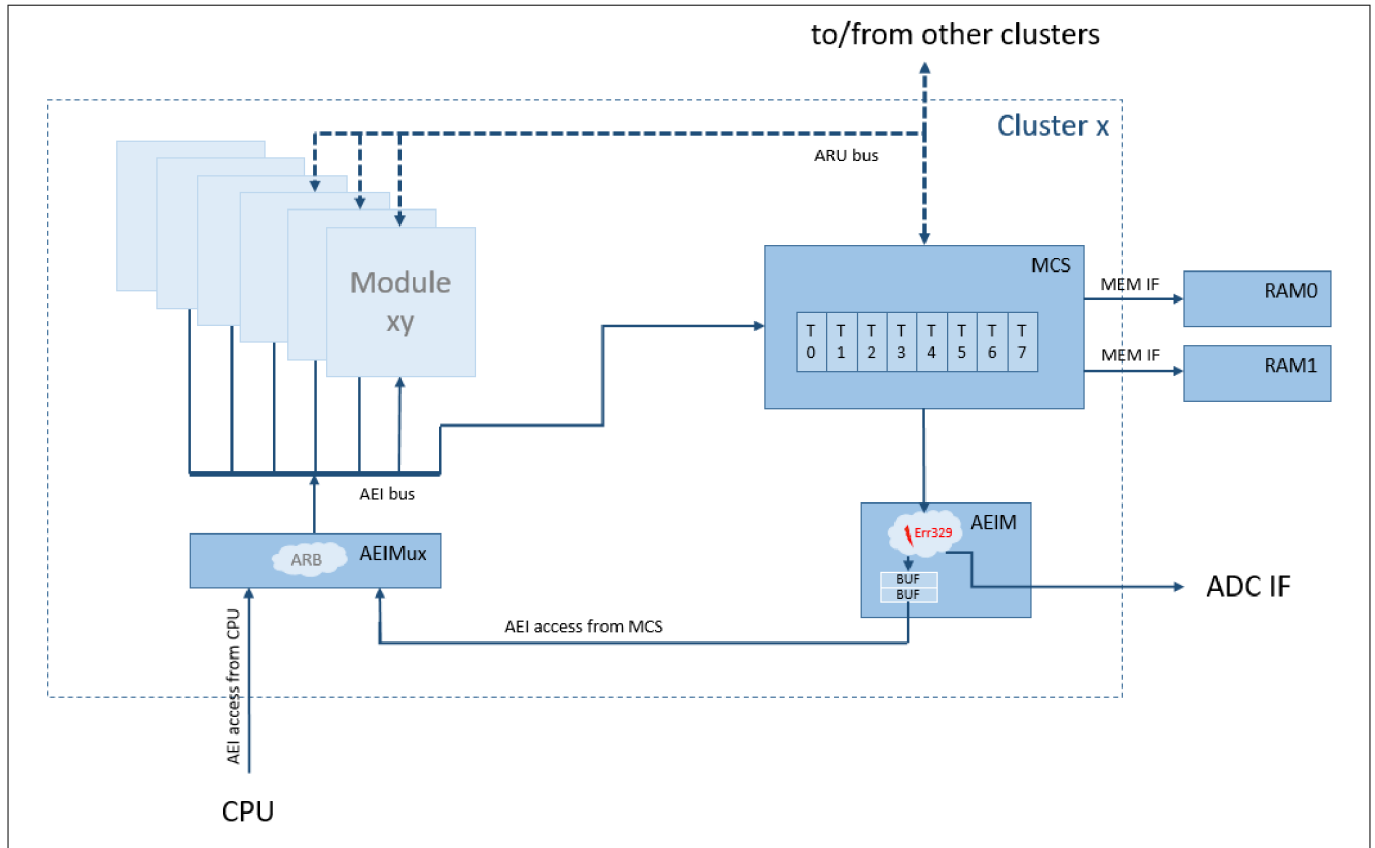
**Figure 4 Cluster-internal AEI network**

Problem GTM\_AI.329 is related to a potential incorrect handling of MCS access requests to the AEI bus at the AEIM entry stage in case that one AEIM buffer is already filled. If in such a case a new access request from MCS enters the AEIM logic during a very specific time window (related to progress on the AEI bus), the AEIM logic might signalize incorrect parameters back to MCS that could result in incorrect data, the loss of data or a repetitive execution of MCS accesses to AEI.

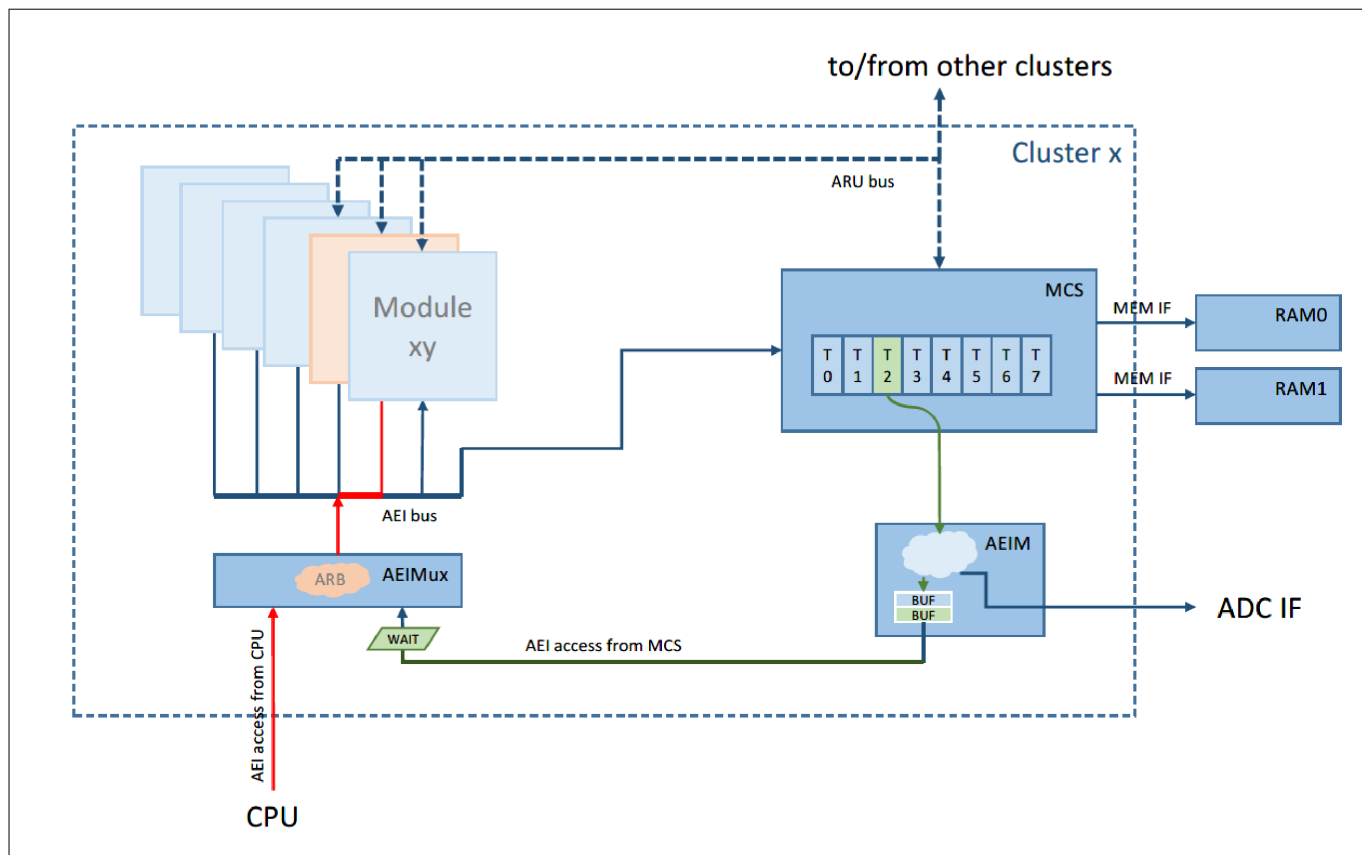
**Figure 5** MCS AEI master access path

Figure 5 shows an uncritical traffic situation. Here an access of a MCS thread to the AEI bus (green access path) is temporary delayed due to an ongoing AEI bus access from the CPU (red access path). The MCS access to the AEI bus will be safely buffered at the AEIM (green buffer). As soon as the CPU access to the AEI bus completes, the buffered AEI bus access from MCS will be executed.

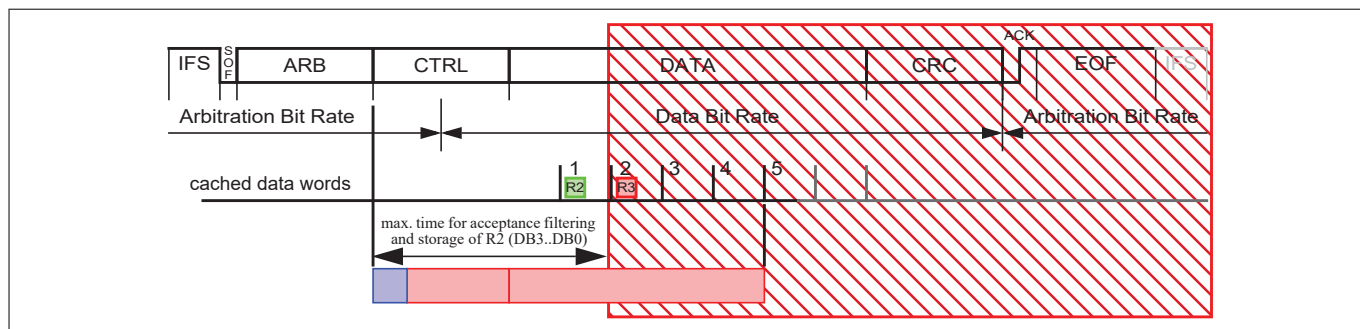
**Figure 10** CAN Frame with DLC > 4

The figure that follows shows how the available time for acceptance filtering and storage is reduced.

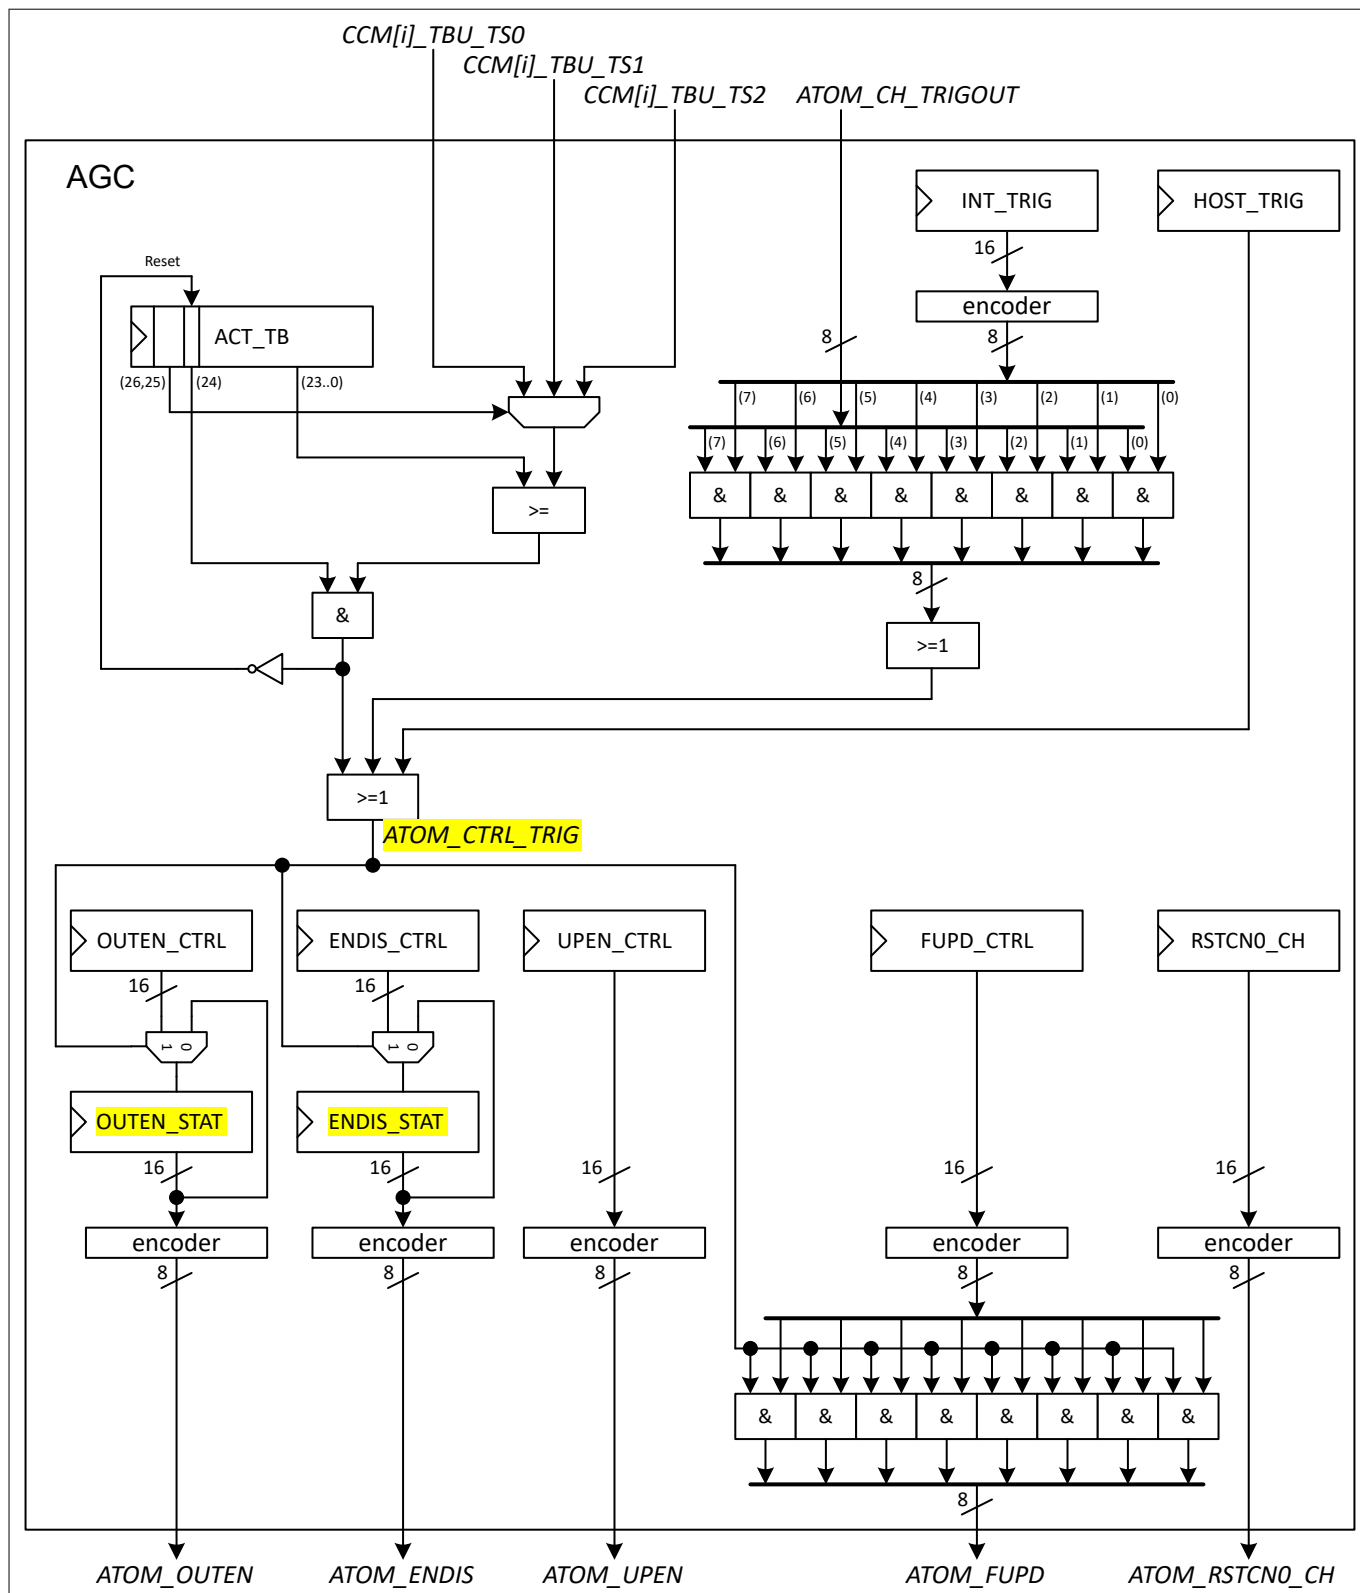
Figure 11 ATOM Global channel control mechanism

The following behavior is part of the ATOM and also TOM. In the clock cycle in which ATOM\_CTRL\_TRIG (see yellow highlight in the attached figure) is active, a simultaneous bus write access to register ATOM[i]\_AGC\_ENDIS\_STAT or also ATOM[i]\_AGC\_OUTEN\_STAT is ignored, regardless of the update value from the associated registers ATOM[i]\_AGC\_ENDIS\_CTRL/ATOM[i]\_AGC\_OUTEN\_CTRL.

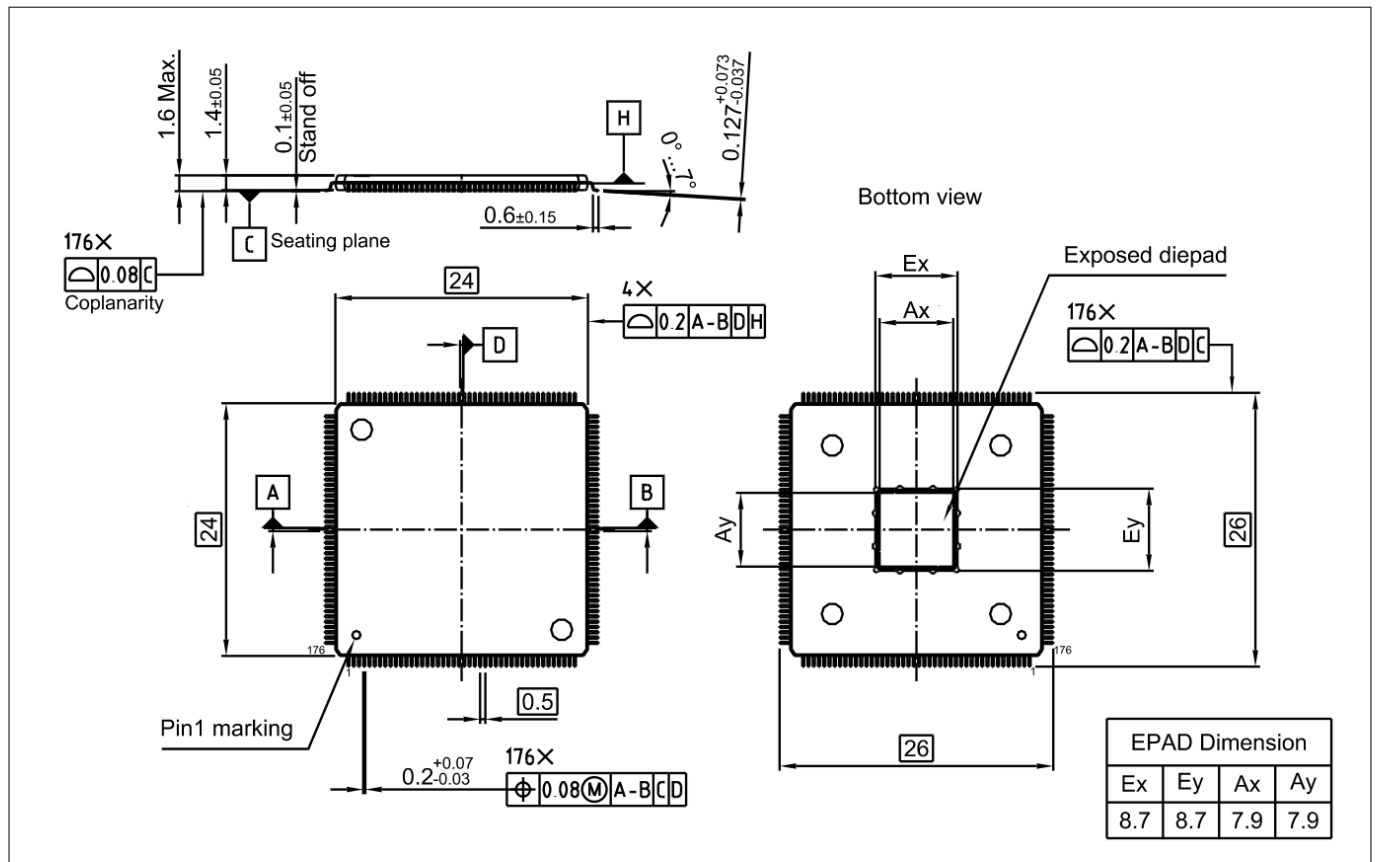
**Figure 14** Package Outlines LQFP-176 for TC36x

**Note:** For the exposed diepad of the LQFP-176 package of the TC36x, structural corner protrusions have to be considered for purposes of system design and integration with a maximum boundary of 9.4 mm.

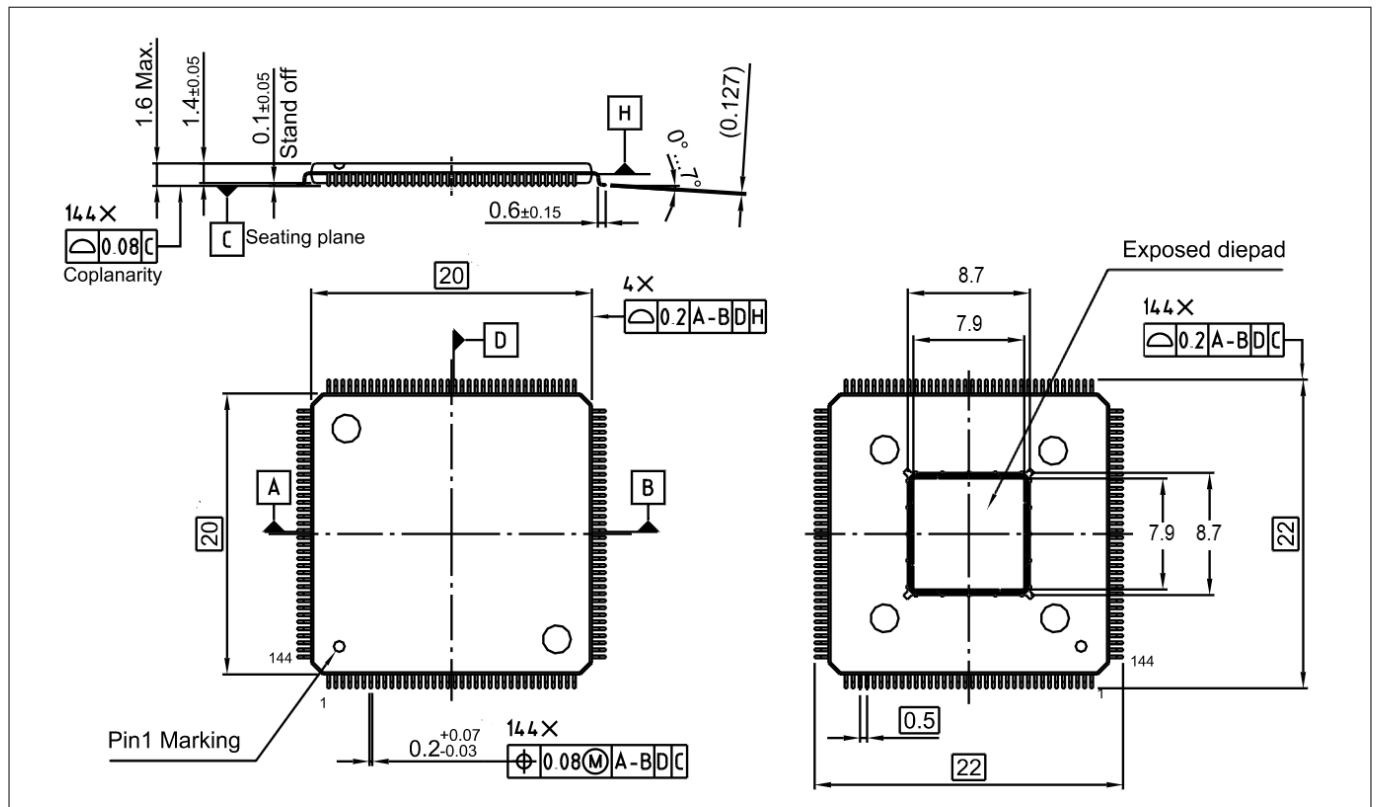
**Figure 15** Package Outlines LQFP-144 for TC36x

**Note:** For the exposed diepad of the LQFP-144 package of the TC36x, structural corner protrusions have to be considered for purposes of system design and integration with a maximum boundary of 9.4 mm.

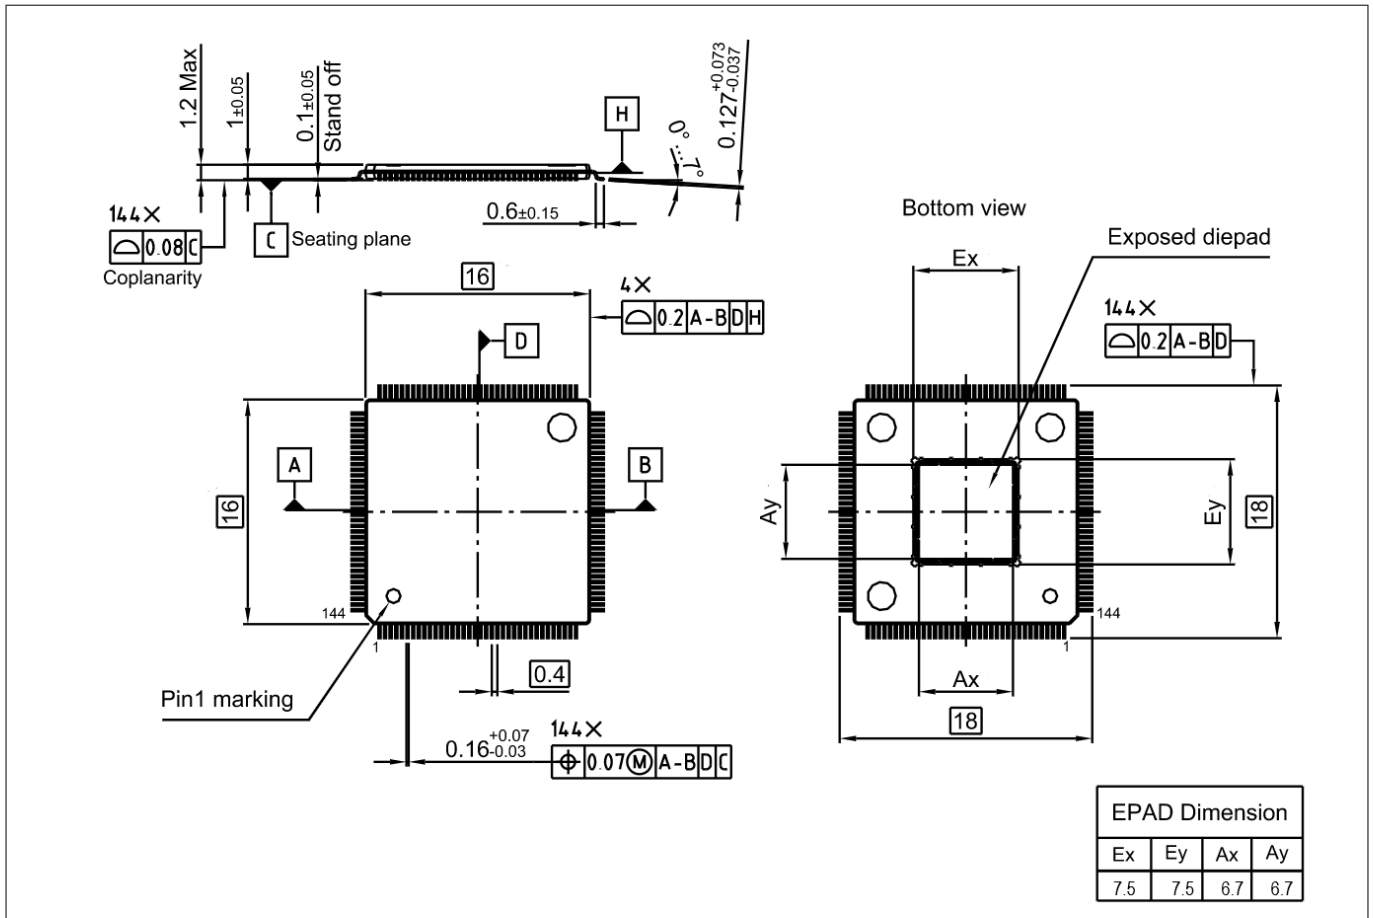
Figure 16 Package Outlines TQFP-144 for TC36x

**Note:** For the exposed diepad of the TQFP-144 package of the TC36x, structural corner protrusions have to be considered for purposes of system design and integration with a maximum boundary of 8.0 mm.
