Device TC37x
Marking/Step (E)ES-AA, AA
Package see Data Sheet

10296AERRA

This Errata Sheet describes the deviations from the current user documentation.

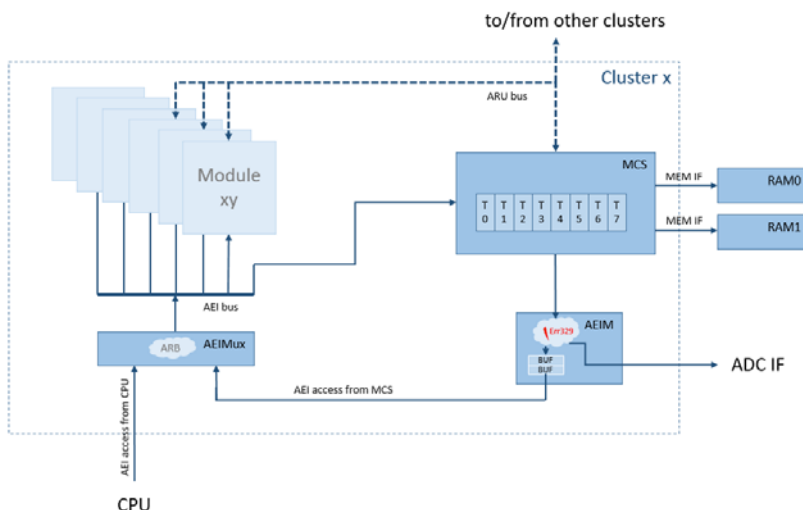
Figure 5 Cluster-internal AEI network

Problem GTM_AI.329 is related to a potential incorrect handling of MCS access requests to the AEI bus at the AEIM entry stage in case that one AEIM buffer is already filled. If in such a case a new access request from MCS enters the AEIM logic during a very specific time window (related to progress on the AEI bus), the AEIM logic might signalize incorrect parameters back to MCS that could result in incorrect data, the loss of data or a repetitive execution of MCS accesses to AEI.
