Device TC39x
Marking/Step (E)ES-BD, BD
Package see Data Sheet

10291AERRA

This Errata Sheet describes the deviations from the current user documentation.

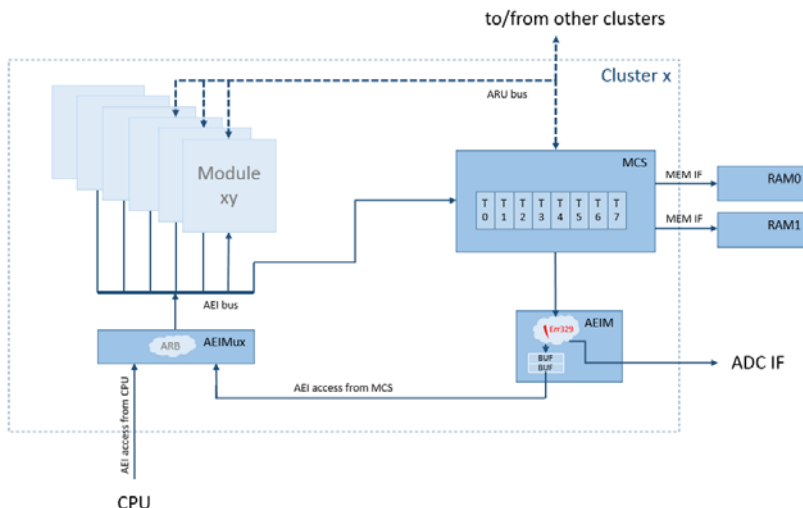
Figure 5 Cluster-internal AEI network

Problem GTM_AI.329 is related to a potential incorrect handling of MCS access requests to the AEI bus at the AEIM entry stage in case that one AEIM buffer is already filled. If in such a case a new access request from MCS enters the AEIM logic during a very specific time window (related to progress on the AEI bus), the AEIM logic might signalize incorrect parameters back to MCS that could result in incorrect data, the loss of data or a repetitive execution of MCS accesses to AEI.

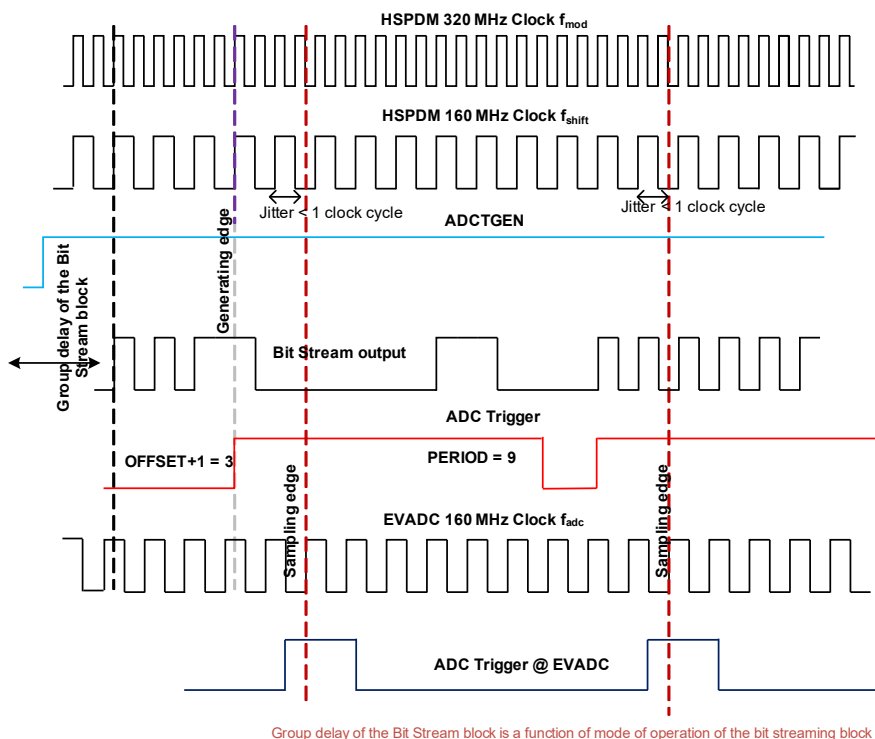
Figure 13 ADC Trigger Concept

HSPDM_TC.H004 ADC Trigger Concept - Figure update

Figure “ADC Trigger Concept” in the current version of the HSPDM chapter of the TC3xx User’s Manual shall be replaced with the following updated figure:

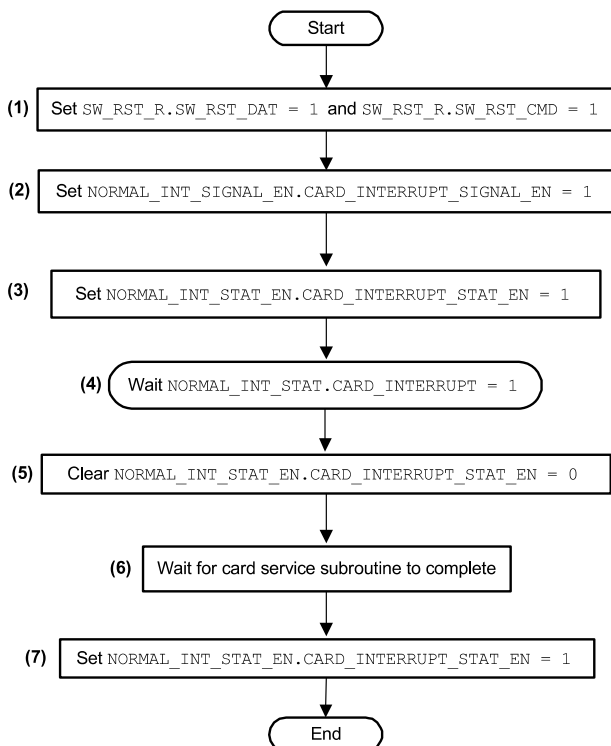
Figure 14 SDIO Card Interrupt Sequence

SDMMC_TC.H002 SDIO Card Interrupt Sequence - Figure update

Figure “SDIO Card Interrupt Sequence” in the SDMMC chapter of the current version of the TC3xx User’s Manual is wrong. The correct sequence is shown in the following **Figure 14**.
