Device TC22x/TC21x
Marking/Step ES-AC, AC
Package see Data Sheet

10208AERRA

This Errata Sheet describes the deviations from the current user documentation.

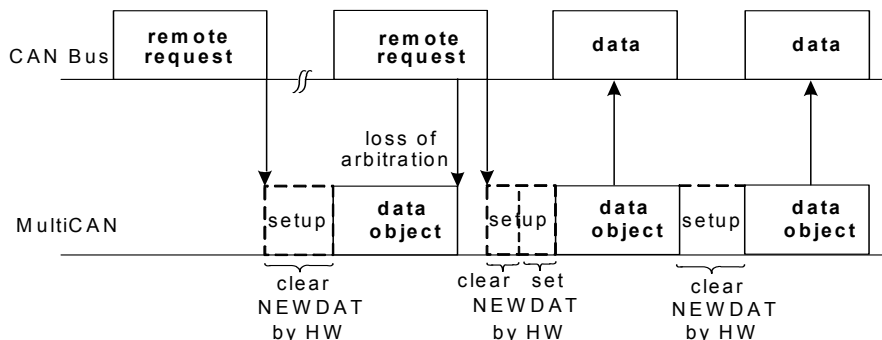
Figure 5 Loss of Arbitration

When the appropriate message object (data frame) triggered by the first remote frame wins the arbitration, it will be sent out and `NEWDAT` is not reset. This leads to an additional data frame, that will be sent by this message object (clearing `NEWDAT`).

There will, however, not be more data frames than there are corresponding remote requests.
