**Device** TC27x  
**Marking/Step** ES-DC, DC  
**Package** see Data Sheet

## 10216AERRA

This Errata Sheet describes the deviations from the current user documentation.

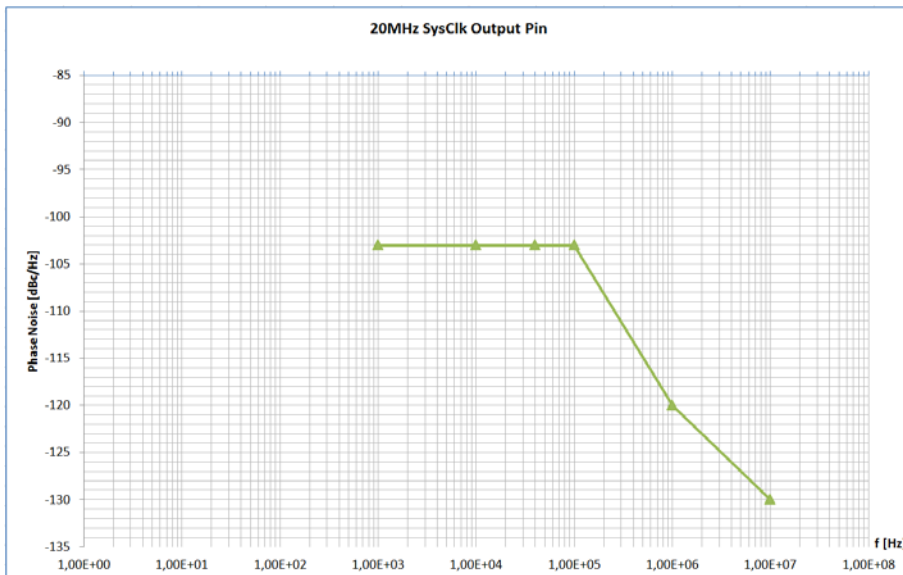
The diagram below shows the phase noise density on the SysClk pin when no application pattern but only the HSSL/HSCT subsystem is running:

**Figure 8 Phase Noise Density on SysClk Output Pin**

When designing the PLL for an HSSL/HSCT ASIC, the values for  $I_{PN}$  and  $J_{ABS20}$  above and ultimately  $BER_{20} = 10^{-12}$  can be achieved with the following recommendations:

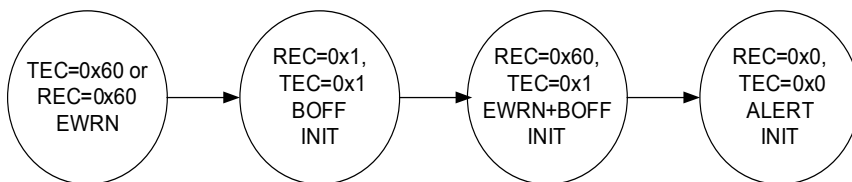
**MultiCAN\_AI.H007 Alert Interrupt Behavior in case of Bus-Off**

**Figure 10 Alert Interrupt Behavior in case of Bus-Off**

When the threshold for error warning (EWRN) is reached (default value of Error Warning Level EWRN = 0x60), then the EWRN interrupt is issued. The bus-off (BOFF) status is reached if TEC > 255 according to CAN specification, changing the MultiCAN module with REC and TEC to the same value 0x1, setting the INIT bit to 1<sub>B</sub>, and issuing the BOFF interrupt. The bus-off recovery phase starts automatically. Every time an idle time is seen, REC is incremented. If REC = 0x60, a combined status EWRN+BOFF is reached. The corresponding interrupt can also be seen as a pre-warning interrupt, that the bus-off recovery phase will be finished soon. When the bus-off recovery phase has finished (128 times idle time have been seen on the bus), EWRN and BOFF are cleared, the ALERT interrupt bit is set and the INIT bit is still set.

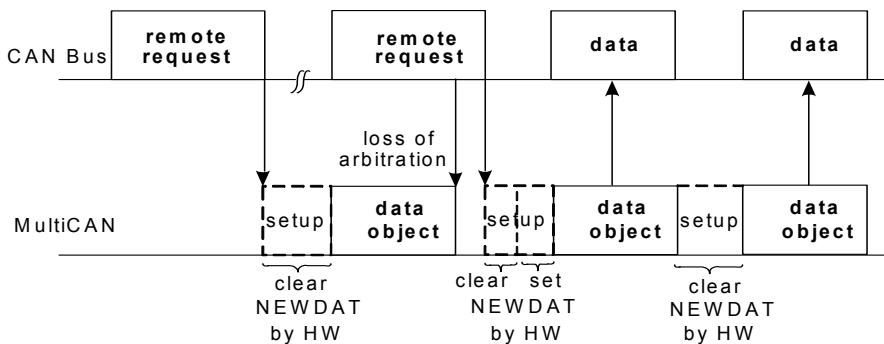
When the appropriate message object (data frame) triggered by the first remote frame wins the arbitration, it will be sent out and `NEWDAT` is not reset. This leads to an additional data frame, that will be sent by this message object (clearing `NEWDAT`).

There will, however, not be more data frames than there are corresponding remote requests.

**Figure 11 Loss of Arbitration**
