Device TC29x
Marking/Step ES-BC, BC
Package see Data Sheet

This Errata Sheet describes the deviations from the current user documentation.

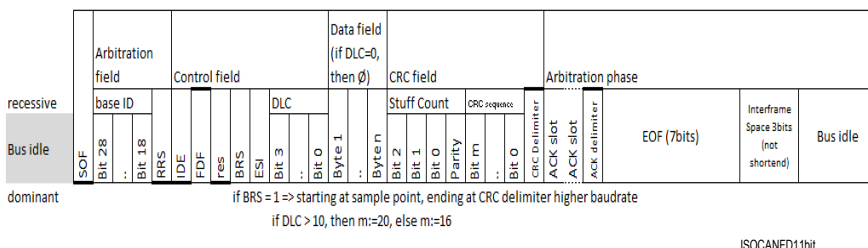
Figure 9 ISO CAN FD 11-bit ID Data Frames

Since the Stuff Count bits are part of the CRC field, fixed stuff bits will be added before and after the Stuff Count bits. **Figure 9** and **Figure 10** show the frame format of the ISO 11898-1:2015 CAN FD protocol. There is no change in the classical CAN frame format.

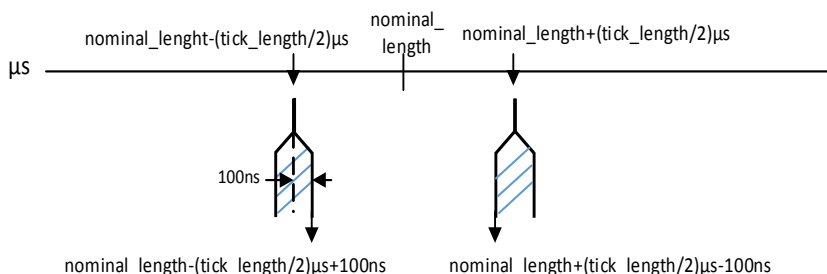
Figure 12 SENT Standard Tolerance

The length of a nibble in the SENT protocol determines the value of this nibble. For each value this length can vary, but it has to be at least inside a given range. This range is given by the SENT standard.

- The lower border is $\text{nominal_value} - (\text{tick_length}/2) \mu\text{s} + 100 \text{ ns}$
- The upper border is $\text{nominal_value} + (\text{tick_length}/2) \mu\text{s} - 100 \text{ ns}$.

In this design step the range is delimited as follows:

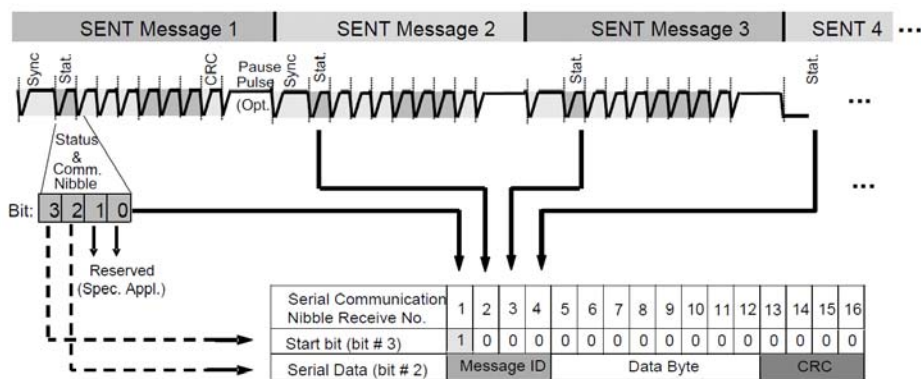
Figure 14 Short Serial Message, Serial Data Encoding over 16

One serial message is composed of 16 SENT consecutive error-free messages.

Correction

Figure 14 shows a corrected version of this figure.
