# AURIX™ TC33x/TC32x errata sheet

Marking/Step: (E)ES-AA, AA

This document describes the deviations of the device from the current user documentation, to support the assessment of the effects of these deviations on your custom hardware and software implementations.

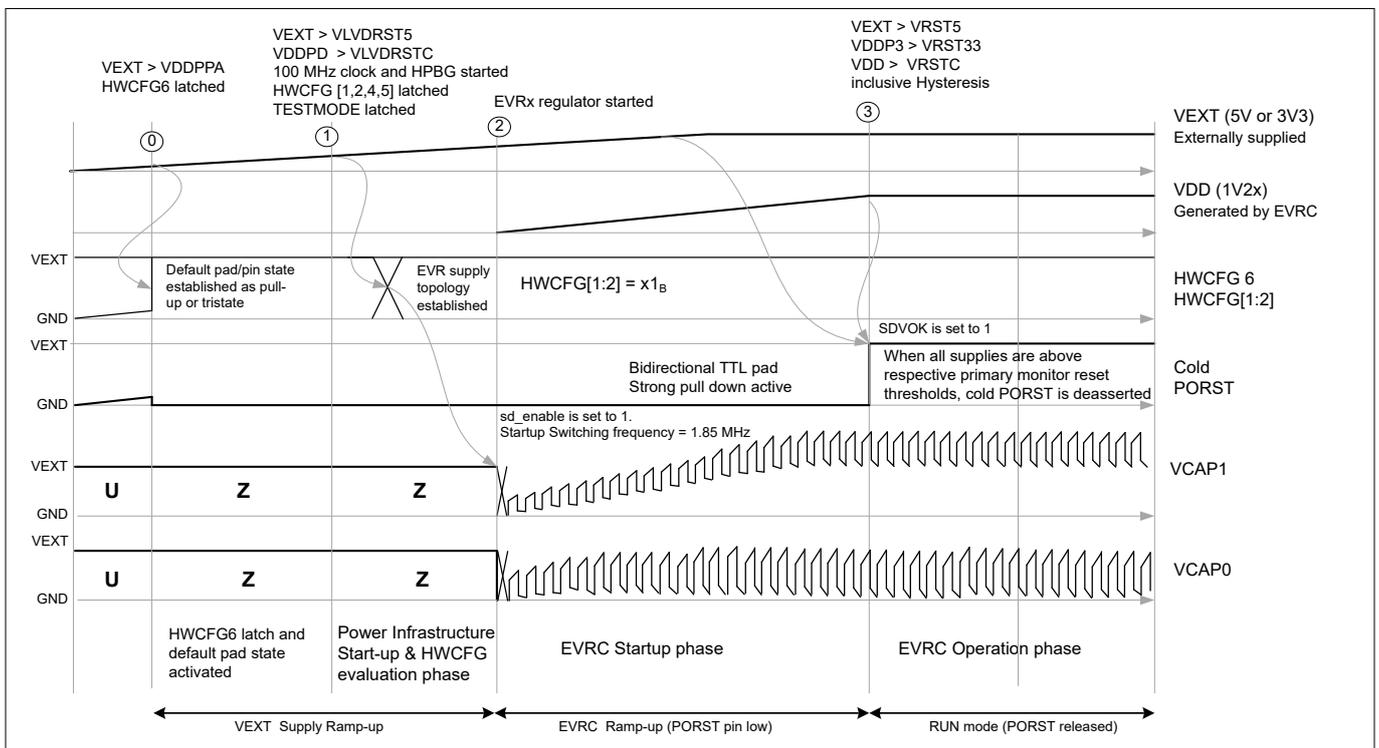
**Figure 10 VCAP behavior during start-up when EVRC regulator is used - corrected**

See corrected figures included below.
