## XC2300 Derivatives

16/32-Bit Single-Chip Microcontroller  
with 32-Bit Performance

Errata Sheet

V1.9 2014-10

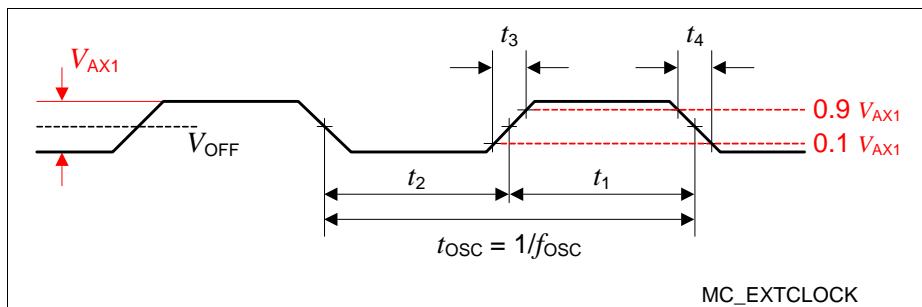
**Figure 7 External Clock Drive XTAL1**

1) The amplitude voltage  $V_{AX1}$  refers to the offset voltage  $V_{OFF}$ . This offset voltage must be stable during the operation and the resulting voltage peaks must remain within the limits defined by  $V_{IX1}$ .

*Note: For crystal or ceramic resonator operation, it is strongly recommended to measure the oscillation allowance (negative resistance) in the final target system (layout) to determine the optimum parameters for oscillator operation.*  
*The manufacturers of crystals and ceramic resonators offer an oscillator evaluation service. This evaluation checks the crystal/resonator specification limits to ensure a reliable oscillator operation.*
