Device	XMC1300
Marking/Step	EES-AA, ES-AA, AA
Package	PG-TSSOP-16/38, PG-VQFN-24/40

Overview

This “Errata Sheet” describes product deviations with respect to the user documentation listed below.

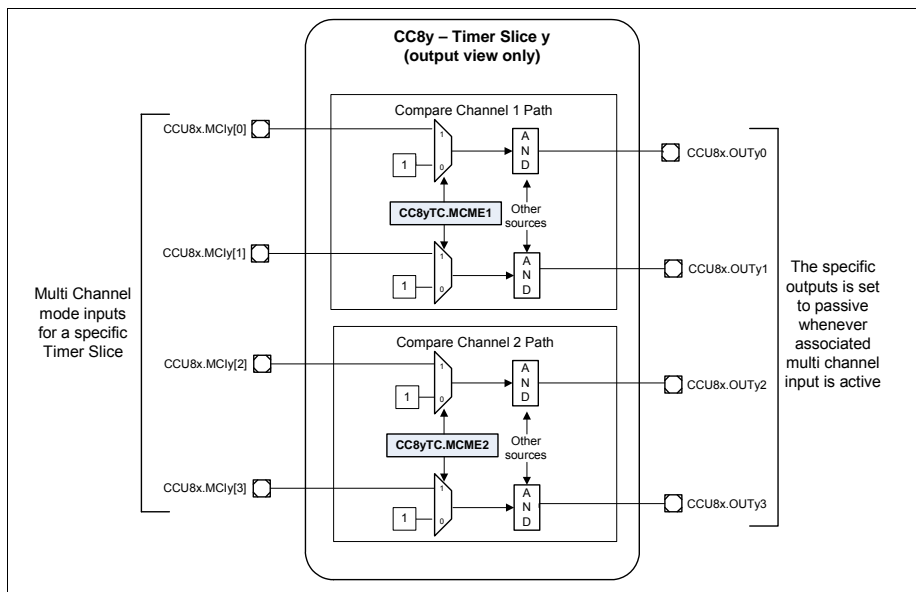
Figure 5 Multi Channel Mode diagram

After enabled, the Multi Channel mode is then controlled by several input signals, one signal per output. Whenever an input is active, the specific PWM output is set to passive level - Figure 1.

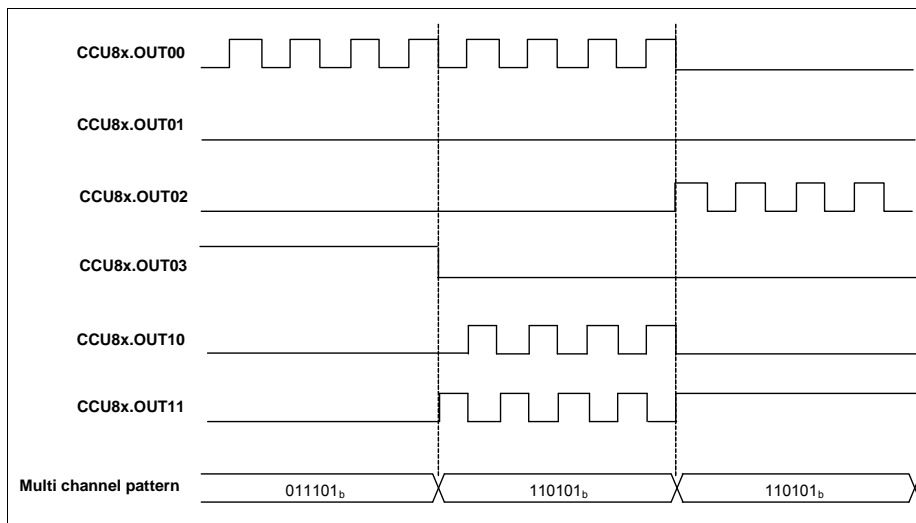
Figure 6 Multi Channel Mode applied to several CCU8 outputs

A normal use case is the parallel control of the PWM output for BLDC motor control. In Figure 2, we can see the Multi Channel Pattern being updated synchronously to the PWM signals. Whenever a multi channel input is active (in this case 0), the specific output is set into passive level (the level in which the external switch is OFF).
