Device	XMC4100/XMC4200
Marking/Step	EES-AA, ES-AA
Package	PG-VQFN-48, PG-LQFP-64

Overview

Document ID is **02530AERRA**.

This “Errata Sheet” describes product deviations with respect to the user documentation listed below.

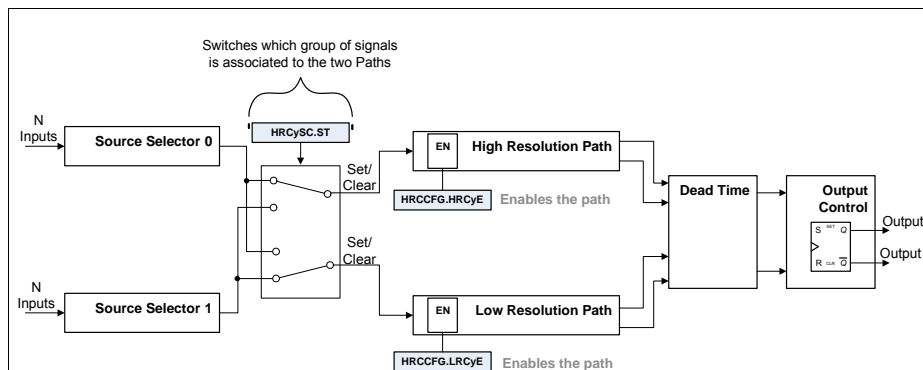
Figure 9 High Resolution Channel (HRC) simplified block diagram

HRPWM_AI.001 HRPWM output signal interference while using two control sources

From the scheme of each HRC, it is possible to control the output PWM signal via two Source Selectors (Source Selector 0 and Source Selector 1). Each of these Source Selectors can generate a pair of PWM set and clear signals (that are propagated to the output control stage).

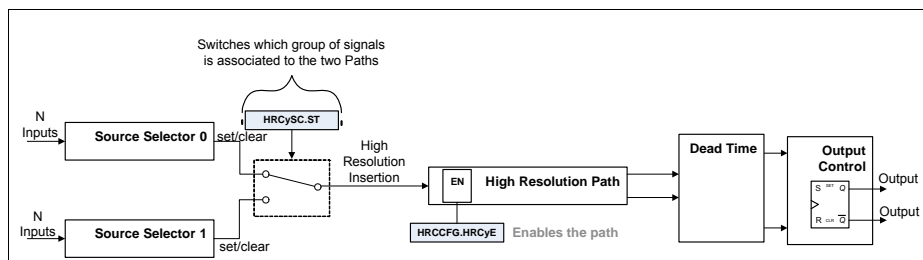
Figure 10 HRC with only one path enabled and two Source Selectors

This scenario where only one path is enabled but both Source Selectors are being used, and by being used is understood that signals are being actively decoded from the Source Selectors (input signals for the Source Selectors are being updated) is depicted on [Figure 10](#) - in this example the High Resolution Path is the one being used.

In the above scenario, every time that the HRCyST.ST bitfield is 1_B , the Source Selector 1 is the one that has control over the PWM signal. Whenever the HRCyST.ST bitfield is 0_B is the Source Selector 0 that has control over the PWM signal.

If the described condition occurs, then the signal generated by Source Selector 1 is lost and the PWM signal is not handled properly - **Figure 11**.

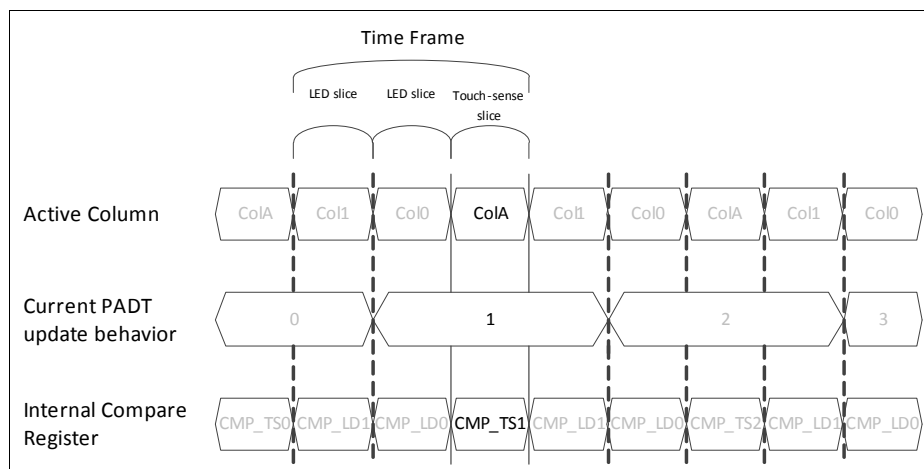
Figure 17 Internal Compare Register updated with correct compare register value with 2 LED columns enabled

If the number of LED columns enabled is 2 or more, the additional LED columns would provide some buffer time for the delay. So, at the start of a new touch-sense time slice, the update of PADT value would have taken place. Hence, the

current active PADT compare register value is updated to the internal compare register (**Figure 17**).

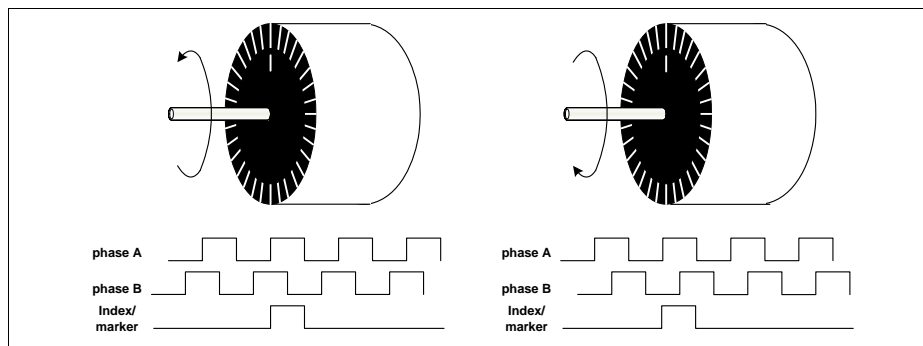
Figure 19 Rotary Encoder outputs - Phase A, Phase B and Index

POSIF_AI.001 Input Index signal from Rotary Encoder is not decoded when the length is 1/4 of the tick period

When the index signal is smaller than 1/2 of the tick period, the POSIF module is not able to decode this signal properly, Figure 2 - notice that the reference edge of the index generation in this figure is the falling of Phase B, nevertheless this is an example and depending on the encoder type, this edge may be one of the other three.
