Device	XMC4100/XMC4200
Marking/Step	ES-AB, AB
Package	PG-VQFN-48, PG-LQFP-64

Document ID is **087/18**.

This “Errata Sheet” describes product deviations with respect to the user documentation listed below.

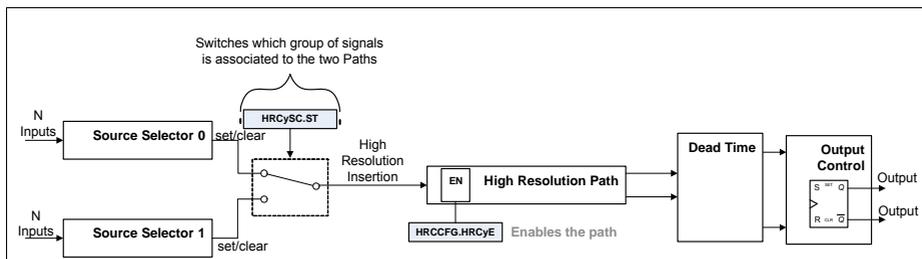
Figure 10 HRC with only one path enabled and two Source Selectors

This scenario where only one path is enabled but both Source Selectors are being used, and by being used is understood that signals are being actively decoded from the Source Selectors (input signals for the Source Selectors are being updated) is depicted on [Figure 10](#) - in this example the High Resolution Path is the one being used.

In the above scenario, every time that the HRCyST.ST bitfield is 1_B , the Source Selector 1 is the one that has control over the PWM signal. Whenever the HRCyST.ST bitfield is 0_B is the Source Selector 0 that has control over the PWM signal.

If the described condition occurs, then the signal generated by Source Selector 1 is lost and the PWM signal is not handled properly - **Figure 11**.

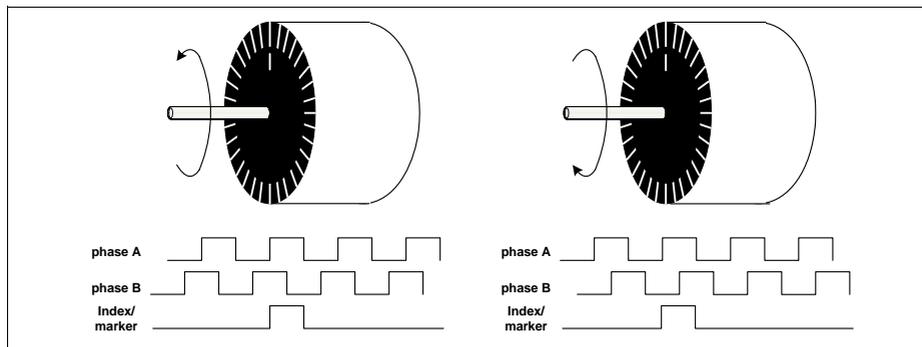
Figure 18 Rotary Encoder outputs - Phase A, Phase B and Index

Each POSIF module can be used as an input interface for a Rotary Encoder. It is possible to configure the POSIF module to decode 3 different signals: Phase A, Phase B (these two signals are 90° out of phase) and Index. The index signal is normally understood as the marker for the zero position of the motor Figure 1.

When the index signal is smaller than 1/2 of the tick period, the POSIF module is not able to decode this signal properly, Figure 2 - notice that the reference edge of the index generation in this figure is the falling of Phase B, nevertheless this is an example and depending on the encoder type, this edge may be one of the other three.

To make usage of the Index signal, when the length of this signal is less than 1/2 of the tick period, one should connect it directly to the specific counter/timer. This connection should be done at port level of the device (e.g. connecting the device port to the specific Timer/Counter(s)), Figure 3.
