Device	XMC4100/XMC4200
Marking/Step	ES-BA, BA
Package	PG-VQFN-48, PG-(LT)QFP-64

Document ID is **086/18**.

This “Errata Sheet” describes product deviations with respect to the user documentation listed below.

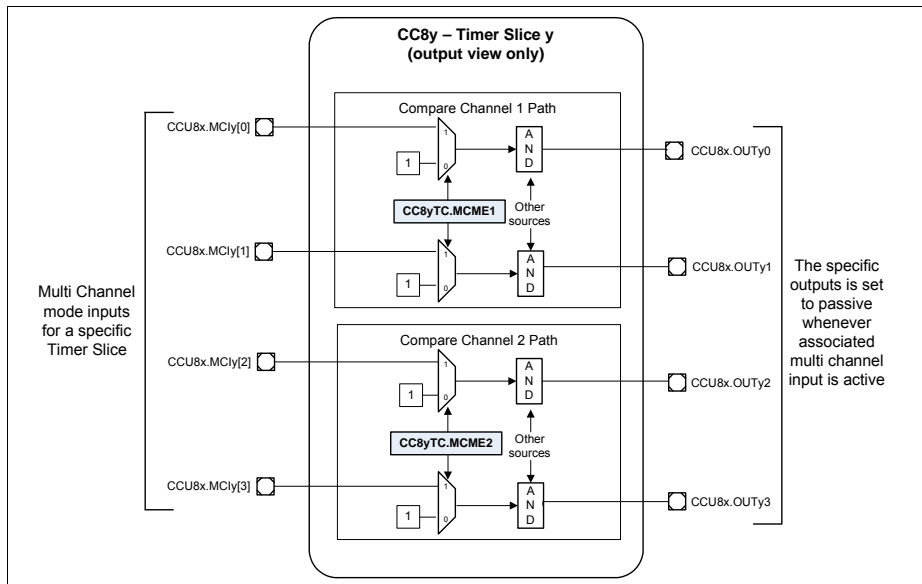
Figure 3 Multi Channel Mode diagram

The Multi Channel mode is normally used to modulate in parallel several PWM outputs (a complete CCU8 - up to 16 PWM signals can be modulated in parallel).

A normal use case is the parallel control of the PWM output for BLDC motor control. In Figure 2, we can see the Multi Channel Pattern being updated synchronously to the PWM signals. Whenever a multi channel input is active (in this case 0), the specific output is set into passive level (the level in which the external switch is OFF).
