Device XMC4300
Marking/Step ES-AA, AA
Package PG-LQFP-100

Document ID is **085/18**

This “Errata Sheet” describes product deviations with respect to the user documentation listed below.

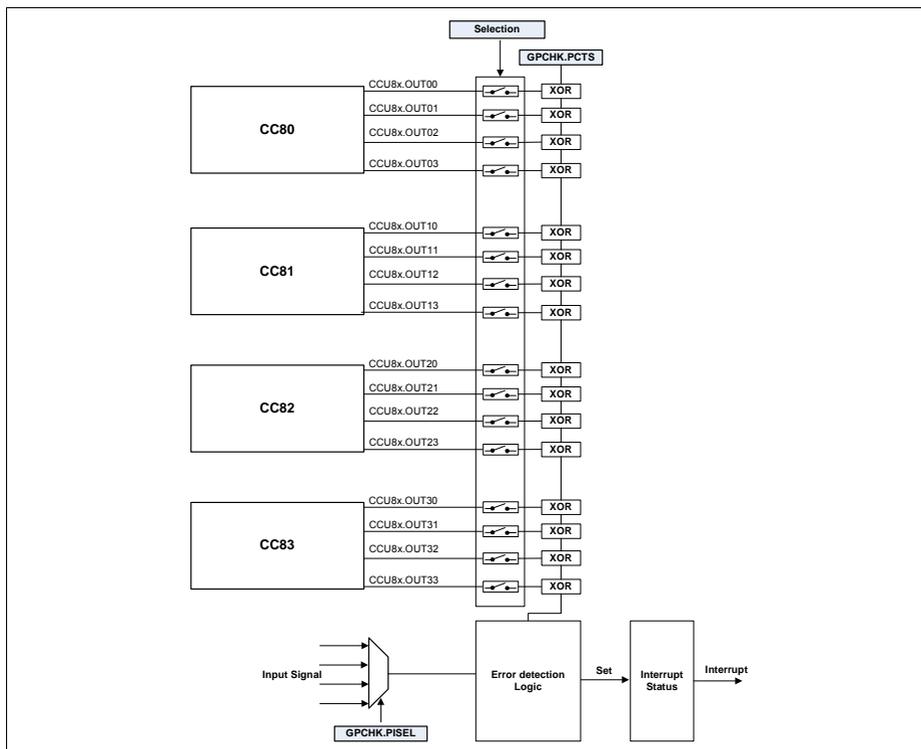
Figure 2 Parity Checker diagram

This means that if in the previous PWM cycle an error was detected and one interrupt was triggered, the software needs to read back the status register before the end of the immediately next PWM cycle.

This is indeed only necessary if multiple interrupt sources are ORed together in the same interrupt line. If this is not the case and the parity checker error source is the only one associated with an interrupt line, then there is no need to read back the status information. This is due to the fact, that only one action can be triggered in the software routine, the one linked with the parity checker error.

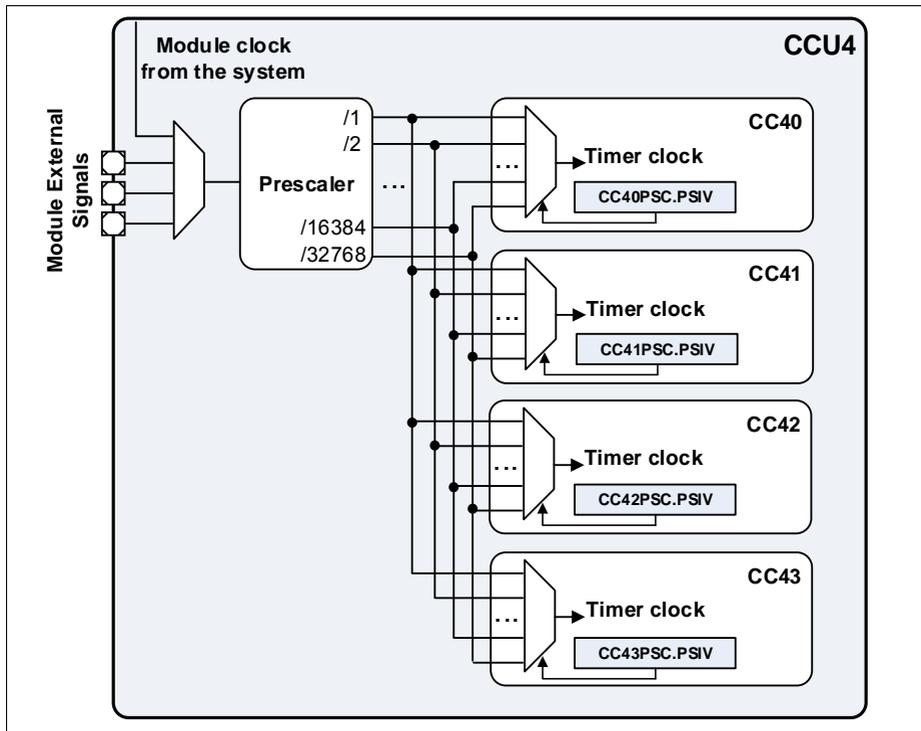
Figure 4 Clock Selection Diagram for CCU4

This is only applicable if the Module Clock provided by the system (the normal default configuration and use case scenario) is not being used. In the case that the normal clock configured and programmed at system level is being used, there is not any type of constraints.

One should not also confuse the usage of an external signal as clock for the module with the usage of an external signal for counting. These two features are completely unrelated and there are not any dependencies between both.
