Device	XMC4400
Marking/Step	ES-BA, BA
Package	PG-LQFP-64/100

Document ID is **083/18**.

This “Errata Sheet” describes product deviations with respect to the user documentation listed below.

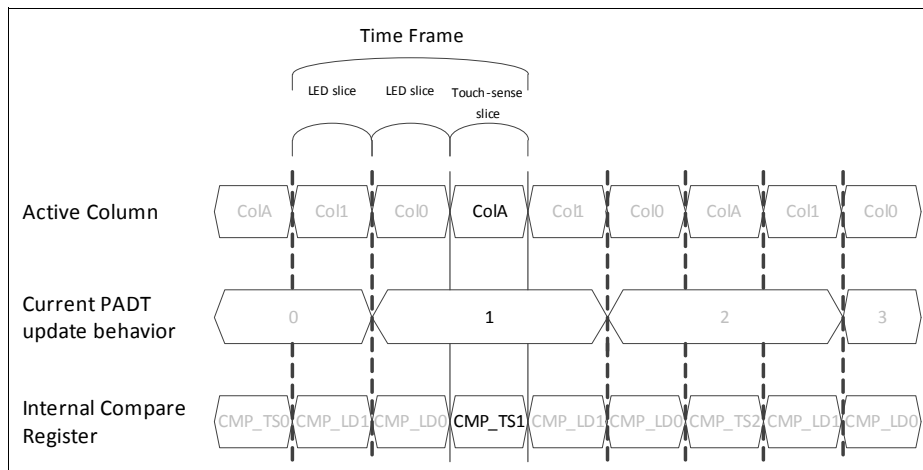
**Figure 12 Internal Compare Register updated with correct compare register value with 2 LED columns enabled**

If the number of LED columns enabled is 2 or more, the additional LED columns would provide some buffer time for the delay. So, at the start of a new touch-sense time slice, the update of PADT value would have taken place. Hence, the current active PADT compare register value is updated to the internal compare register ([Figure 12](#)).

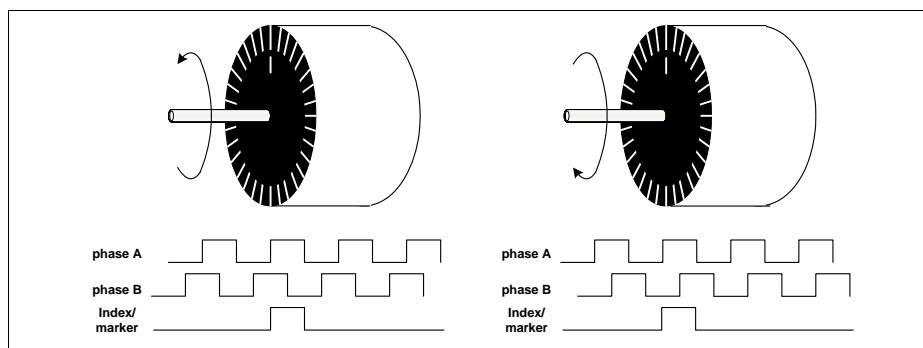
**Figure 14 Rotary Encoder outputs - Phase A, Phase B and Index**

Each POSIF module can be used as an input interface for a Rotary Encoder. It is possible to configure the POSIF module to decode 3 different signals: Phase A, Phase B (these two signals are 90° out of phase) and Index. The index signal is normally understood as the marker for the zero position of the motor Figure 1.

When the index signal is smaller than 1/2 of the tick period, the POSIF module is not able to decode this signal properly, Figure 2 - notice that the reference edge of the index generation in this figure is the falling of Phase B, nevertheless this is an example and depending on the encoder type, this edge may be one of the other three.

To make usage of the Index signal, when the length of this signal is less than 1/2 of the tick period, one should connect it directly to the specific counter/timer. This connection should be done at port level of the device (e.g. connecting the device port to the specific Timer/Counter(s)), Figure 3.
