Device	XMC4500
Marking/Step	ES-AC, AC
Package	PG-LQFP-100/144, PG-LFBGA-144

Document ID is **081/18**.

This “Errata Sheet” describes product deviations with respect to the user documentation listed below.

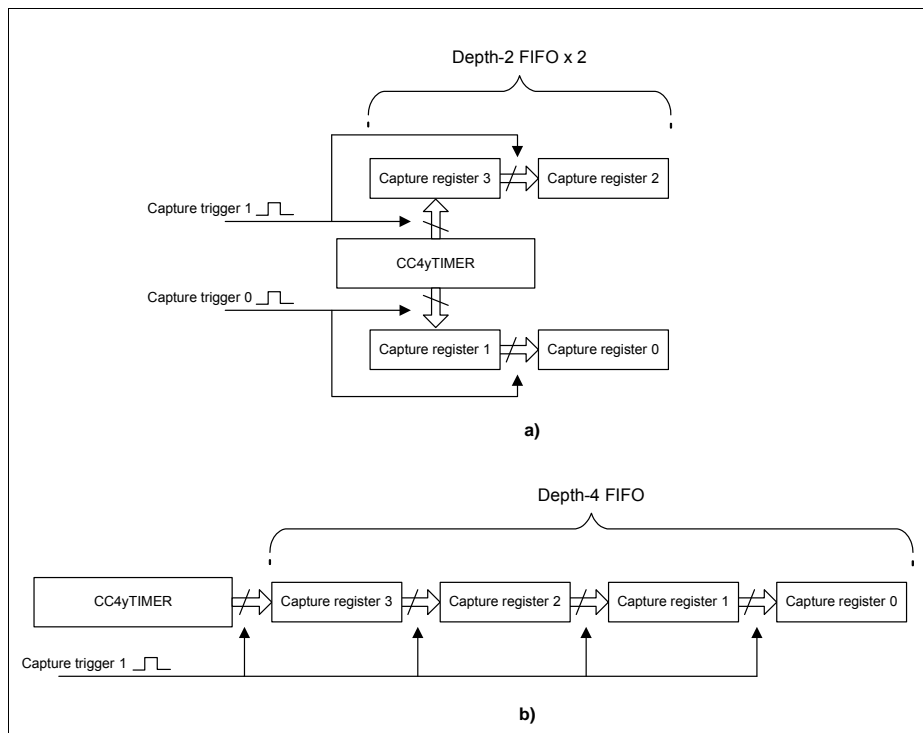
**Figure 2 CCU4 capture modes - a) Depth-2 x2 Capture; b) Depth-4 Capture**

These situations occur whenever capture trigger 1 is being used (when the CC4yCMC.CAP1S field is programmed with a value different from 00<sub>B</sub>).

Note that the period interrupt is only necessary if the capture trigger periodicity is bigger than the timer period itself.

By using the floating prescaler function present in each timer slice, the capture routine can ignore the missing period interrupt, for a capture trigger frequency as low as 0.25 Hz (for  $f_{CCU}$  equal to 120 MHz).

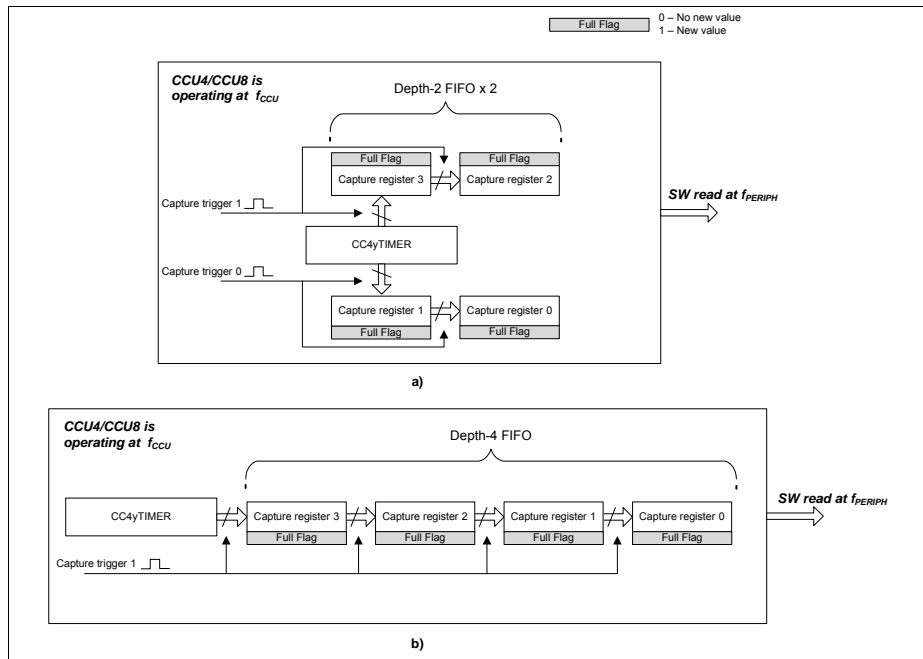
**Figure 10 Capture Modes Structure - a) Depth-2 x2 Capture; b) Depth-4 Capture**

Each CCU4/CCU8 Timer Slice contains a Full Flag field in every capture register. The structure of the different capture modes for each Timer Slice can be seen in [Figure 10](#).

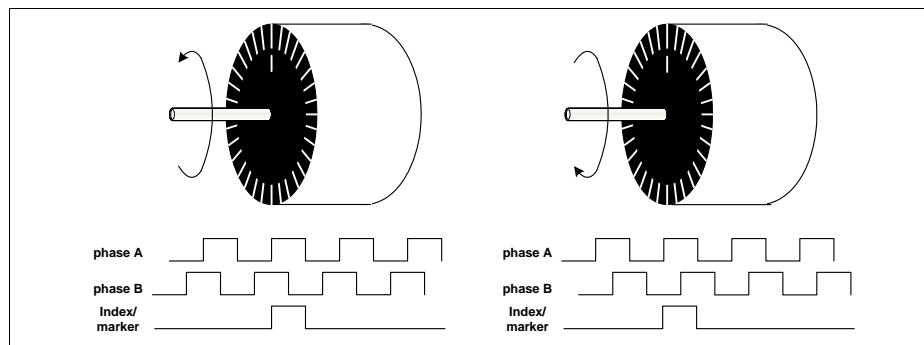
**Figure 19 Rotary Encoder outputs - Phase A, Phase B and Index**

A, Phase B (these two signals are 90° out of phase) and Index. The index signal is normally understood as the marker for the zero position of the motor Figure 1.

When the index signal is smaller than 1/2 of the tick period, the POSIF module is not able to decode this signal properly, Figure 2 - notice that the reference edge of the index generation in this figure is the falling of Phase B, nevertheless this is an example and depending on the encoder type, this edge may be one of the other three.
