<b>Device</b>	<b>XMC4500</b>
<b>Marking/Step</b>	<b>ES-AC, AC</b>
<b>Package</b>	<b>PG-LQFP-100/144, PG-LFBGA-144</b>

Document ID is **116/17**.

This “Errata Sheet” describes product deviations with respect to the user documentation listed below.

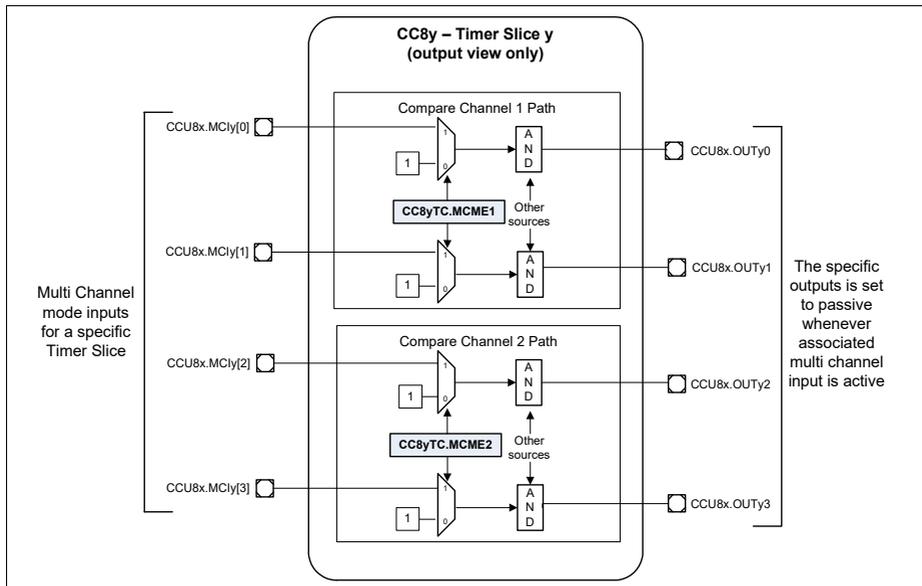
Figure 5 Multi Channel Mode diagram

After enabled, the Multi Channel mode is then controlled by several input signals, one signal per output. Whenever an input is active, the specific PWM output is set to passive level - Figure 1.

A glitch is present at the PWM outputs whenever the dead time of the specific compare channel is enabled - CC8yDTC.DTE1 and/or CC8yDTC.DTE2 set to 1<sub>B</sub> (each compare channel has a separate dead time function) - and the specific multi channel pattern for the channel is 01<sub>B</sub> or 10<sub>B</sub>.

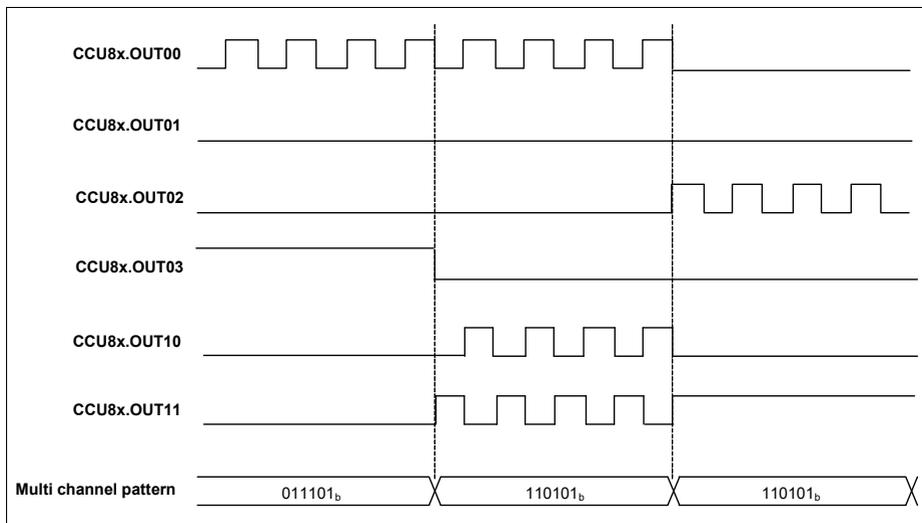
Figure 6 Multi Channel Mode applied to several CCU8 outputs

A normal use case is the parallel control of the PWM output for BLDC motor control. In Figure 2, we can see the Multi Channel Pattern being updated synchronously to the PWM signals. Whenever a multi channel input is active (in this case 0), the specific output is set into passive level (the level in which the external switch is OFF).

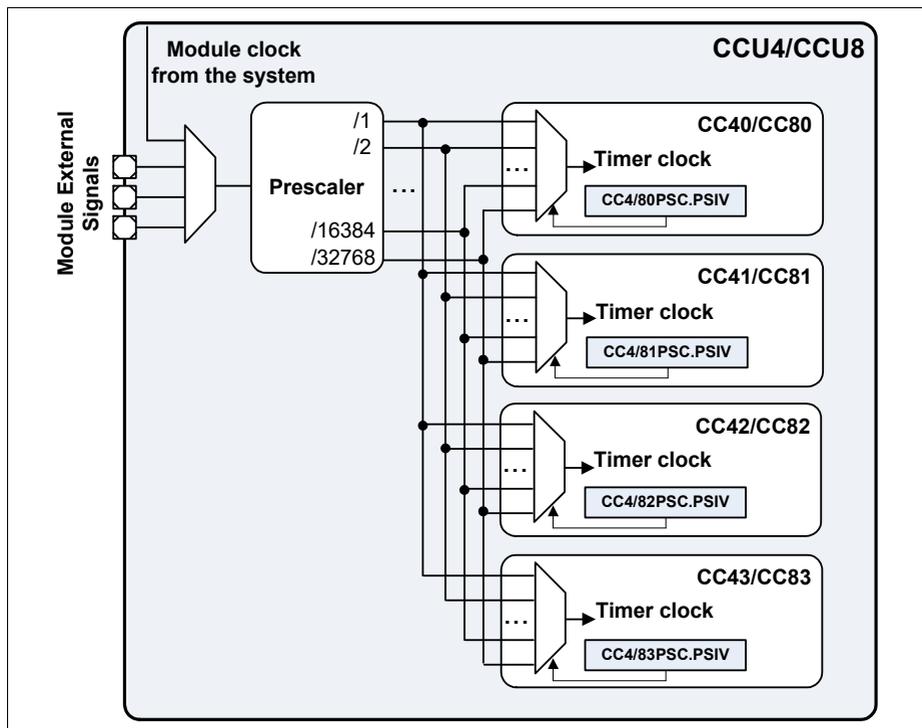
Figure 13 Clock Selection Diagram for CCU4/CCU8

Each CCU4/CCU8 module offers the possibility of selecting an external signal to be used as the master clock for every timer inside the module Figure 1. External signal in this context is understood as a signal connected to other module/IP or connected to the device ports.

This is only applicable if the Module Clock provided by the system (the normal default configuration and use case scenario) is not being used. In the case that the normal clock configured and programmed at system level is being used, there is not any type of constraints.

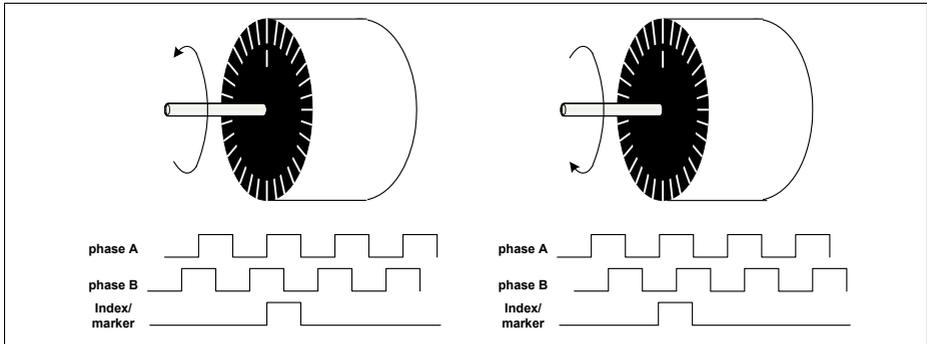
**Figure 19 Rotary Encoder outputs - Phase A, Phase B and Index**

A, Phase B (these two signals are 90° out of phase) and Index. The index signal is normally understood as the marker for the zero position of the motor Figure 1.

When the index signal is smaller than 1/2 of the tick period, the POSIF module is not able to decode this signal properly, Figure 2 - notice that the reference edge of the index generation in this figure is the falling of Phase B, nevertheless this is an example and depending on the encoder type, this edge may be one of the other three.
