Device	XMC1300
Marking/Step	EES-AB, ES-AB, AB
Package	PG-TSSOP-16/28/38, PG-VQFN-24/40

This “Errata Sheet” describes product deviations with respect to the user documentation listed below.

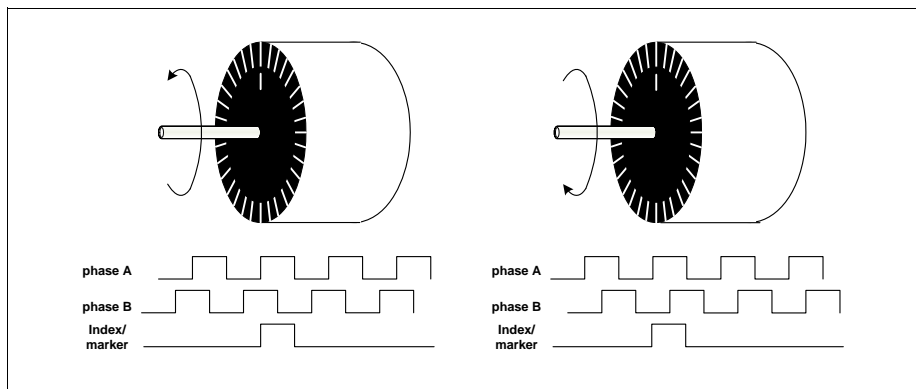
Figure 4 Rotary Encoder outputs - Phase A, Phase B and Index

POSIF_AI.001 Input Index signal from Rotary Encoder is not decoded when the length is 1/4 of the tick period

Each POSIF module can be used as an input interface for a Rotary Encoder. It is possible to configure the POSIF module to decode 3 different signals: Phase A, Phase B (these two signals are 90° out of phase) and Index. The index signal is normally understood as the marker for the zero position of the motor Figure 1.
