Device TC1762
Marking/Step EES-AC, ES-AC, AC
Package PG-LQFP-176-2

02971AERRA

This Errata Sheet describes the deviations from the current user documentation.

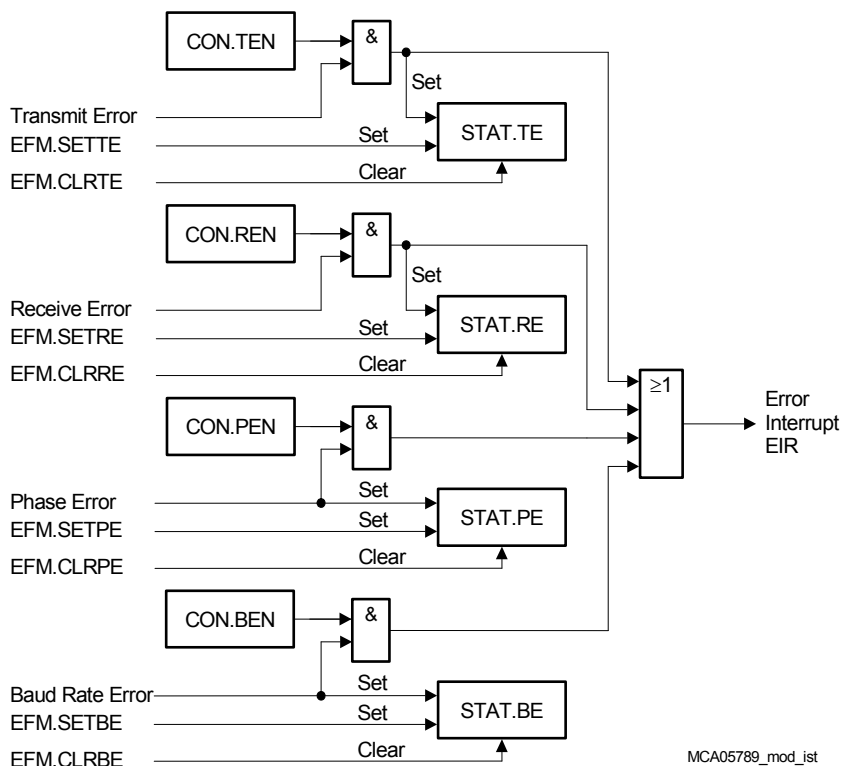
Figure 8 SSC Error Interrupt Control

The SSC is able to detect four different error conditions. Receive Error and Phase Error are detected in all modes, while Transmit Error and Baud Rate Error apply to Slave Mode only. In case of a Transmit Error or Receive Error, the respective error flags are set and the error interrupt requests will be generated by activating the EIR line only if the corresponding error enable bits have been set. In case of a Phase Error or Baud Rate Error, the respective error flags are always set and the error interrupt requests will be generated by activating the EIR line only if the corresponding error enable bit has been set. The error interrupt handler may then check the error flags to determine the cause of the error interrupt. The error flags are not reset automatically, but must be cleared via register `EFM` after servicing. This allows servicing of some error conditions via interrupt, while others may be polled by software. The error status flags can be set and reset by software via the error flag modification register `EFM`.

Note: The error interrupt handler must clear the associated (enabled) error flag(s) to prevent repeated interrupt requests. The setting of an error flag by software does not generate an interrupt request.

A **Receive Error** (Master or Slave Mode) is detected when a new data frame is completely received, but the previous data was not read out of the receive buffer register RB. If enabled via `CON.REN`, this condition sets the error flag `STAT.RE` and activates the error interrupt request line EIR. The old data in the receive buffer RB will be overwritten with the new value and is unretrievably lost.

A **Phase Error** (Master or Slave Mode) is detected when the incoming data at pin MRST (Master Mode) or MTSR (Slave Mode), sampled with the same frequency as the module clock, changes between one cycle before and two cycles after the latching edge of the shift clock signal SCLK. This condition sets the error status flag `STAT.PE` and, if enabled via `CON.PEN`, the error interrupt request line EIR.
