Device	TC1766
Marking/Step	EES-BB, ES-BB, BB
Package	PG-LQFP-176-2

01740AERRA

This Errata Sheet describes the deviations from the current user documentation.

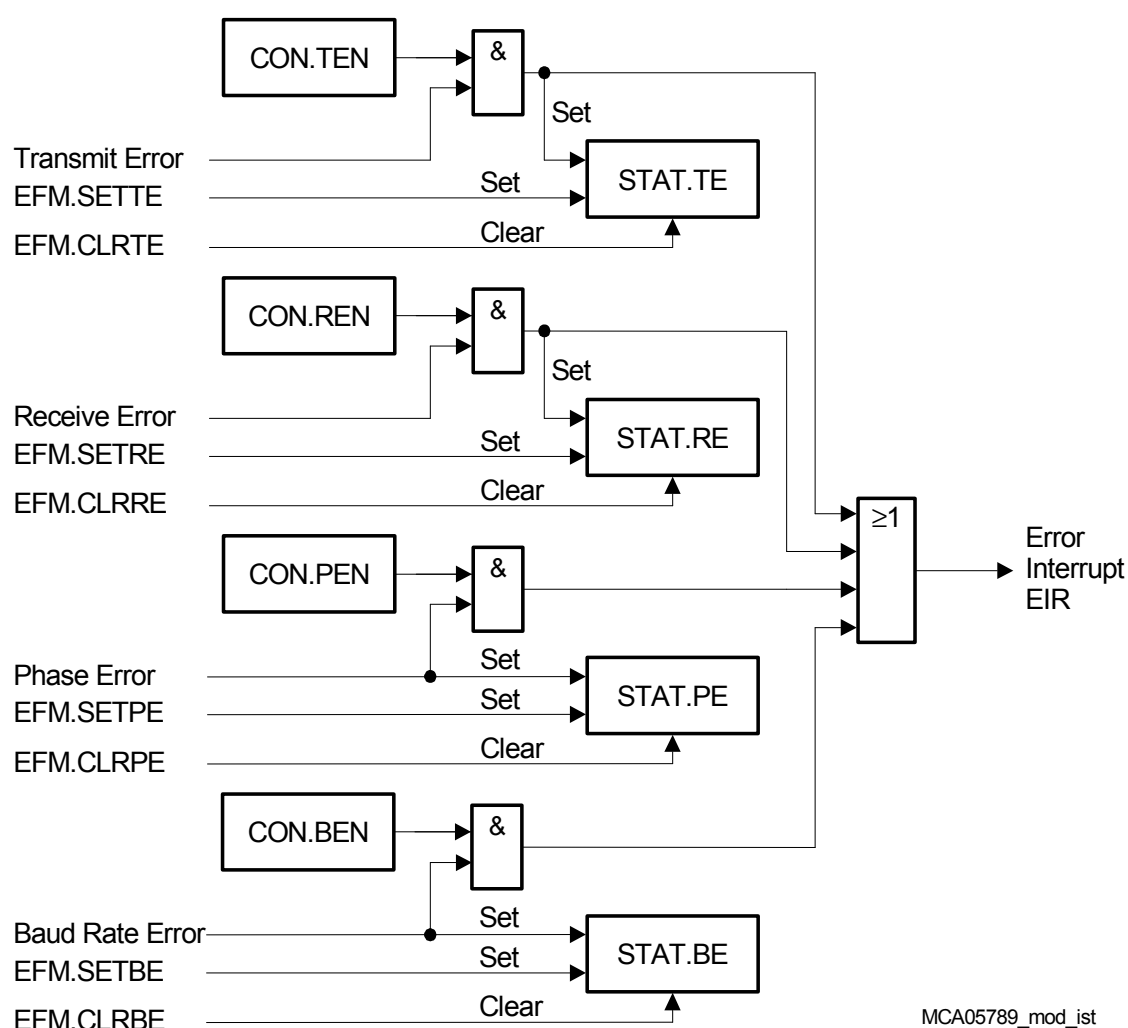
Figure 9 SSC Error Interrupt Control

A **Receive Error** (Master or Slave Mode) is detected when a new data frame is completely received, but the previous data was not read out of the receive buffer register `RB`. If enabled via `CON.REN`, this condition sets the error flag `STAT.RE` and activates the error interrupt request line `EIR`. The old data in the receive buffer `RB` will be overwritten with the new value and is unretrievably lost.

A **Phase Error** (Master or Slave Mode) is detected when the incoming data at pin `MRST` (Master Mode) or `MTSR` (Slave Mode), sampled with the same frequency as the module clock, changes between one cycle before and two cycles after the latching edge of the shift clock signal `SCLK`. This condition sets the error status flag `STAT.PE` and, if enabled via `CON.PEN`, the error interrupt request line `EIR`.

A **Baud Rate Error** (Slave Mode) is detected when the incoming clock signal deviates from the programmed baud rate (shift clock) by more than 100%, meaning it is either more than double or less than half the expected baud rate. This condition sets the error status flag `STAT.BE` and, if enabled via `CON.BEN`, the `EIR` line. Using this error detection capability requires that the slave's shift clock generator is programmed to the same baud rate as the master device. This feature detects false additional pulses or missing pulses on the clock line (within a certain frame).

A **Transmit Error** (Slave Mode) is detected when a transfer was initiated by the master (shift clock becomes active), but the transmit buffer `TB` of the slave was not updated since the last transfer. If enabled via `CON.TEN`, this condition sets the error status flag `STAT.TE` and activates the EIR line. If a transfer starts while the transmit buffer is not updated, the slave will shift out the 'old' contents of the shift register, which is normally the data received during the last transfer. This may lead to the corruption of the data on the transmit/receive line in half-duplex mode (open-drain configuration) if this slave is not selected for transmission. This mode requires that slaves not selected for transmission only shift out ones; thus, their transmit buffers must be loaded with `FFFFH` prior to any transfer.

Note: The error interrupt handler must clear the associated (enabled) error flag(s) to prevent repeated interrupt requests. The setting of an error flag by software does not generate an interrupt request.

Note: A slave with push/pull output drivers not selected for transmission will normally have its output drivers switched off. However, to avoid possible conflicts or misinterpretations, it is recommended to always load the slave's transmit buffer prior to any transfer.

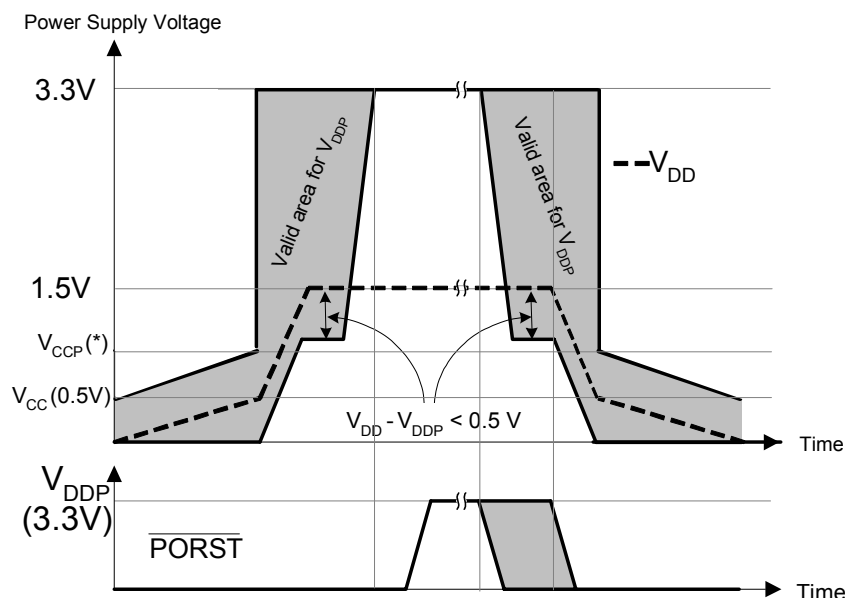
Figure 11 Exemplary power-up/down sequence

- All analog voltages (V_{DDOSC3} , V_{DDM} , V_{DDMF} , V_{DDFL3}) must also follow V_{DDP} power-up/down sequence.
- V_{DDAF} , V_{DDOSC} must follow V_{DD} power-up/down sequence.
- The absolute value of the maximum allowed deviation between any two supplies is 0.5 V while the 1.5V supplies are below their specified operating conditions.

*Note: V_{CC} and V_{CCP} in [Figure 11](#) refer to devices with *PWR_TC.P009* erratum.*
