Device	TC1796
Marking/Step	EES-BD, ES-BD, BD
Package	P-BGA-416, PG-BGA-416

02129AERRA

This Errata Sheet describes the deviations from the current user documentation.

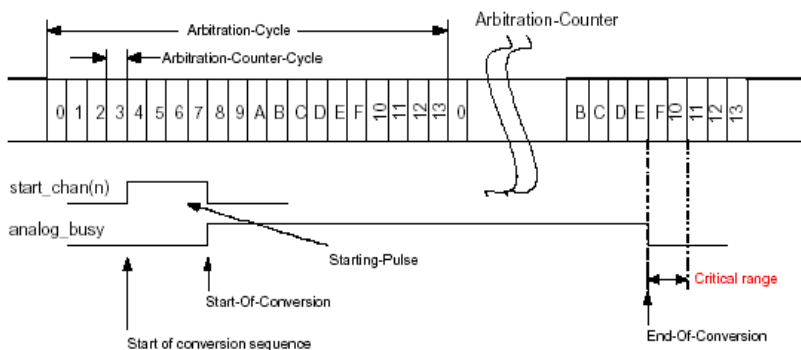
Figure 2

- Fractional divider can only be used with the following settings:
 - `FDR.STEP` = 1006...1023 for normal divider mode
 - `FDR.STEP` = 57...1023 for fractional divider mode
- "Synchronized conversion and cancel-sync-repeat functionality" must not be enabled.
 - `CHCONn.SYM` != b"10"
- "Cancel, Inject and Repeat Enable" must not be enabled.
 - `CHIN.CIREN` = 0.

For details about the conversion sequence, please refer to the figure below:

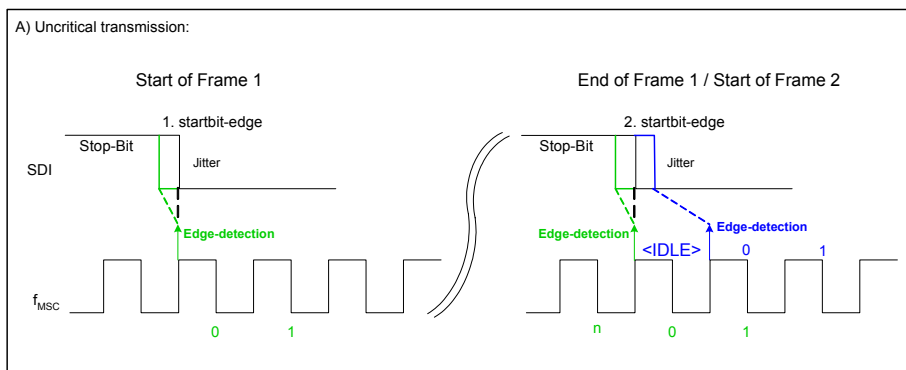
Figure 4 Uncritical transmission

Therefore the state machine of the upstream channel is sensing for an incoming new startbit (high-low edge) in the last state of a frame. If there is no edge, the state machine changes to idle state. If an edge is recognized, the state machine will start receiving the next frame. Under certain timing conditions, the start-bit of an upstream-frame which is send without any idle-time, directly after the previous frame, will not be recognized and therefore this frame will not be received correctly. In that case the startbit might be recognized erroneously within the dataframe. The missbehaviour can occur if the high-low edge of the start-bit is located close to the rising edge of the internal MSC module-clock and is jittering around this clock-edge.

As the falling startbit edge is shifted to the left of the rising clock edge (**Figure 4** left), there occurs a secure detection of the next startbit edge in the last cycle of the previous frame (here cycle n, **Figure 4** right) independent from the applied jitter to this edge.

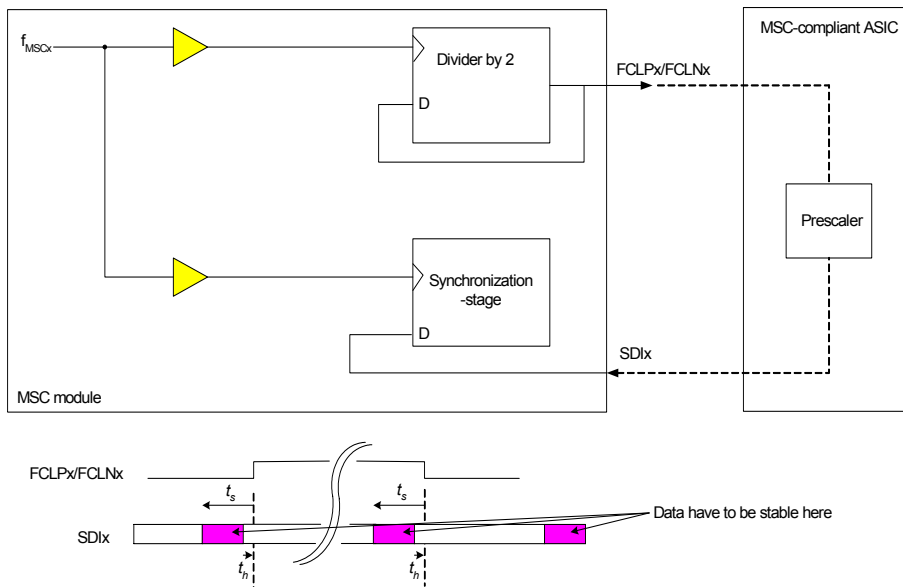
Figure 6 Delay adjustment relative to the module clock

Figure 6 shows the principle blockdiagram of the input synchronization stage of the MSC module.

Setup/Hold-Times for SDI relative to FCLPx/FCLNx (valid for both edges):

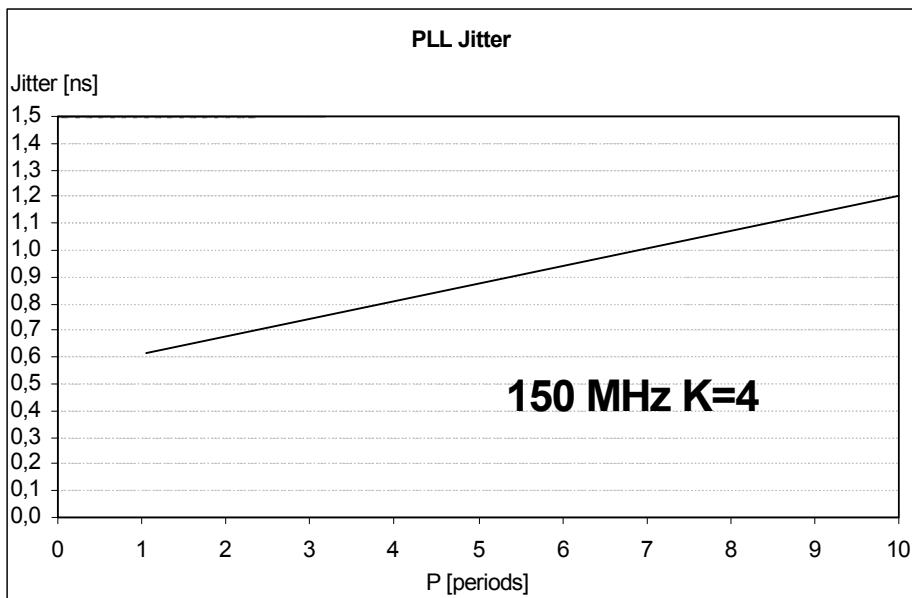
Figure 12 Short term PLL Jitter in f_{CPU} clock periods at $f_{\text{CPU}} = 150 \text{ MHz}$ and $K = 4$

When all listed system preconditions are fulfilled the PLL jitter at 150MHz and $K = 4$ with $K = KDIV + 1$ is below the marked range as shown in the figures.
