Device	TC1796
Marking/Step	EES-BE, ES-BE, BE
Package	P-BGA-416, PG-BGA-416

## 02104AERRA

This Errata Sheet describes the deviations from the current user documentation.

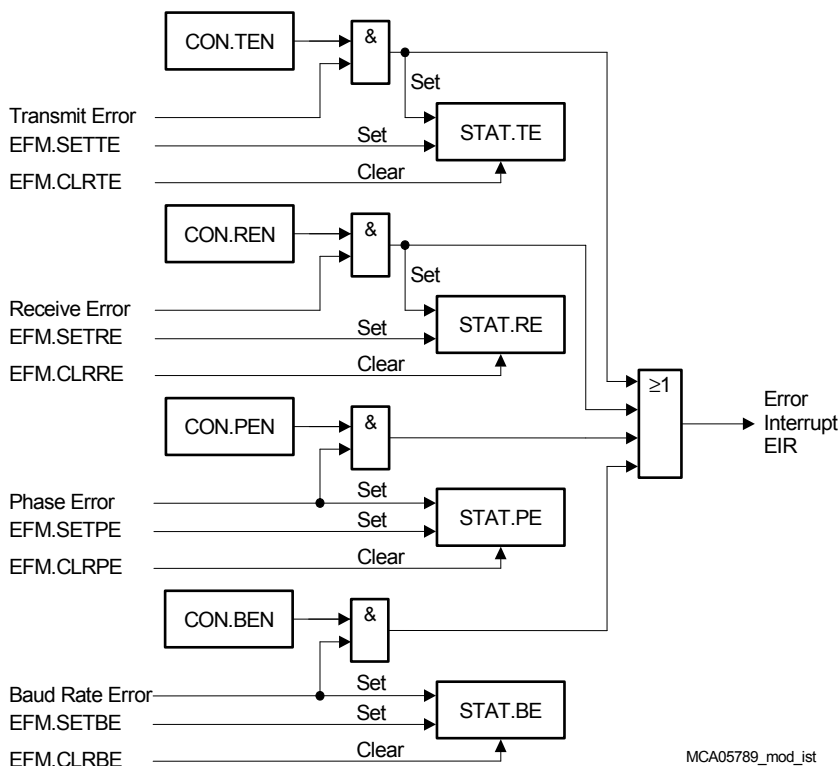
**Figure 9 SSC Error Interrupt Control**

The SSC is able to detect four different error conditions. Receive Error and Phase Error are detected in all modes, while Transmit Error and Baud Rate Error apply to Slave Mode only. In case of a Transmit Error or Receive Error, the respective error flags are set and the error interrupt requests will be generated by activating the EIR line only if the corresponding error enable bits have been set. In case of a Phase Error or Baud Rate Error, the respective error flags are always set and the error interrupt requests will be generated by activating the EIR line only if the corresponding error enable bit has been set. The error interrupt handler may then check the error flags to determine the cause of the error interrupt. The error flags are not reset automatically, but must be cleared via register EFM after servicing. This allows servicing of some error conditions via interrupt, while others may be polled by software. The error status flags can be set and reset by software via the error flag modification register EFM.

A **Receive Error** (Master or Slave Mode) is detected when a new data frame is completely received, but the previous data was not read out of the receive buffer register RB. If enabled via CON.REN, this condition sets the error flag STAT.RE and activates the error interrupt request line EIR. The old data in the receive buffer RB will be overwritten with the new value and is unretrievably lost.

A **Phase Error** (Master or Slave Mode) is detected when the incoming data at pin MRST (Master Mode) or MTSR (Slave Mode), sampled with the same frequency as the module clock, changes between one cycle before and two cycles after the latching edge of the shift clock signal SCLK. This condition sets the error status flag STAT.PE and, if enabled via CON.PEN, the error interrupt request line EIR.

**A Baud Rate Error** (Slave Mode) is detected when the incoming clock signal deviates from the programmed baud rate (shift clock) by more than 100%, meaning it is either more than double or less than half the expected baud rate. This condition sets the error status flag `STAT.BE` and, if enabled via `CON.BEN`, the EIR line. Using this error detection capability requires that the slave's shift clock generator is programmed to the same baud rate as the master device. This feature detects false additional pulses or missing pulses on the clock line (within a certain frame).

**A Transmit Error** (Slave Mode) is detected when a transfer was initiated by the master (shift clock becomes active), but the transmit buffer `TB` of the slave was not updated since the last transfer. If enabled via `CON.TEN`, this condition sets the error status flag `STAT.TE` and activates the EIR line. If a transfer starts while the transmit buffer is not updated, the slave will shift out the 'old' contents of the shift register, which is normally the data received during the last transfer. This may lead to the corruption of the data on the transmit/receive line in half-

*Note: The error interrupt handler must clear the associated (enabled) error flag(s) to prevent repeated interrupt requests. The setting of an error flag by software does not generate an interrupt request.*

*Note: A slave with push/pull output drivers not selected for transmission will normally have its output drivers switched off. However, to avoid possible conflicts or misinterpretations, it is recommended to always load the slave's transmit buffer prior to any transfer.*
